# MONTHLY ELECTRICAL INCIDENTS

ASP Manufacturing

June 2020

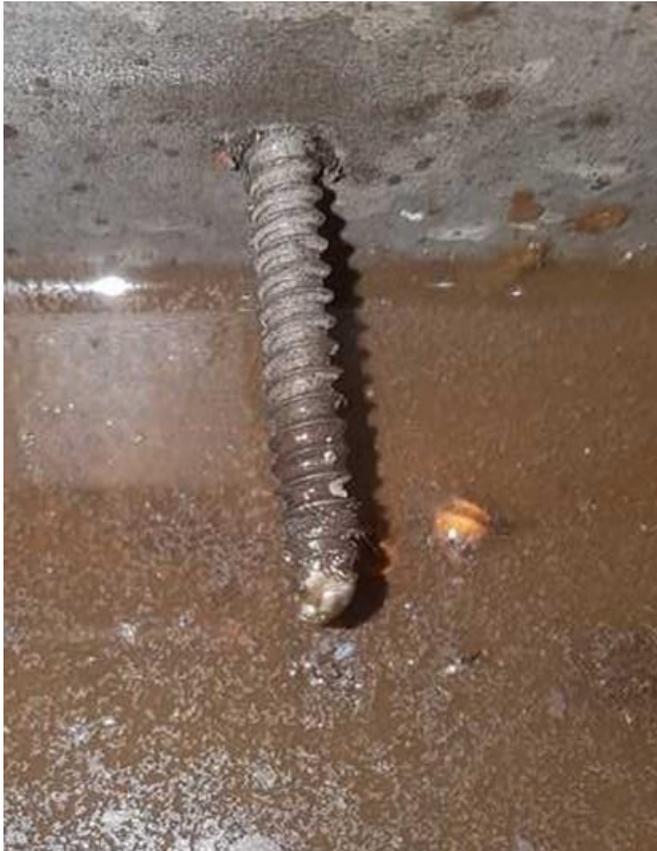
A plumber repairing water pipes noticed a cable running parallel to pipes to be embedded with a wall cladding screw. The cable had been run on top of horizontal wall purlins installed in the early 70s. The cable, a 4C+E 16mm<sup>2</sup>, was supplying a three phase outlet with all three phases still energised. A close inspection of the cable found the screw had penetrated the white phase, the tip of the screw has melted and separated from the conductor and blown the fuse. The belief is that the fuse has been replaced as cable damage could not be found, and the circuit has been in service since.

The wall cladding screw with the melted tip.

Care must be taken to ensure cables are installed with adequate protection, follow the Electrical Installation manual and AS3000.

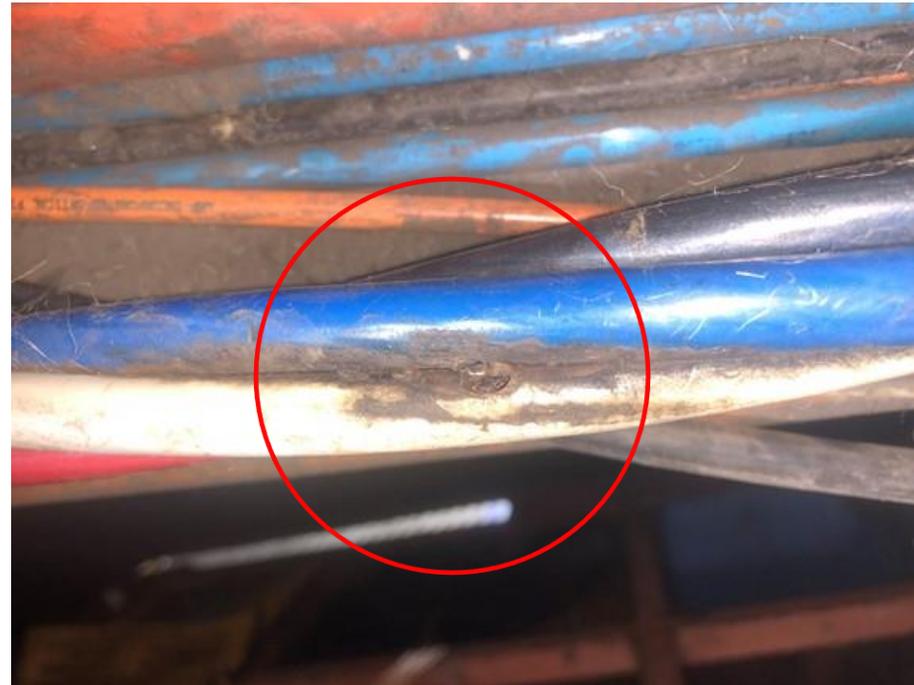
The damaged cable with the outer sheath removed showing the damage to the white phase.

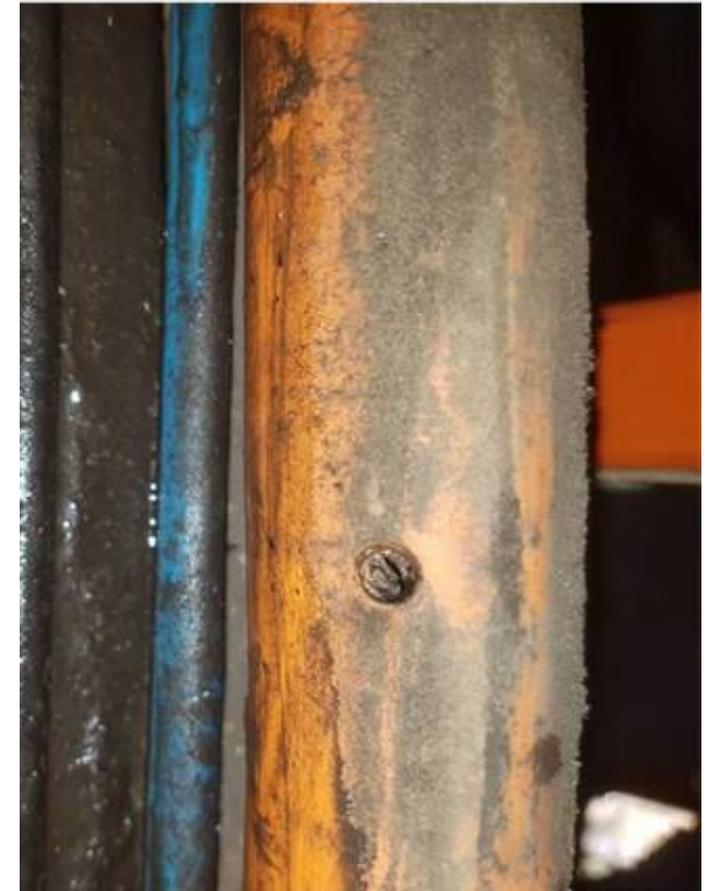
The damaged cable as found.

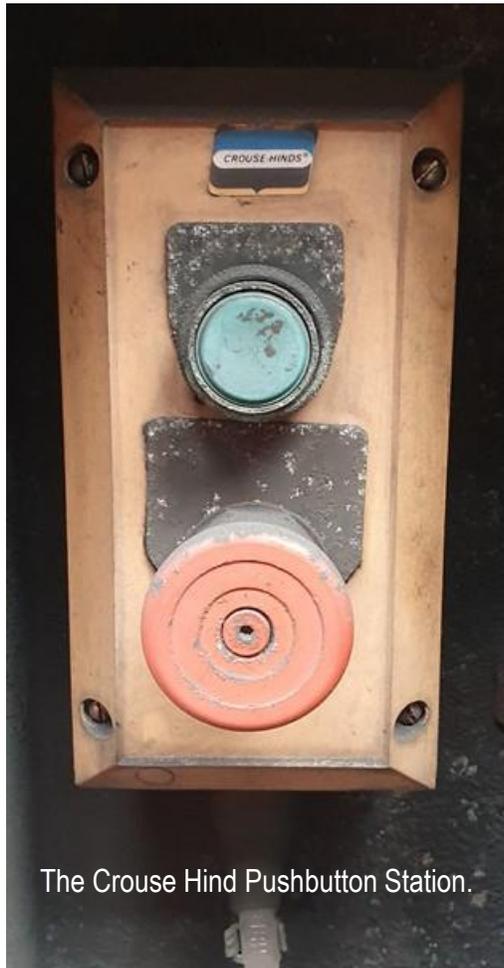
Electricians completing routine maintenance on Stop/Start pushbutton stations found the door gasket to be a fibrous type material. The gasket was tested and found to contain Chrysotile Asbestos. The brand is Crouse Hinds and was installed in approximately 1987. Older electrical equipment may contain hazardous substances such as Asbestos Containing materials (ACM), follow asbestos management procedures whenever suspect material is encountered. Equipment suspected of containing hazardous substances must be identified and managed, refer Electrical Safety Manual section 1.4.2.4 and site specific hazardous substance management procedures.

The Crouse Hind Pushbutton Station.

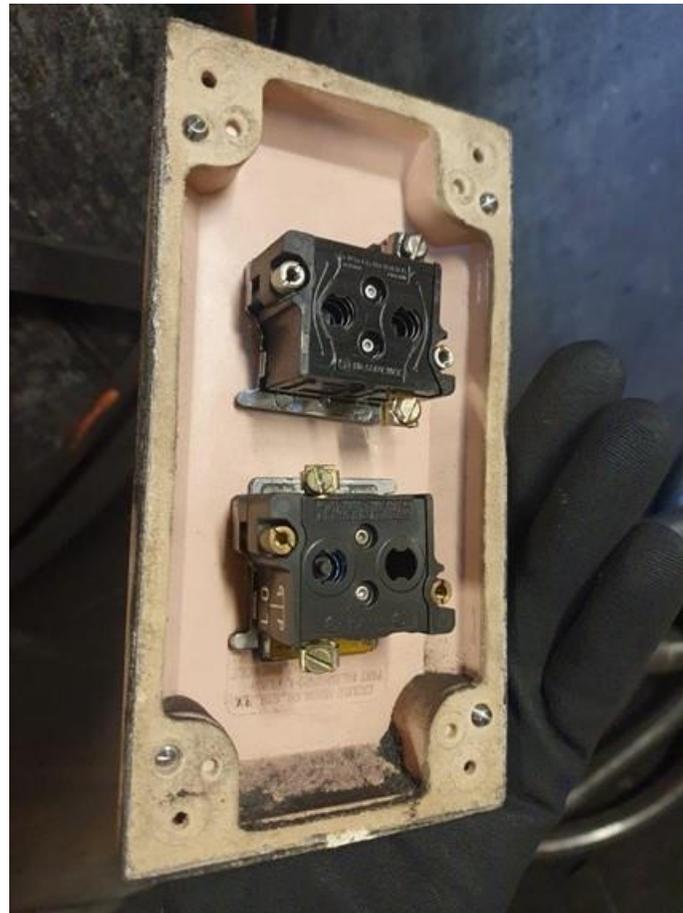
The inside of the front cover of the Crouse Hind Pushbutton Station.

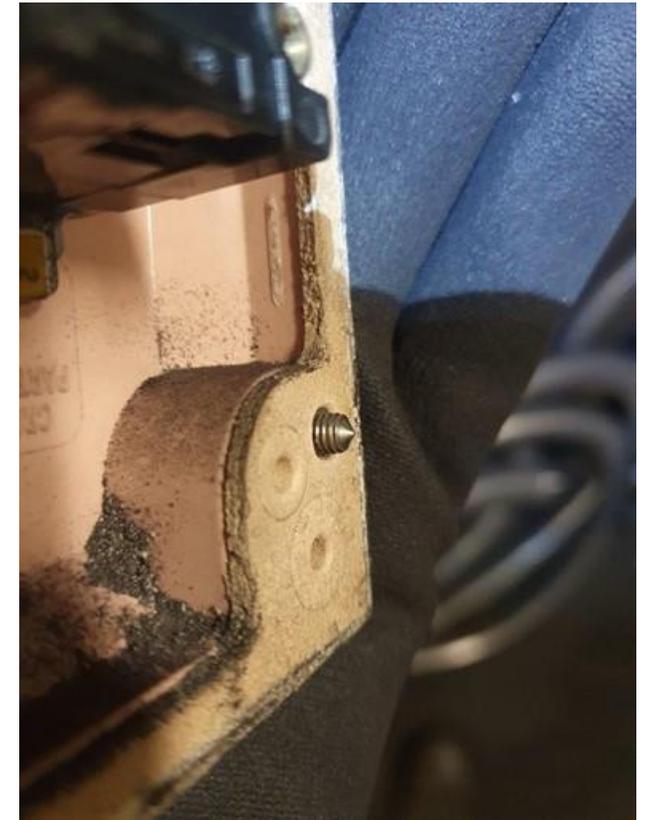
A close up view of the gasket

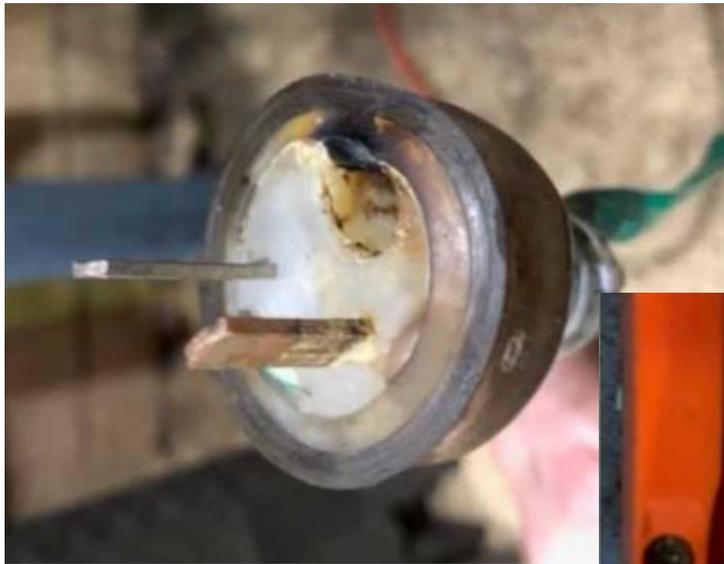
Two examples of old heaters being used without adequate inspection and testing, leading to damaged plugs and sockets. In one case the neutral pin of the heater lead remained stuck in the socket outlet whilst it was being removed, in the other case both the active and neutral pins remained stuck in the socket due to overheating at the outlet. Both electric heaters were old and should have been removed from service. The compliance tags had expired and the outlet sockets had poor spring tension resulting in high contact resistance.

The plug of the lead with the neutral pin missing and showing signs of heat.

As per Electrical Safety Manual section 1.4.11 all portable electrical appliances should have a visual inspection on a regular basis to confirm they are fit for duty. In cases where the equipment is permanently plugged into an outlet the equipment should be inspected when a compliance test and tagging is being conducted. Outlets should be inspected when the RCD compliance test is conducted.

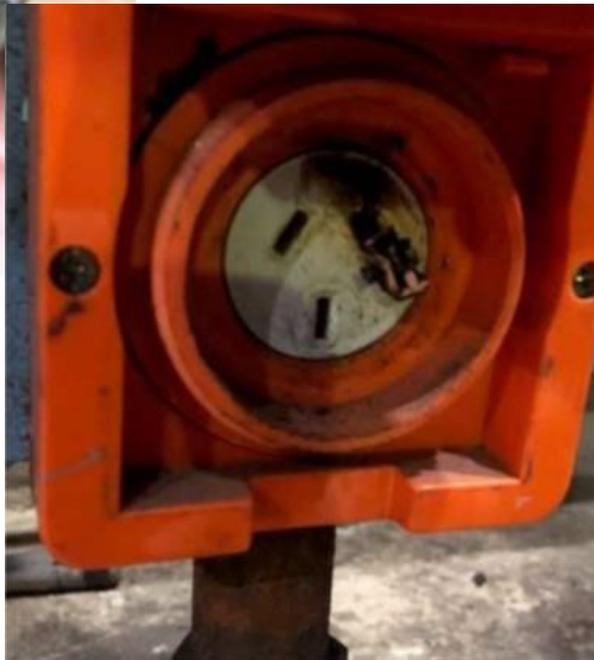
The socket outlet with the neutral pin still inserted

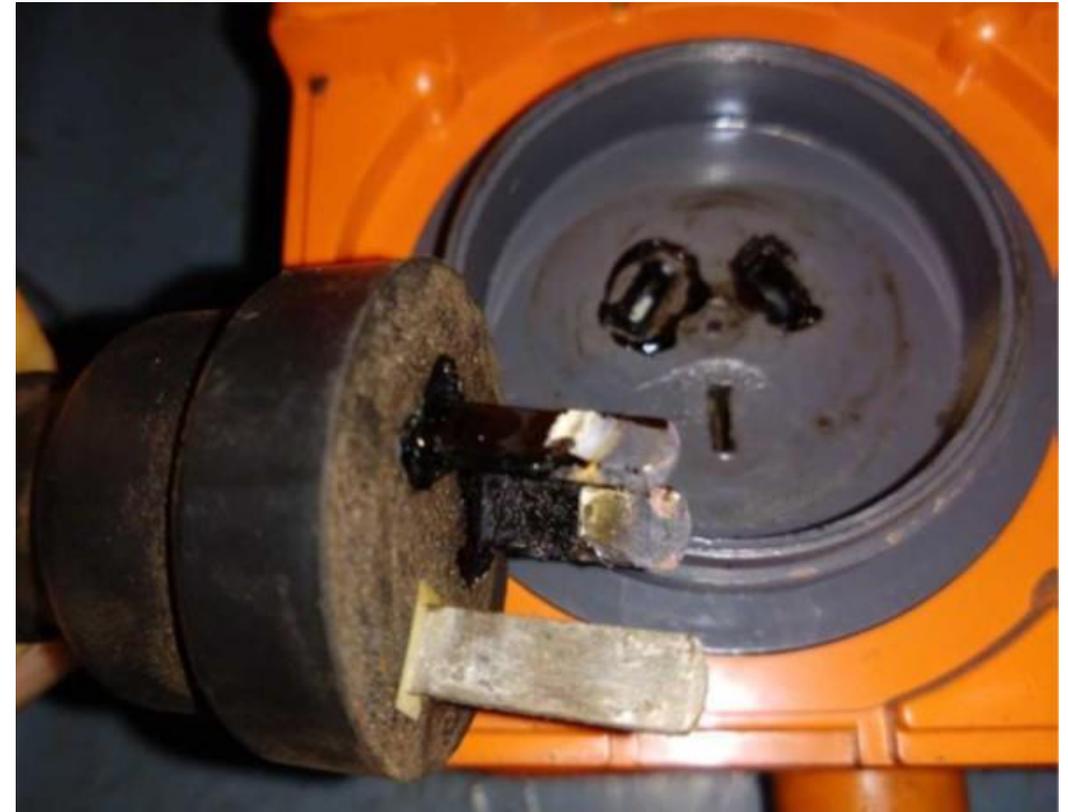
Both pins of the moulded plug of the heater show signs of heat and melted plastic.

Note the melted marks on the socket outlet

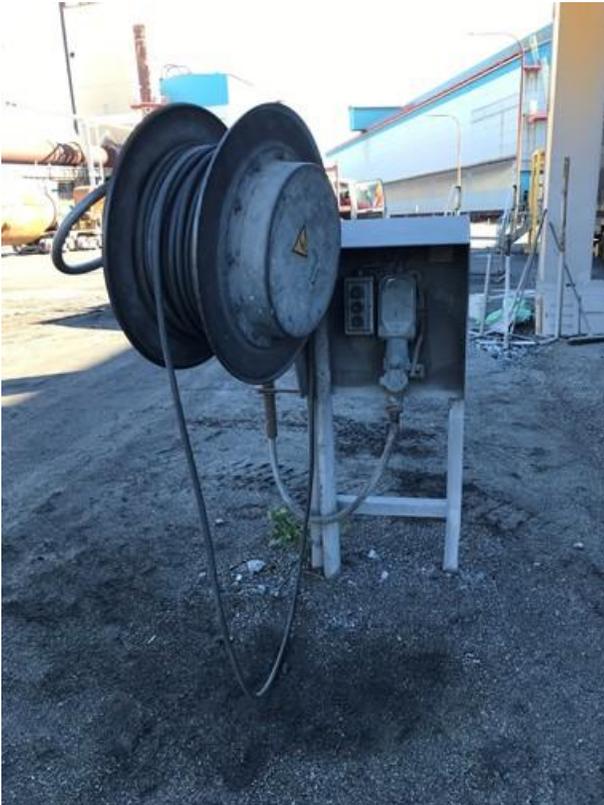
A forklift moving in the reverse direction with a large wide load has struck the Torpedo ladle turning outlet station. The extension lead coming from the outlet station to a Torpedo ladle has been damaged leaving exposed conductors. Fortunately at the time of the incident the outlet station isolator was turned off. Extra care should be taken with mobile machinery near electrical equipment, if the driver is unsighted then an observer should be used.

The Torpedo ladle turning outlet station front view.

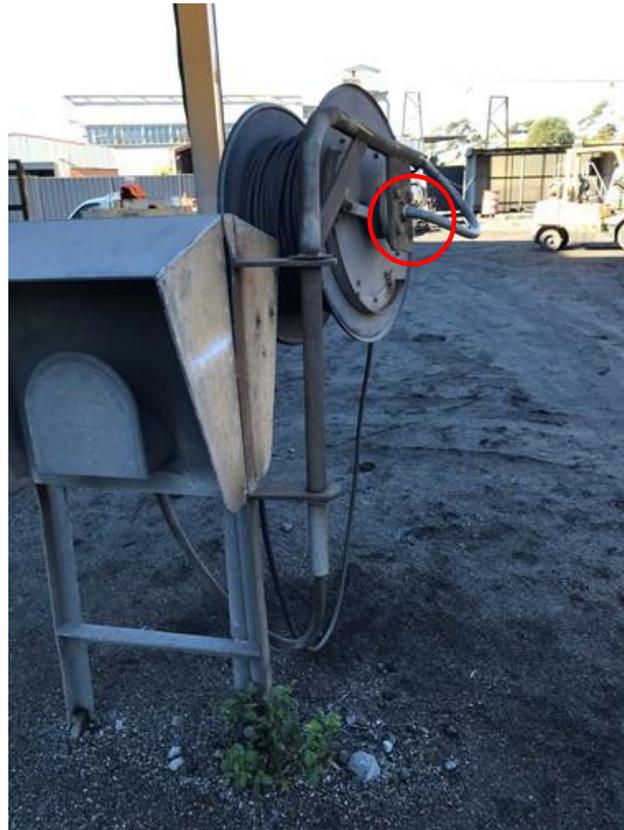
The Torpedo ladle turning outlet station rear view.  
Note the point of contact with forklift load

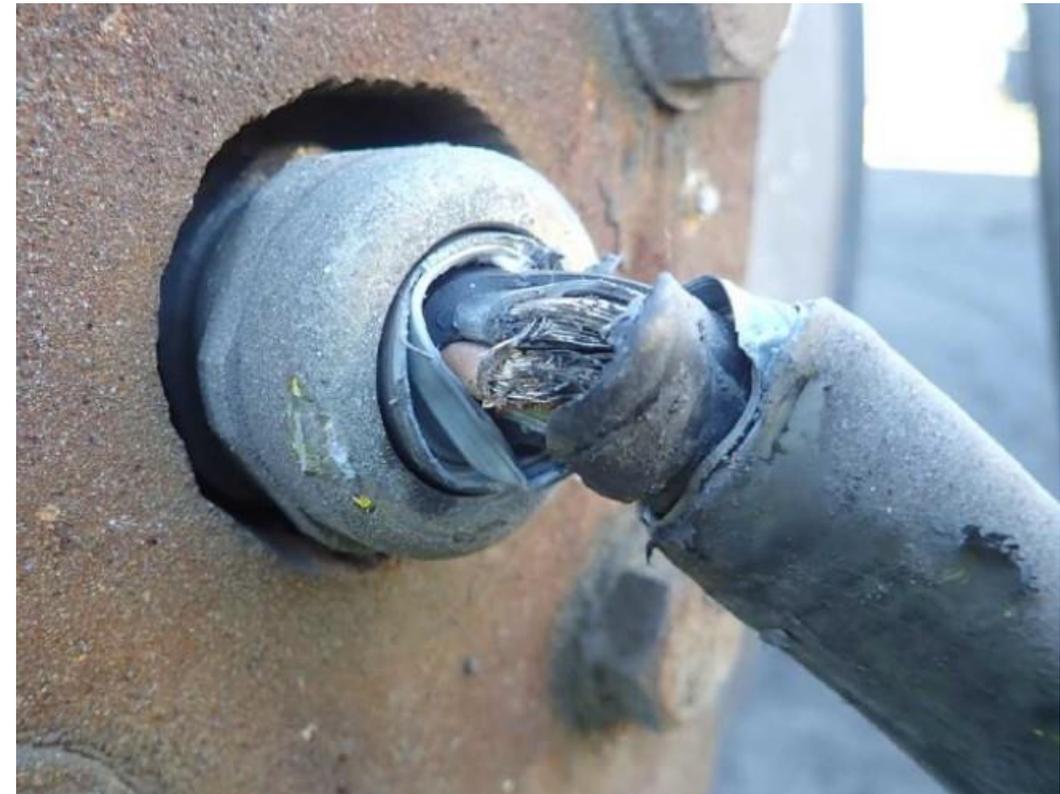
Close up view of the cable damage and exposed conductors

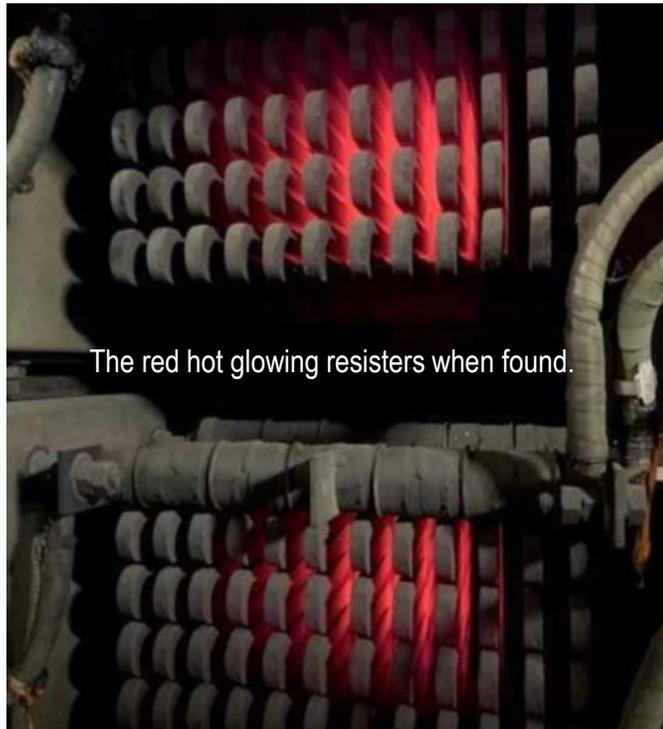
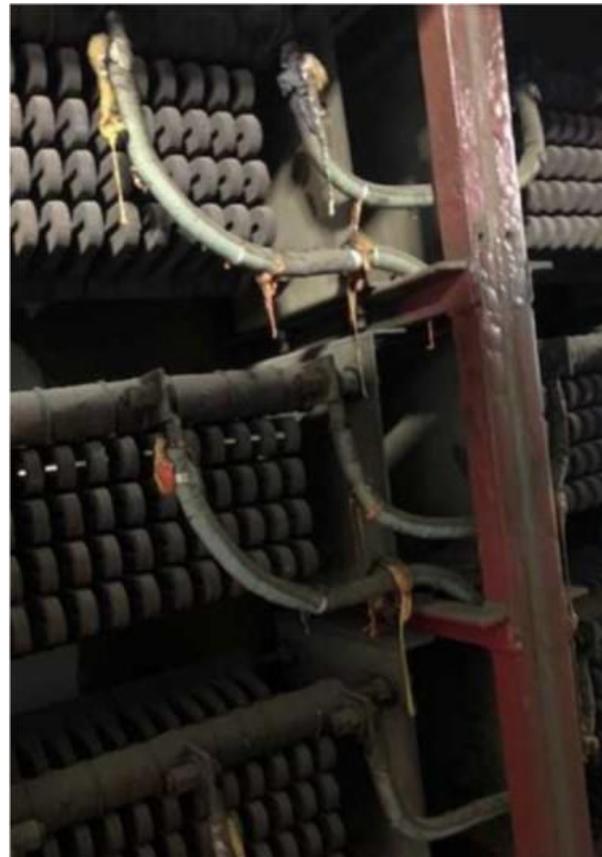
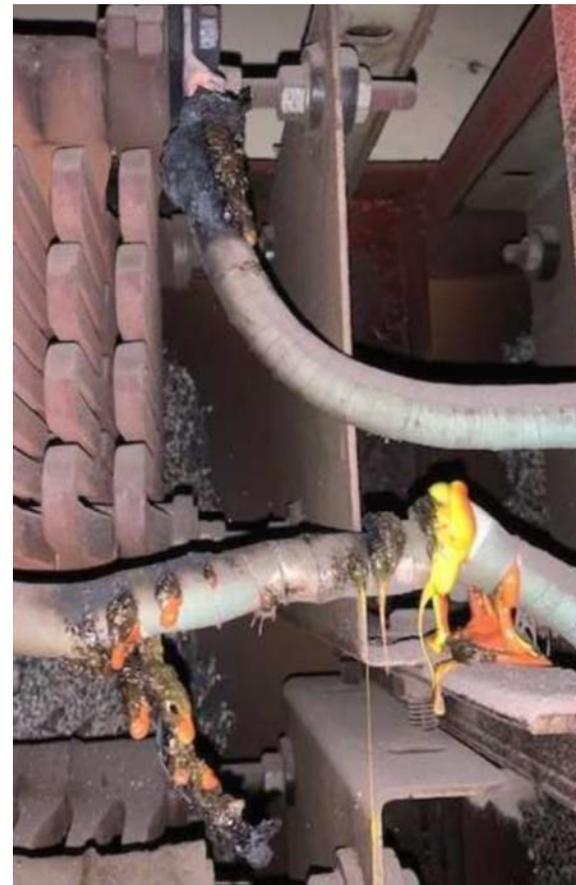
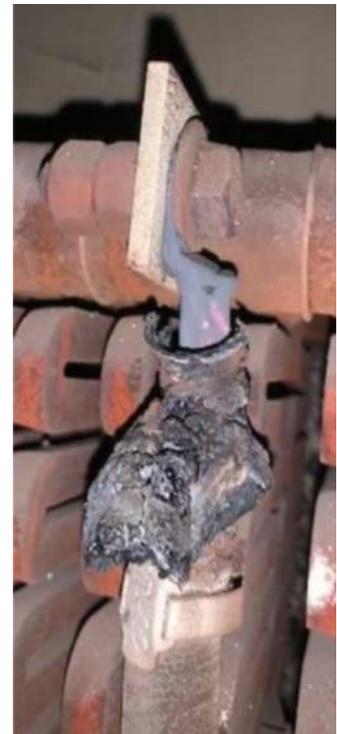
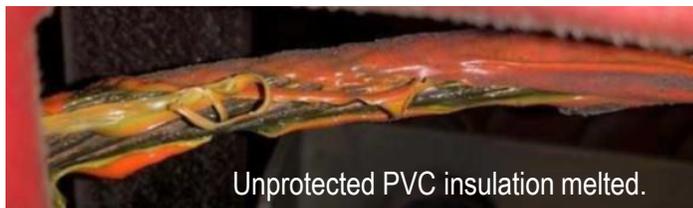
An operator observed smoke coming out of CH1C switchroom. An electrician investigating has found the smoke coming from No.3 Steel car resistor panel with the resistors running very hot and a lot of the PVC insulation on the cabling melting. A sequence of events lead to this damage: an operator left the steel car control station before the car has finished traveling assuming it will stop by itself, the controller became jammed in 1<sup>st</sup> step allowing the car to travel to the end stop and continue to attempt to drive south, and finally the south end travel infrared limit has failed due to the reflector being dirty. With all these events the south contactor has remained energised, the 415V 75kW motor continued to try drive south and the resistors have sustained approximately 100amps for a considerable time. All the PVC insulation had melted from the resistor cables where they were not protected by heat resistant tape, which is believed to be asbestos tape.

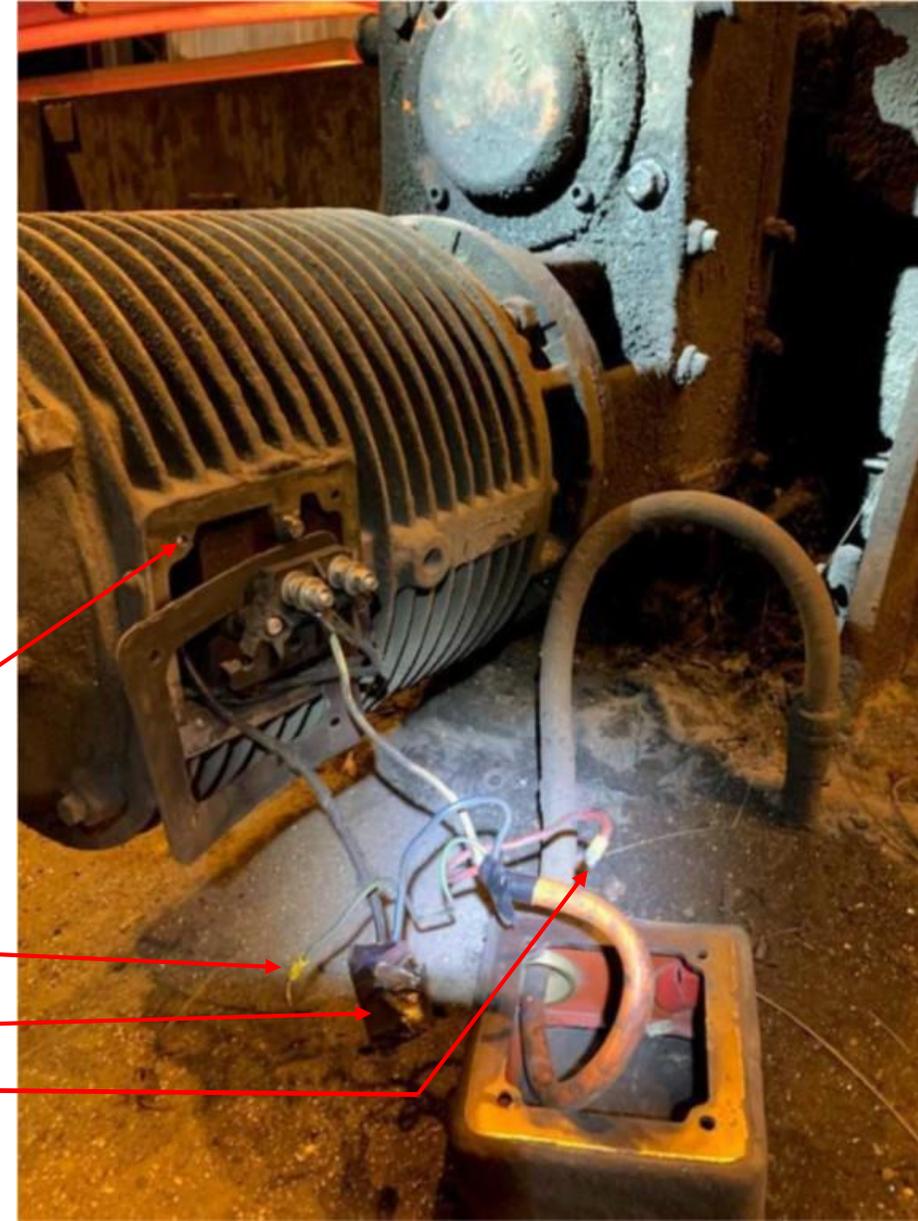
A shift electrician called to find out why a motor trip alarm was active has found a motor in a state of disrepair. The motor terminal box with the lid attached was found on the ground next to the motor and all terminals exposed. The internal holding screws of the terminal box had either worked their way loose and fallen off or become sheared off.

It must be noted that this motor is part of a table roll which traverses very hot 20 tonne slabs. The action of the slab over the roll causes a lot of vibration to the motor. The motor, terminal box screws and terminals are checked and maintained on a 12 weekly basis.

The table roll motor and terminal box when found.

Note the following damage

- Sheared off holding screw stud
- Protective earth wire detached from the earth stud
- Broken terminal block with blue phase
- Red phase lug broken from the terminal block

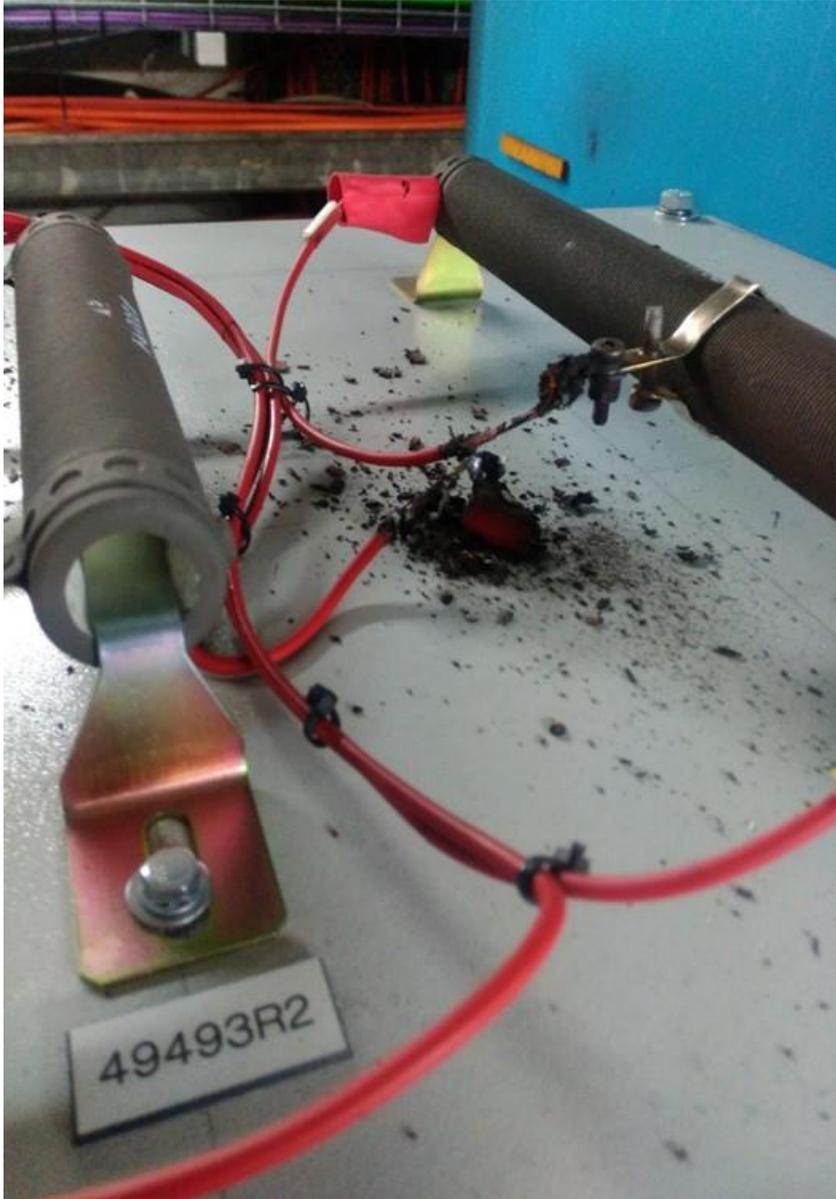
During fault finding why strip was slipping on a bridle roll it has be found the brakes were not lifting. Investigation found an open circuit in the brake resistor circuit due to a hot joint. A closer inspection of the connections to the resisters has found the connection lug was not crimped correctly when installed two and half years ago. All terminations must be completed using the correct size lug for the conductor and the correct crimping tool. Check the crimping and torque settings of tools during construction and continuity of connections during commissioning.

What was found of the brake resistor terminations on top of the drive panel.

Note the wire and lug have completely fallen from the termination point.
