MONTHLY ELECTRICAL INCIDENTS

ASP Manufacturing

July 2020

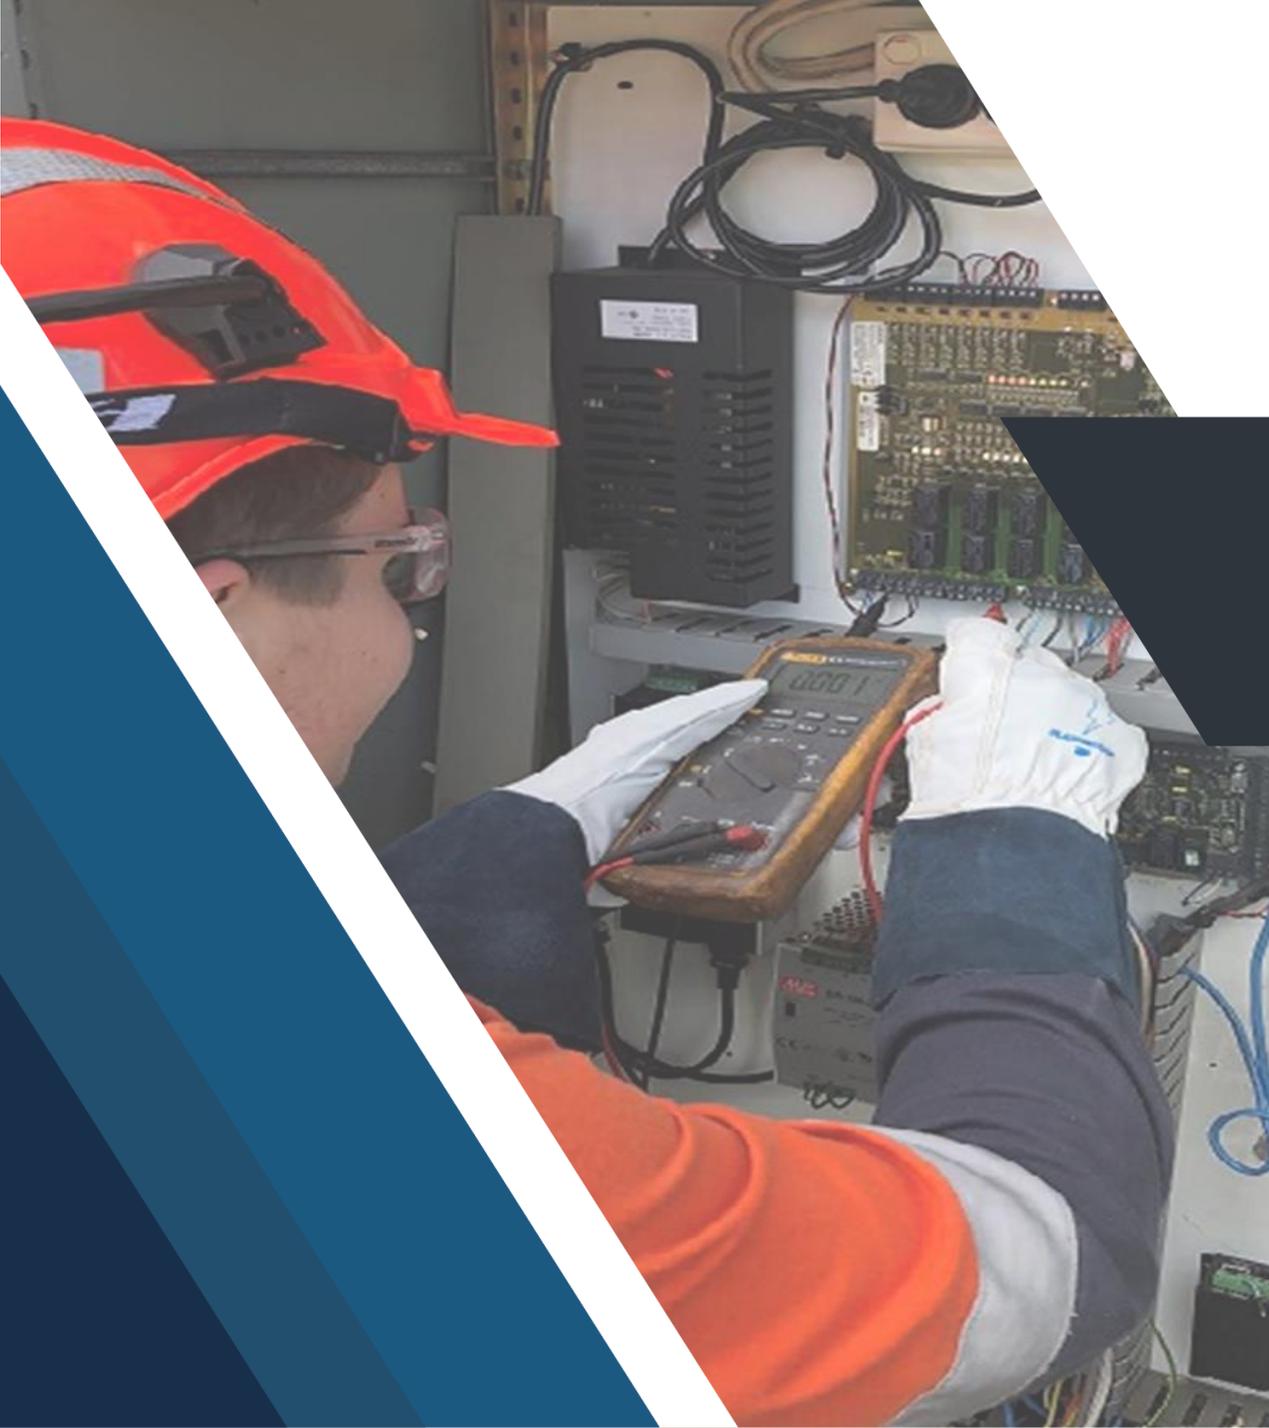
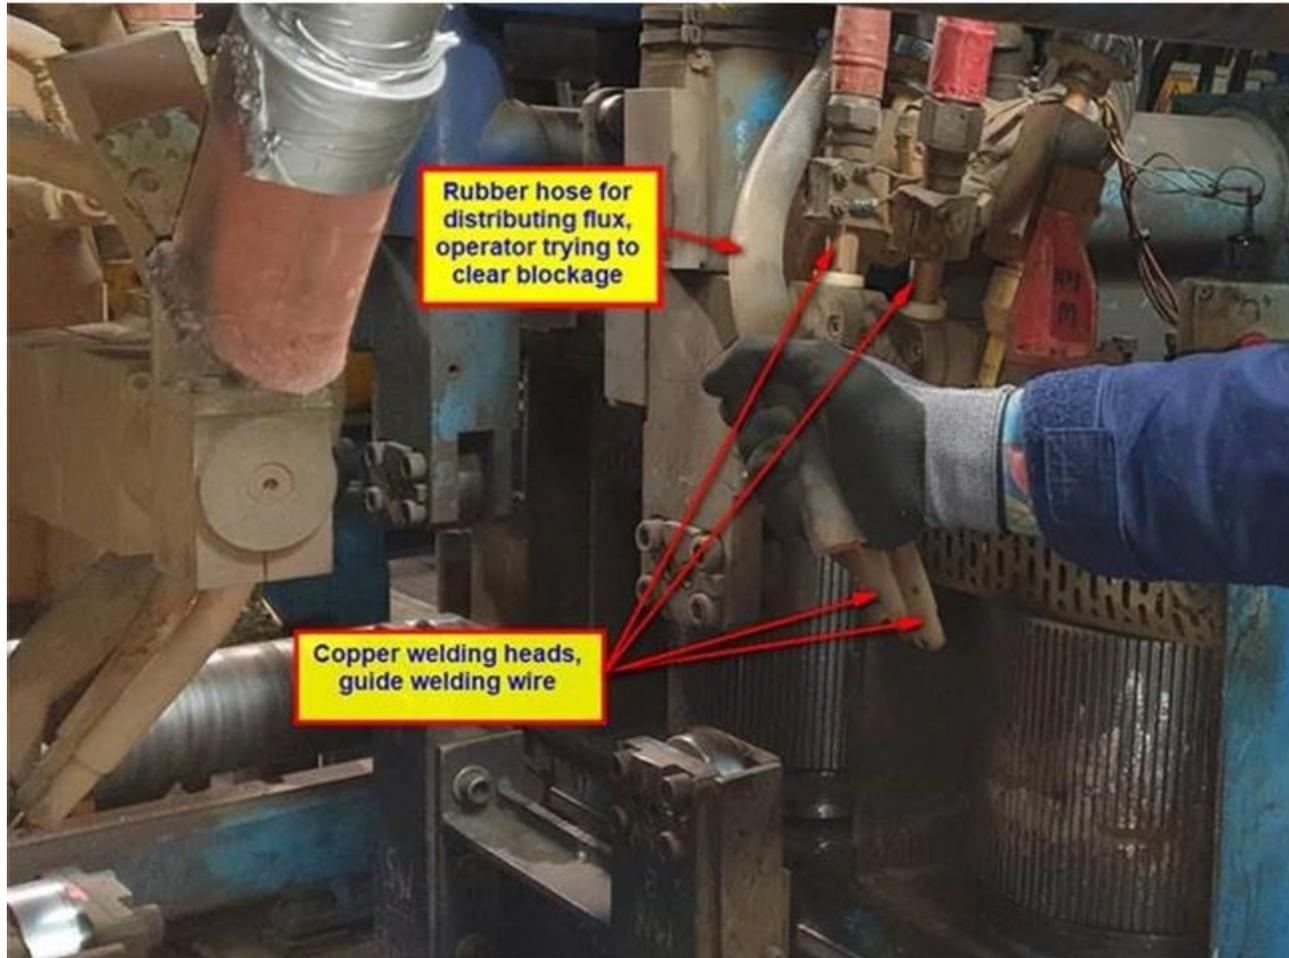
An operator received an **electric shock** to the right hand while adjusting a blockage from the flux hopper on a beam welding machine. The machine has two wire feeders which place welding wire onto the beam adjacent to the flux hopper which allows flux to fall onto the section being welded. When setting up before commencing a weld the wire feeders can be inched down onto the beam, the wires energised with 25 Vac complete a circuit with the earthed beam and finally initiate the flux hopper solenoid to operate. With the blockage in the hopper the operator was holding the PVC/rubber flux hose below the hopper with the right hand and pressing the inch button with the left hand when the back of the right hand came in contact with the energised wire feeder head guides. At the time the operator was sweaty and wearing cut resistant gloves. A solenoid manual override release handle on the hopper was not used in this instance. Operating procedures and practices are being reviewed.

The flux hopper, with the manual override switch and handle

The two insulated wire feeder tubes

The PVC/rubber hose for the flux distribution which was being held by the operator

The two energised copper welding head guides which were contacted by the operator.

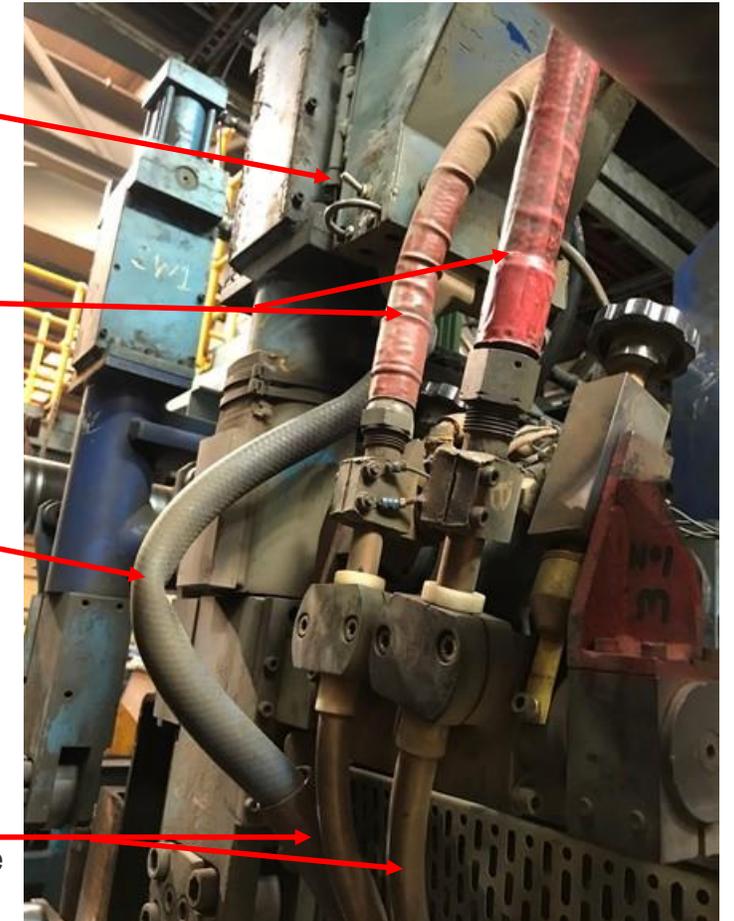
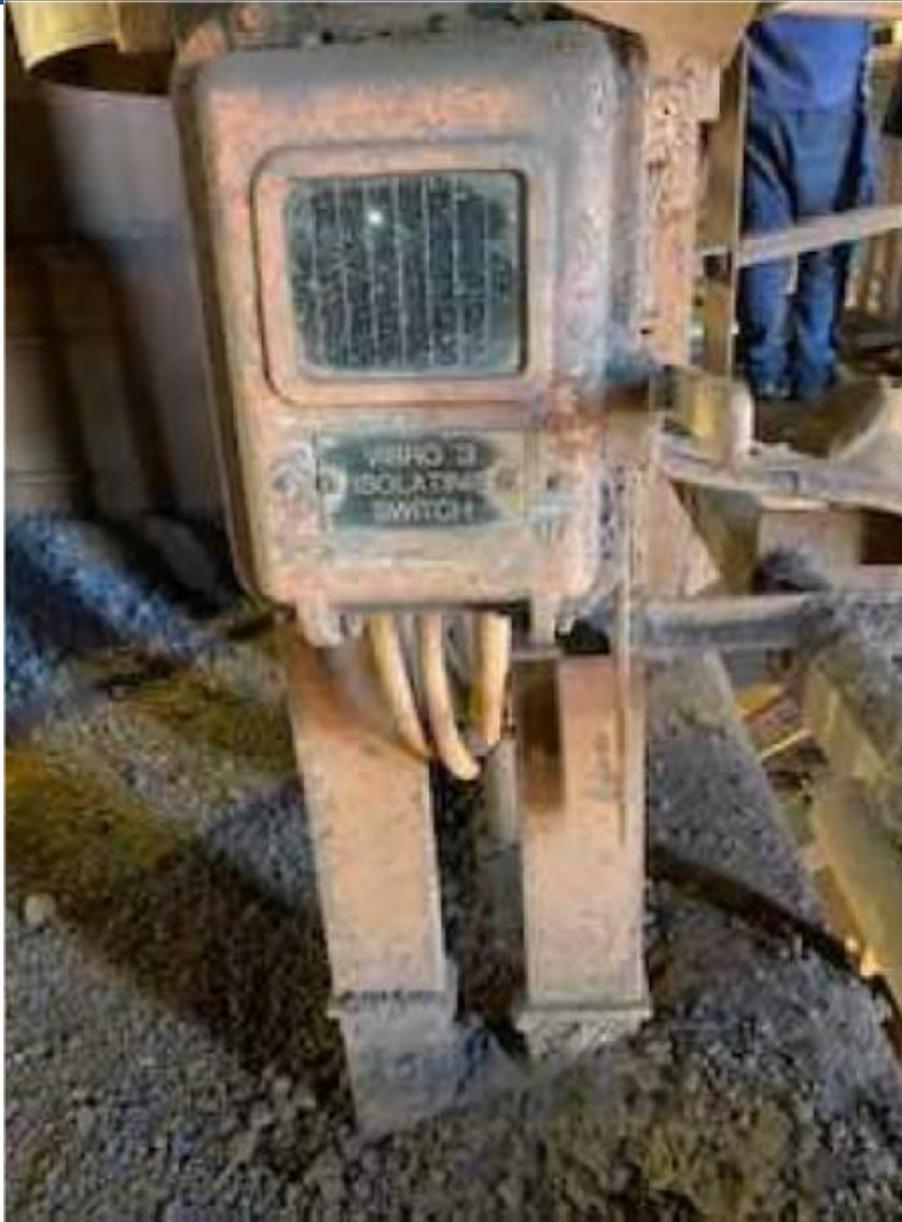
No.3 screen chute vibro failed to stop when the screen was shutdown by automation control. An operator responded to vibro alarms and attempted to stop the unit using a local stop push button, this also failed to stop the vibro. A shift electrician was unable to attend, so the shift controller assessed the risk in conjunction with the electrician and instructed the operator to shut the vibro off using the local off-load isolator after reducing the vibro to idle speed. The local isolator is not intended for interrupting a machine under load.

The off load isolator switch mounted next to the vibro drive.

As per Electrical Safety Manual section 1.4.3.7 'performing operating work in close proximity to live equipment may result in arc blast and flash burn injuries'. To manage this risk never compromise safety for operational pressures, identify all the hazards, use appropriate PPE and do not operate switches under load unless designed for that purpose.

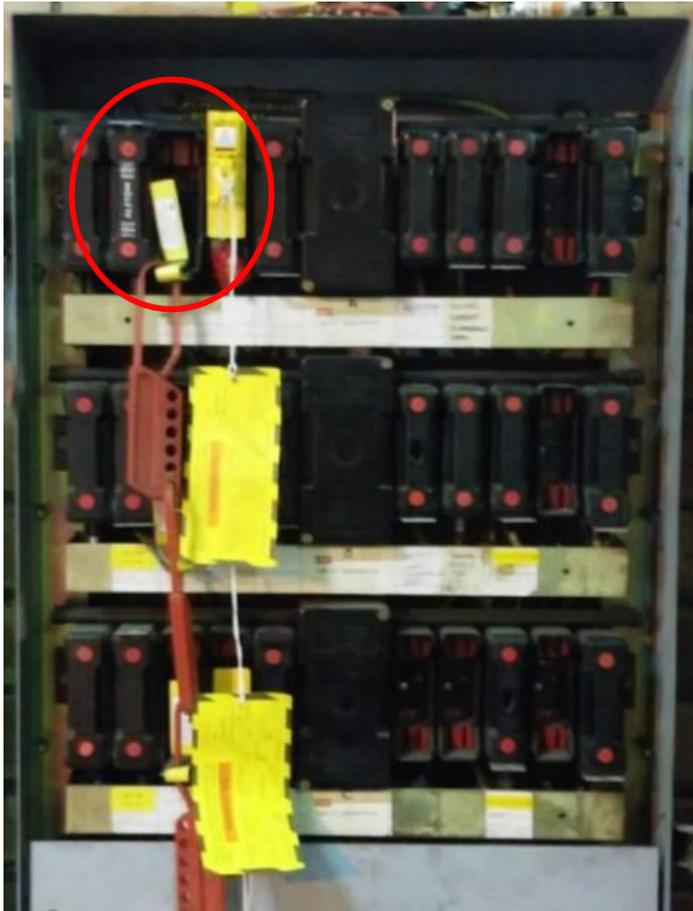
Electricians have found a hot joint in a fuseboard after reports of the power and lighting intermittently working in the site sheds it supplied. The red phase of the three phase feed to the site shed was found to have a burnt conductor at the bottom of the fuseholder. A closer inspection revealed the bottom of the fuse holder has been destroyed by the hot joint, the spring-loaded section of the fuse base came away with the fuse carrier when it was removed.

The Fuseboard with the fuse indicated .

Fuseboards require periodic inspection and maintenance. Checking the tension of screws securing conductors and fuse holder spring tension should be part of maintenance procedures to prevent this type of incident from occurring.

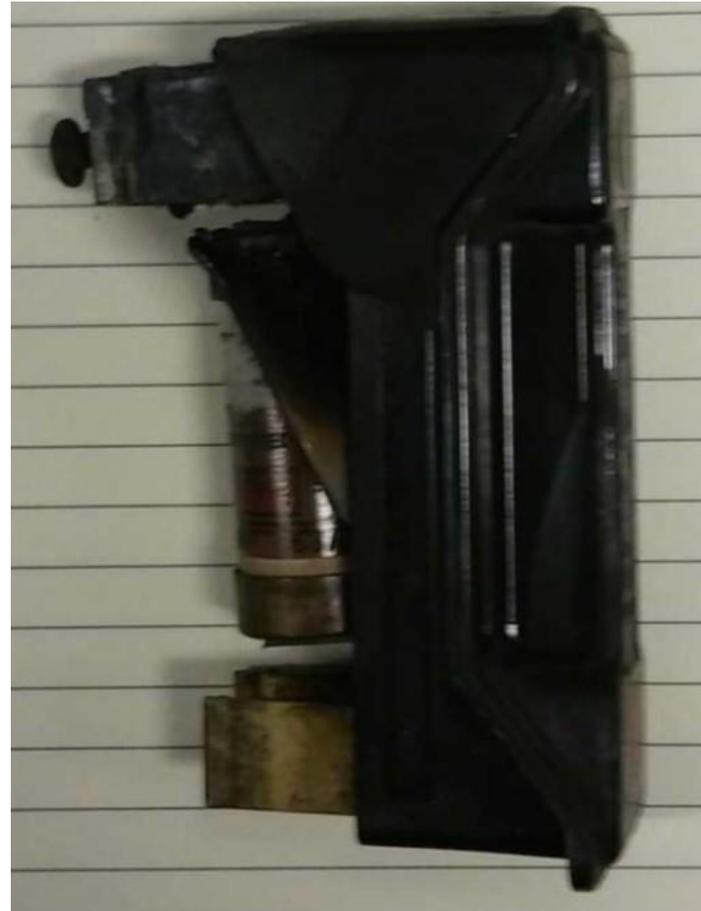
The fuse carrier removed with the spring-loaded section of the base still attached.

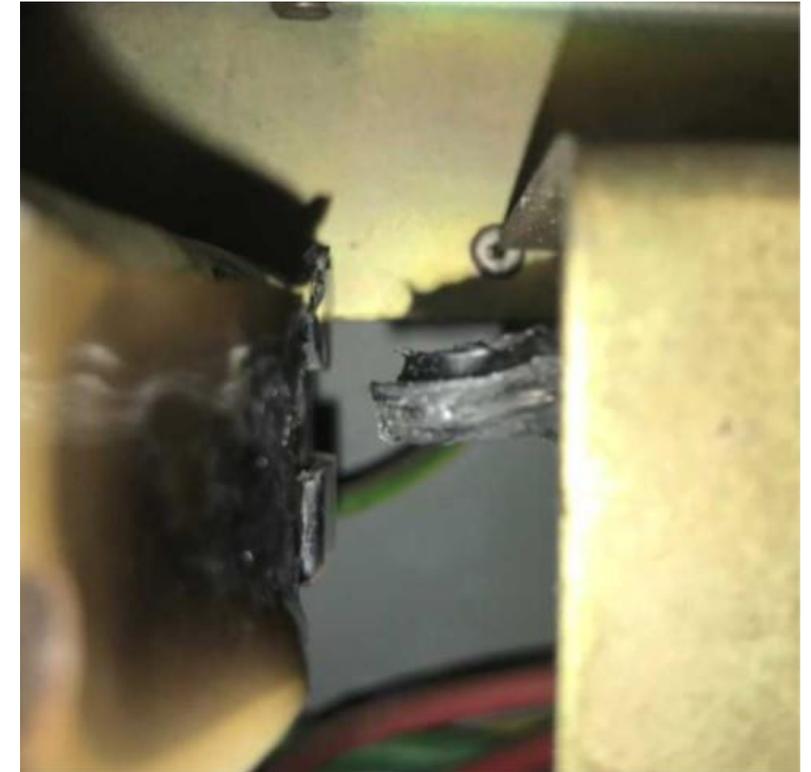
A close up of the burnt wire at the base of the fuse.

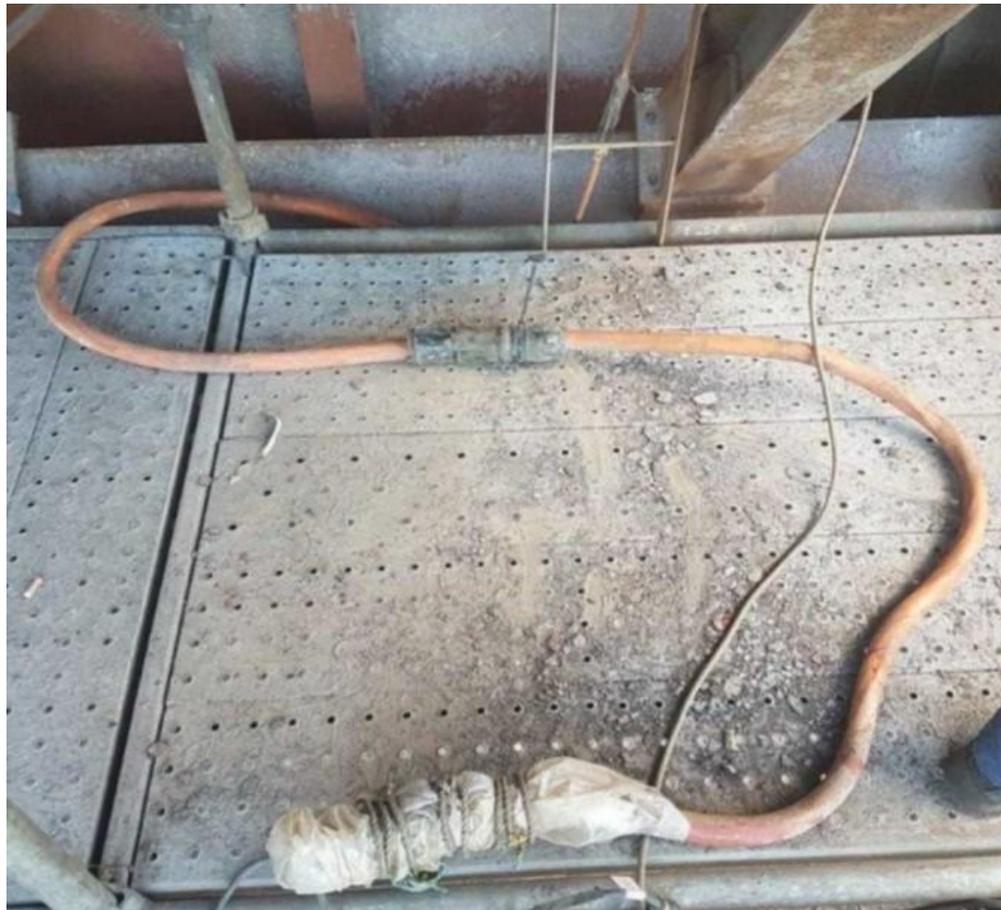
Significant damage was identified to insulation on a cable supplying a de-dusting fan motor when the motor and fan were removed for replacement. The cable sheath was worn through at points in contact with the cable rack exposing insulated cores, the earth core conductor was completely exposed. The cable rack was an old style construction featuring round bar support braces and the installation was subject to significant vibration from the fan and vibros operating below. It's essential cables are installed with adequate support and protection for the operating environment. Cable racks and conductive parts supporting electrical equipment must be adequately earthed or equipotential bonded to restrict touch potential should insulation failure occur.

The disconnected motor cable with the round bar cable rack in the background which was used to support the cable

Several different views of the damaged cable

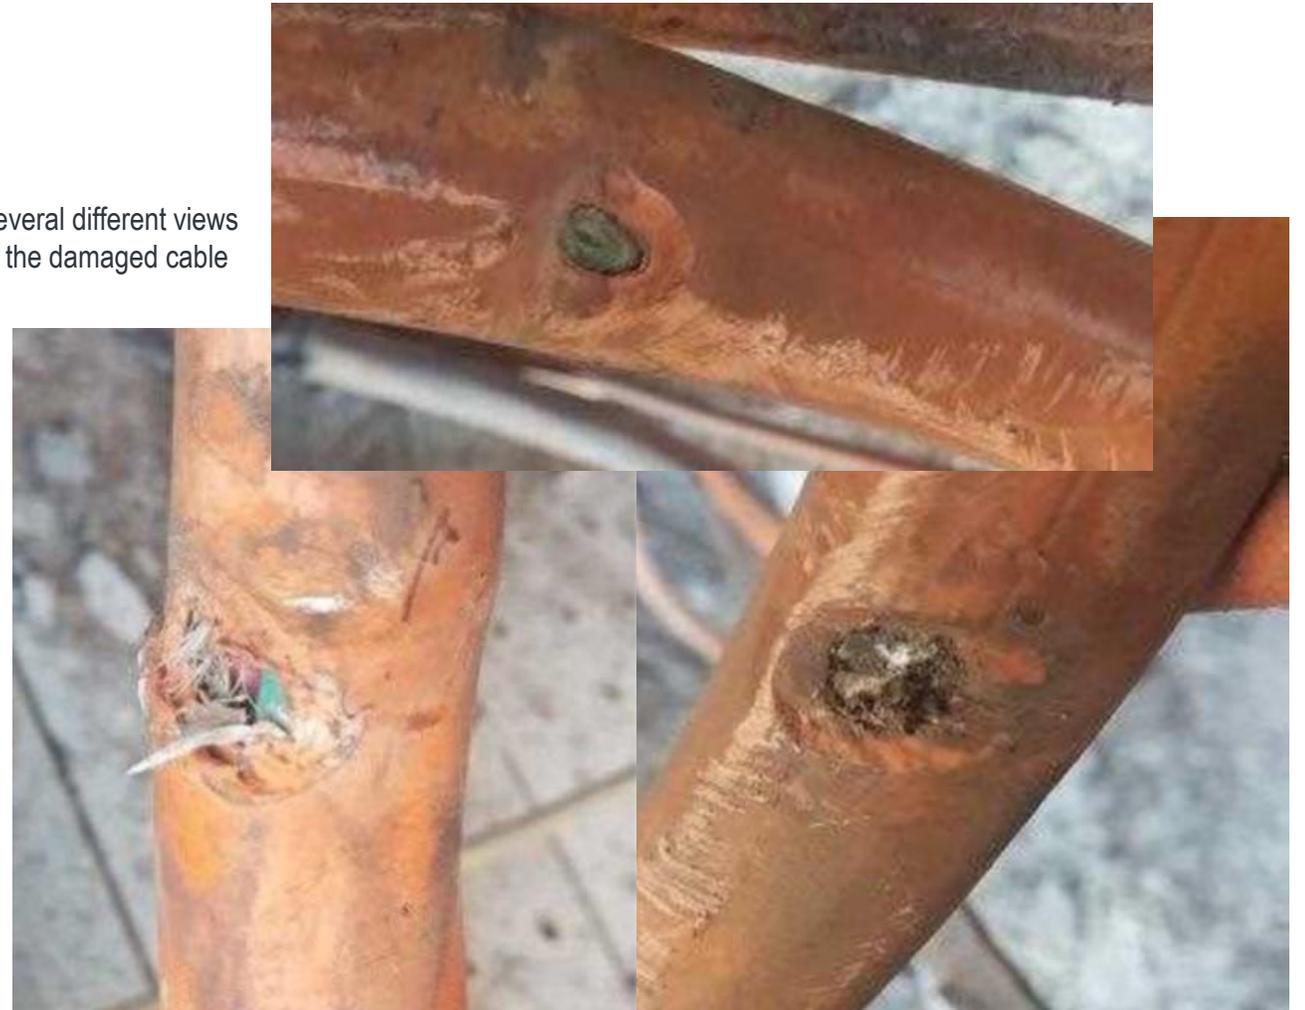
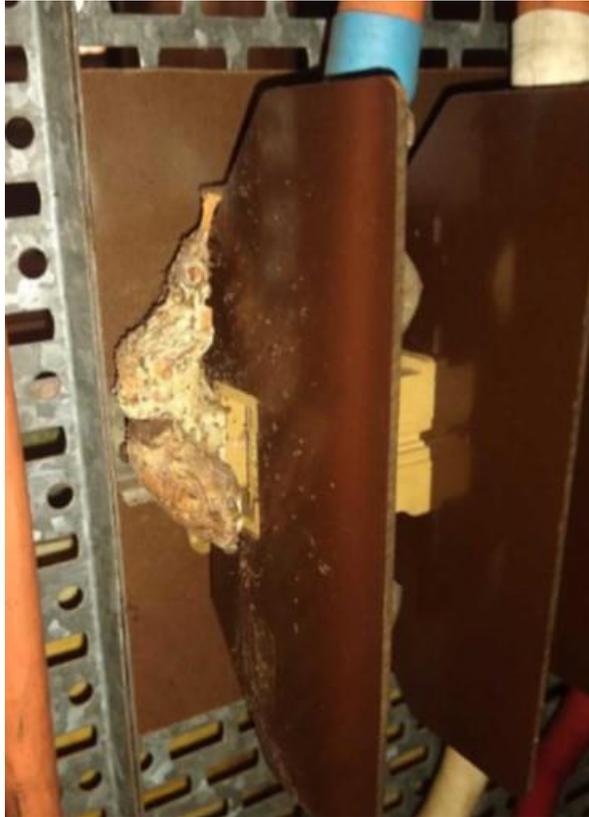
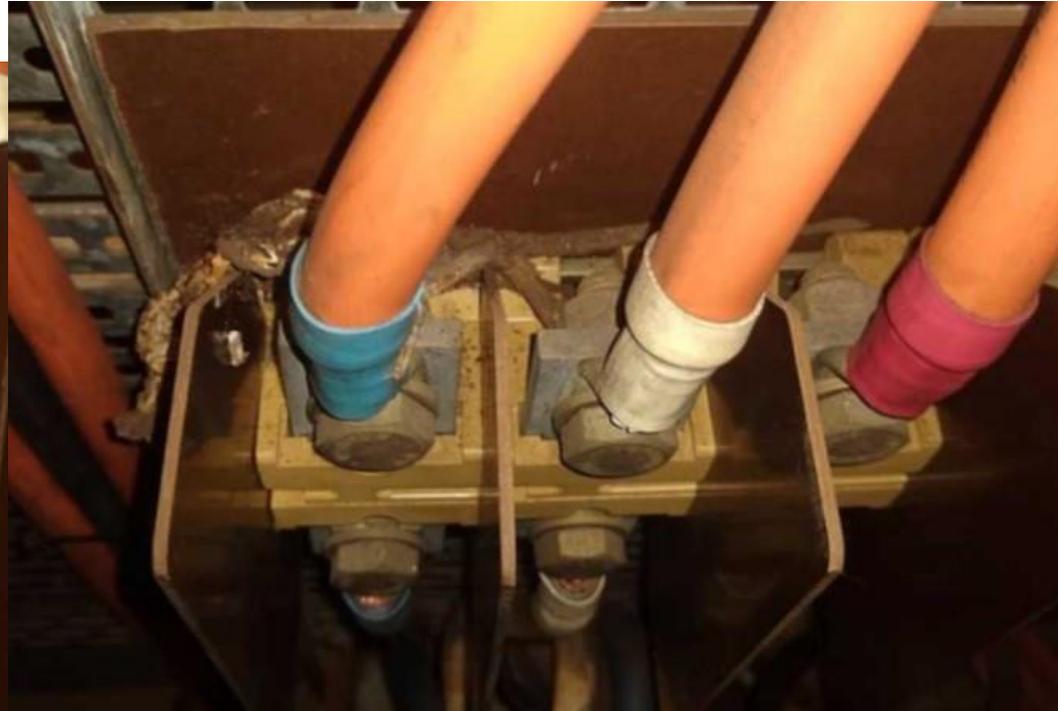
During isolation and Test Before You Touch verification of No.2 Grinder for a motor and drive upgrade an unpleasant discovery was found on the incoming power supply cables. An emancipated mouse was found across two of the phases which had been there quite a while. Switchrooms and panel openings must be secured against vermin for reliable operation and to reduce fire risks.

A side view and top view of the main incomer terminations.

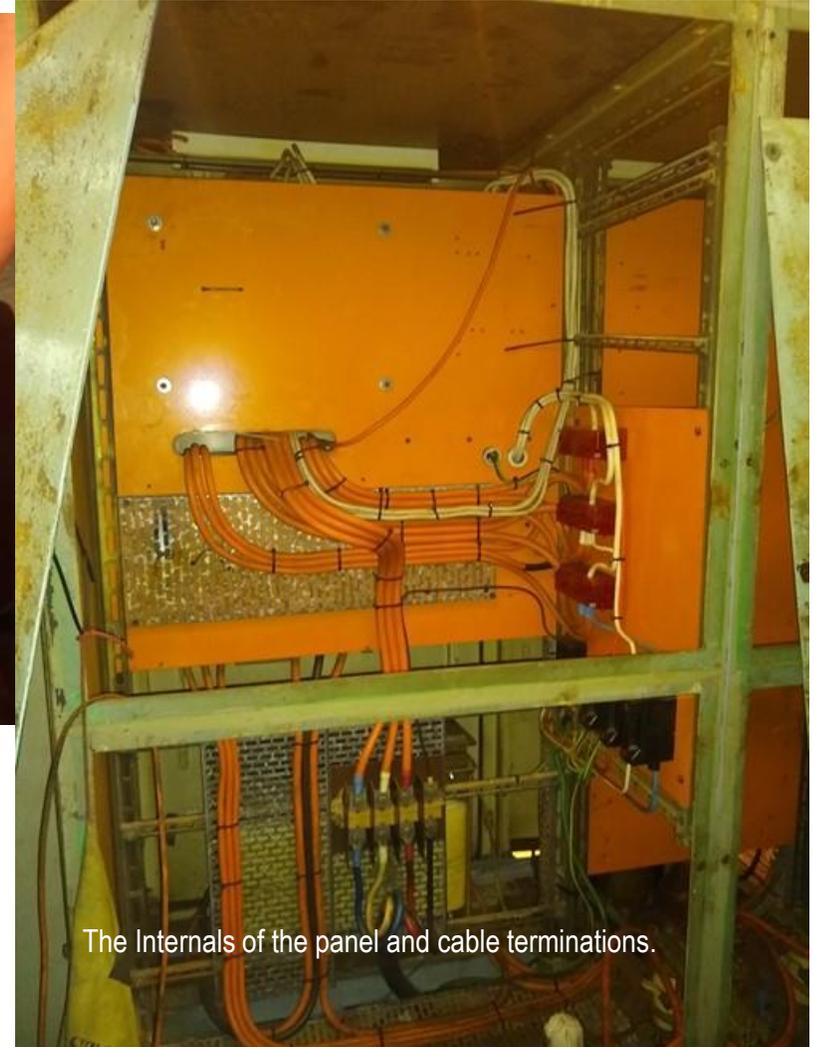
The Internals of the panel and cable terminations.
