SAFETY BULLETIN

DATE: MARCH 2019

Welding-related electric shocks increase

This safety bulletin provides safety advice for the NSW mining industry.

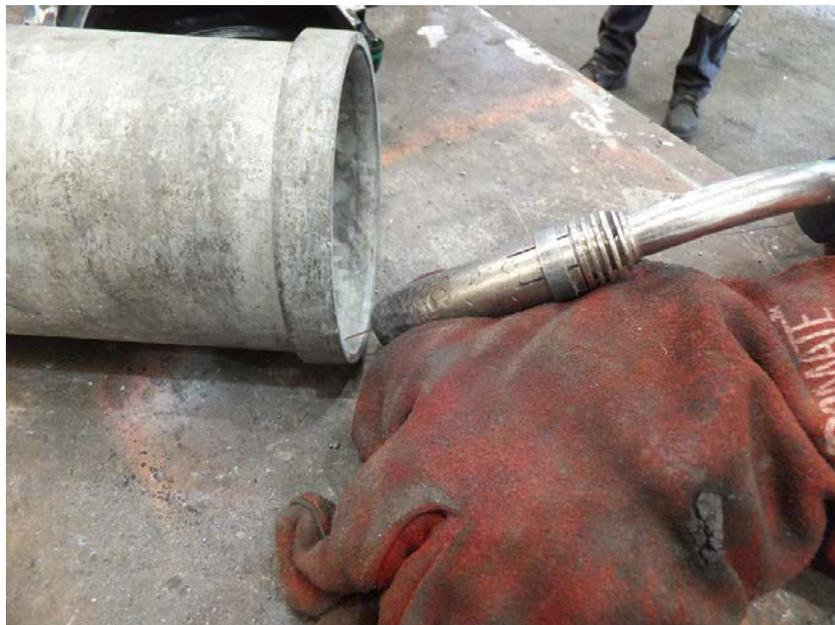
A worker was using a MIG welder in a surface workshop of an underground coal mine. The worker rested the handpiece tip on his gloved hand to steady the handpiece. The worker then felt a shock in his left hand.

Figure 1: Shock while welding pipe

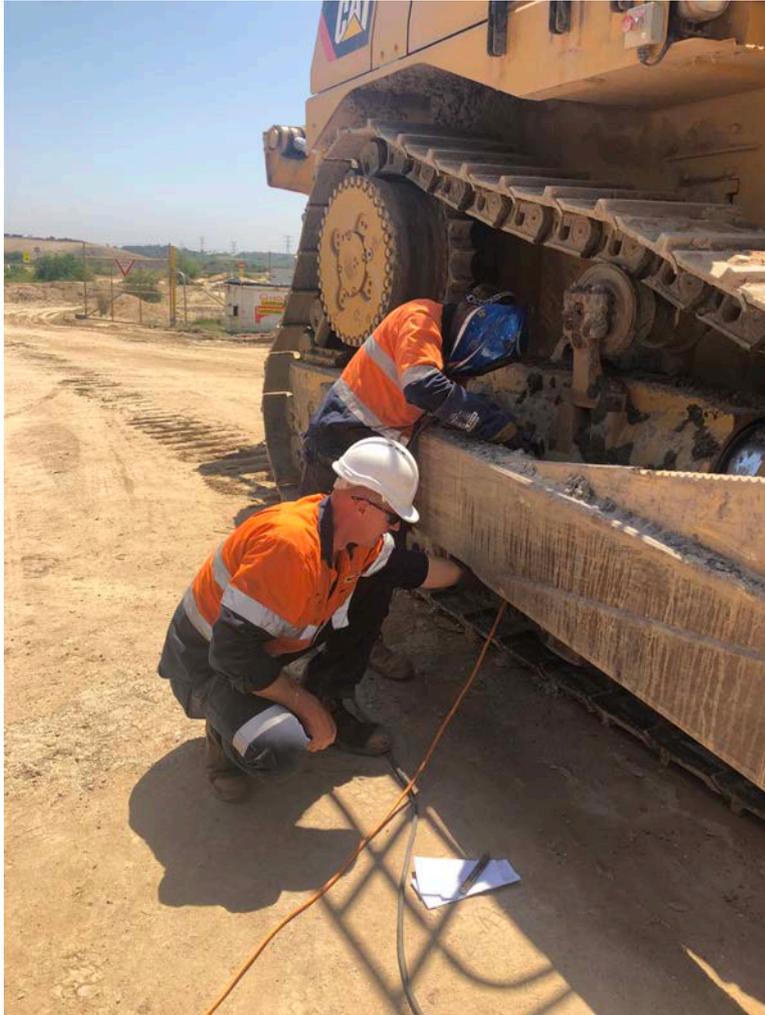
A fitter had washed down a dozer in a sand mine and was preparing to weld. Another worker saw the fitter positioned awkwardly so went to assist. After getting a welding glove, he held a pipe in place. The worker felt a tingle up his arm when the fitter struck the arc.

Figure 2: Re-enactment of assistant suffering an electric shock

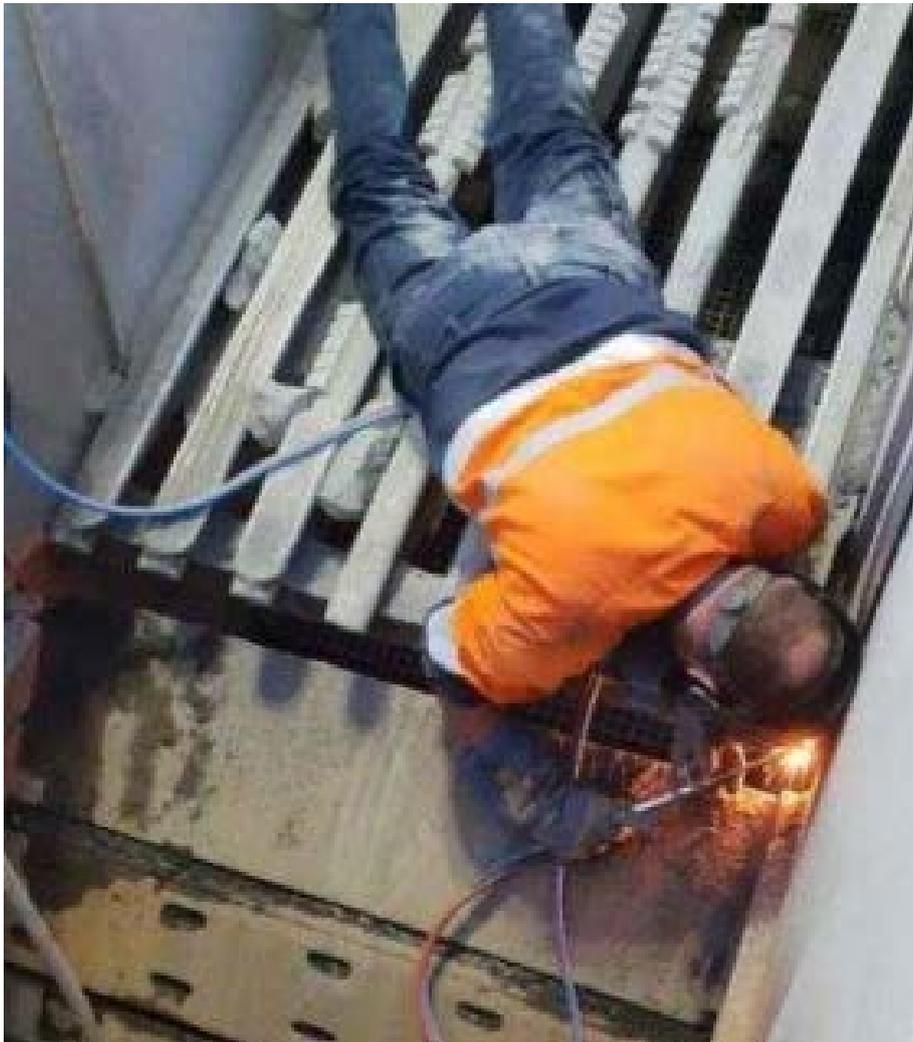
A contractor boilermaker was welding on grizzly panel in a quarry. The earth had been positioned on the opposite side of the grizzly to the area being worked on. The boilermaker was lying on the grizzly. When a programmable logic controller (PLC) code was loaded, a spray bar over the grizzly activated. The arc had already been struck, and welding was underway when the boilermaker suffered the shock.

Figure 3: The photograph was taken earlier in the day of the incident when the worker was in the same position at the time of the incident

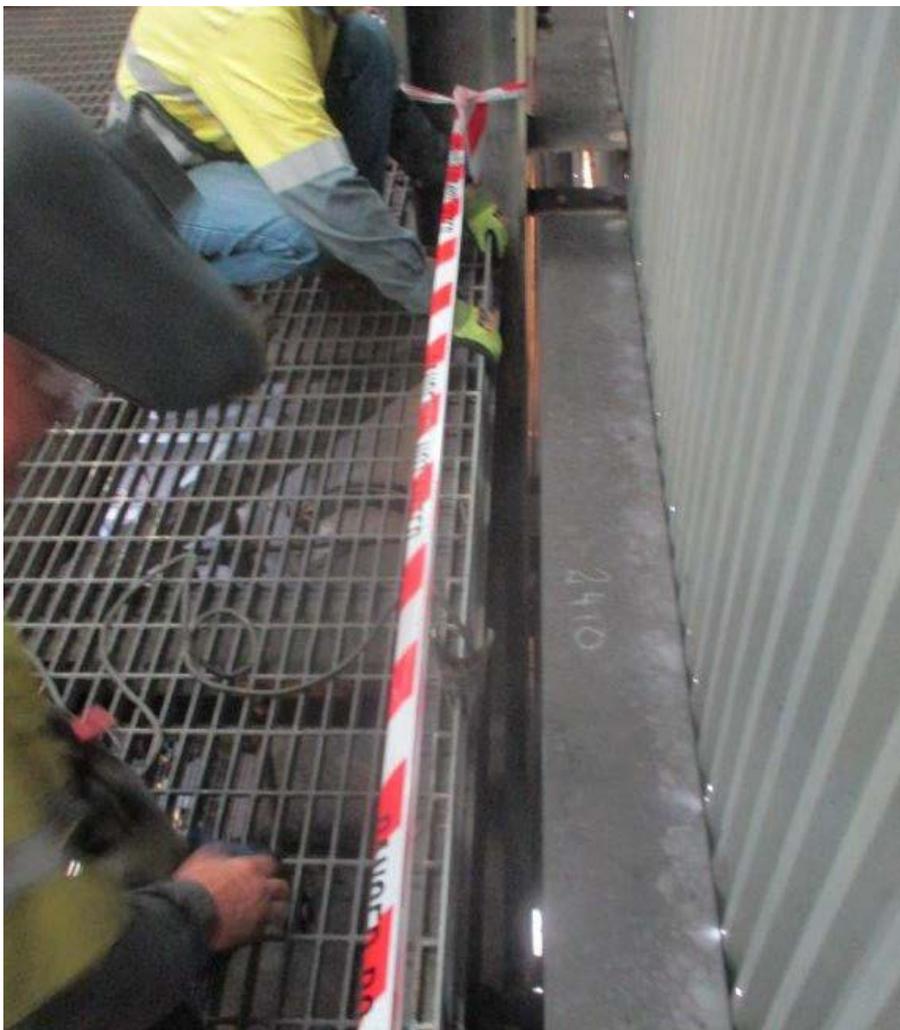
A trades assistant and boilermaker were repairing a walkway. The trades assistant was holding a kick board in position to be welded. As the boilermaker struck the arc, the trades assistant felt an electric shock through the right-hand glove. The trades assistant had his shoulder against a steel column. The boilermaker had the earth return on the opposite side to the trades assistant holding the work piece.

Figure 4: A re-enactment of the incident on the walkway
