# MONTHLY ELECTRICAL INCIDENTS

**ASP Manufacturing**

**June 2021**

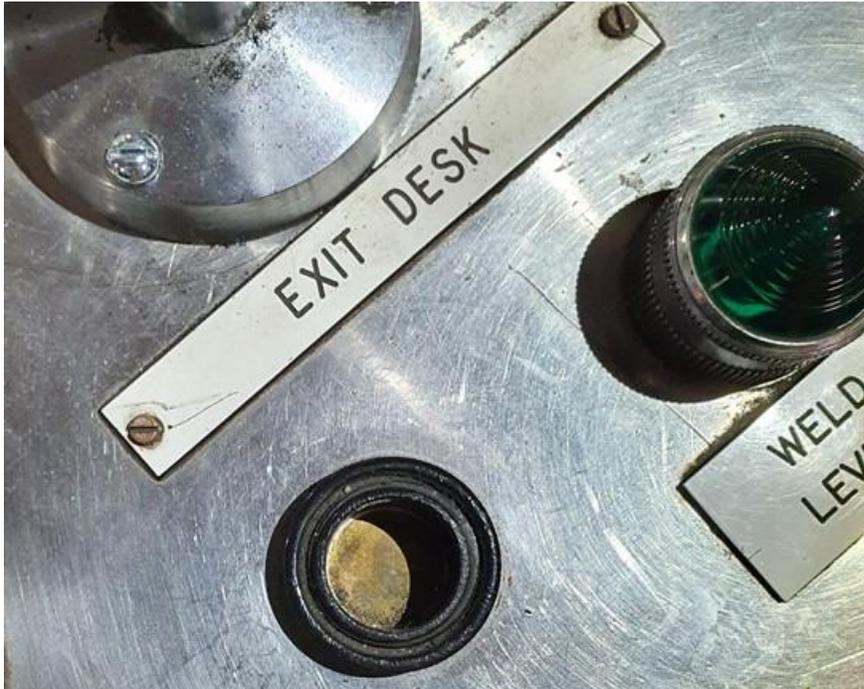
An operator received an **Electric shock** to the left hand when attempting to silence an alarm by placing a finger over the alarm buzzer to muffle noise. The Sonalert buzzer protective grill was missing, allowing the operator's finger to contact internal parts energised at 240Vac while their hand rested on the earthed control desk. A brass disc inside the buzzer helps generate sound, if depressed (as done by the operator) it may become energised at 240V ac after contacting other live parts within the unit.

The buzzer on the operators desk with cover missing and brass plate visible

The integrity of operator controls must be maintained, damaged or defective equipment must be reported and removed from service until repaired or replaced. ELV operator controls significantly reduce the risk of electric shock, and may provide the only suitable solution for harsh environments or operational exposures.

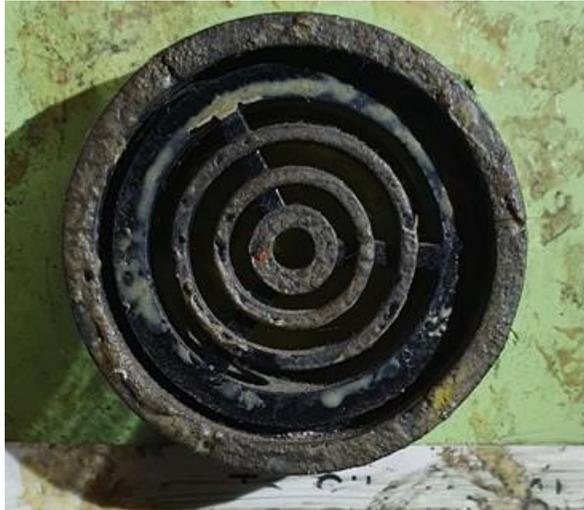
A buzzer on another desk and what it should look like

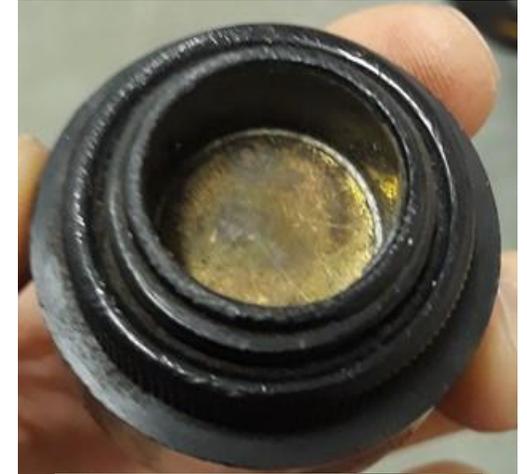
A top and side view of a spare Sonalert showing the brass plate inside the top of the unit and the terminals at the bottom

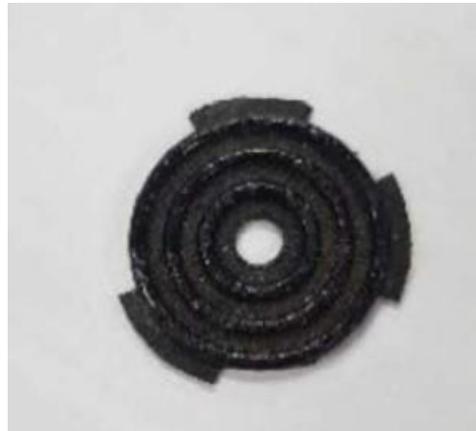
The missing broken off buzzer cover

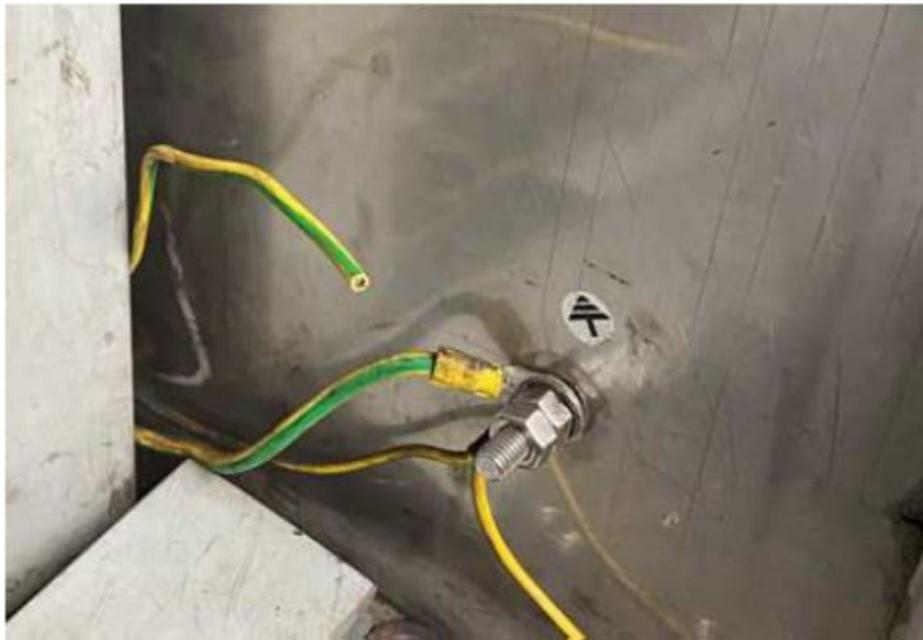
An electrician working inside a field control box noticed an unterminated earth wire. The wire was adjacent to the earth stud, did not appear to be damaged nor was there evidence of a broken lug and it appears the wire had never been terminated. The wire was traced to a cable running to a sump pump motor isolator, where it was terminated to the enclosure earth stud and outgoing motor cable earth. The protective earth conductor of this motor was not effectively connected to the protective earth from the supply.

The earthing stud within the field control box.  
Clearly showing the earth core of the motor cable not terminated.

Protective earthing of an electrical installation provides essential protection to limit prospective touch voltages and allow automatic disconnection of supply. The integrity of earthing associated with a circuit must be verified in accordance with AS3000 Section 8.3.5 and recorded as part of Notification of Safety and Compliance.

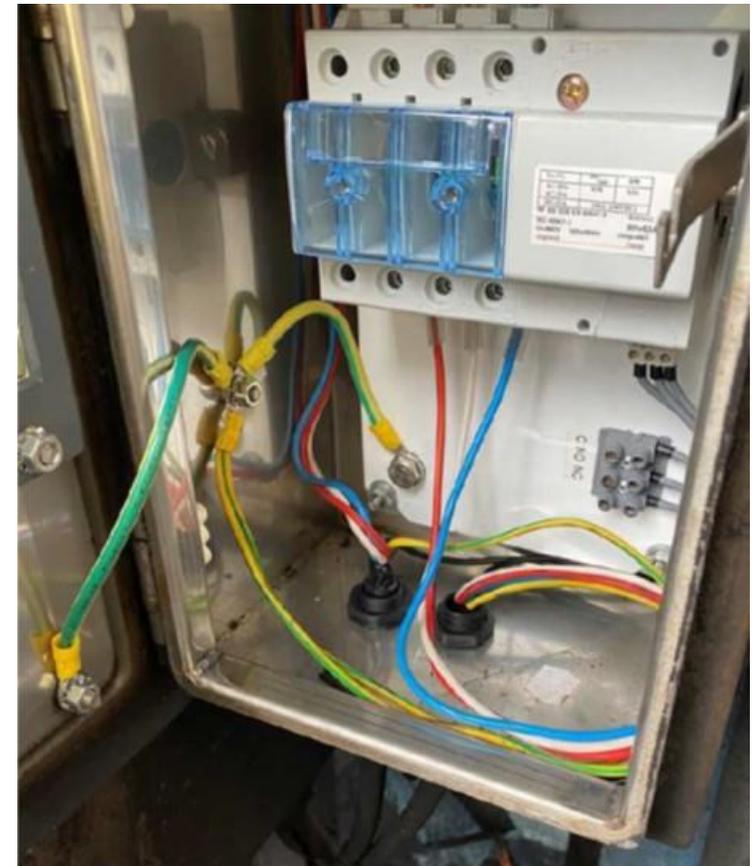
The same earth core of  
the motor cable correctly  
connected inside the  
motor isolator

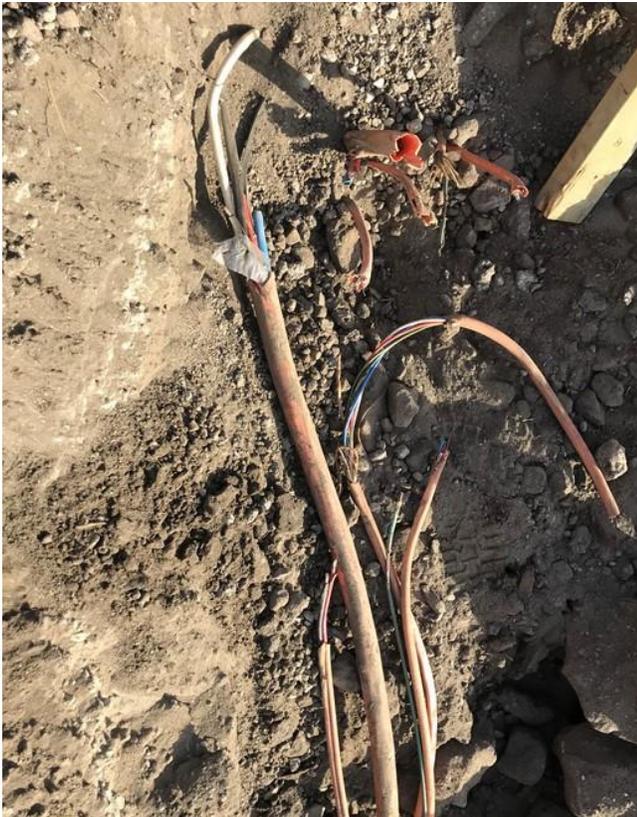
A number of cables were dug up during excavation for the installation of a new rail track, five cables and an earth cable were severed by the excavator. The cables were not identified on the excavation permit and nothing was identified using non-contact tracing prior to commencing excavation. The cables installation is believed to be 50 years old with the cables buried in sand and covered by timber sleepers which may have been the standard for that time. No other identification was provided to indicate cables were buried below.

The severed cables during the excavation

As per electrical Installation manual section 4.4.10 all underground cabling is to be clearly recorded on site layout drawings, buried in sand at the correct depth, to have polymeric mechanical protection and have orange marker tape buried appropriately above the installation.

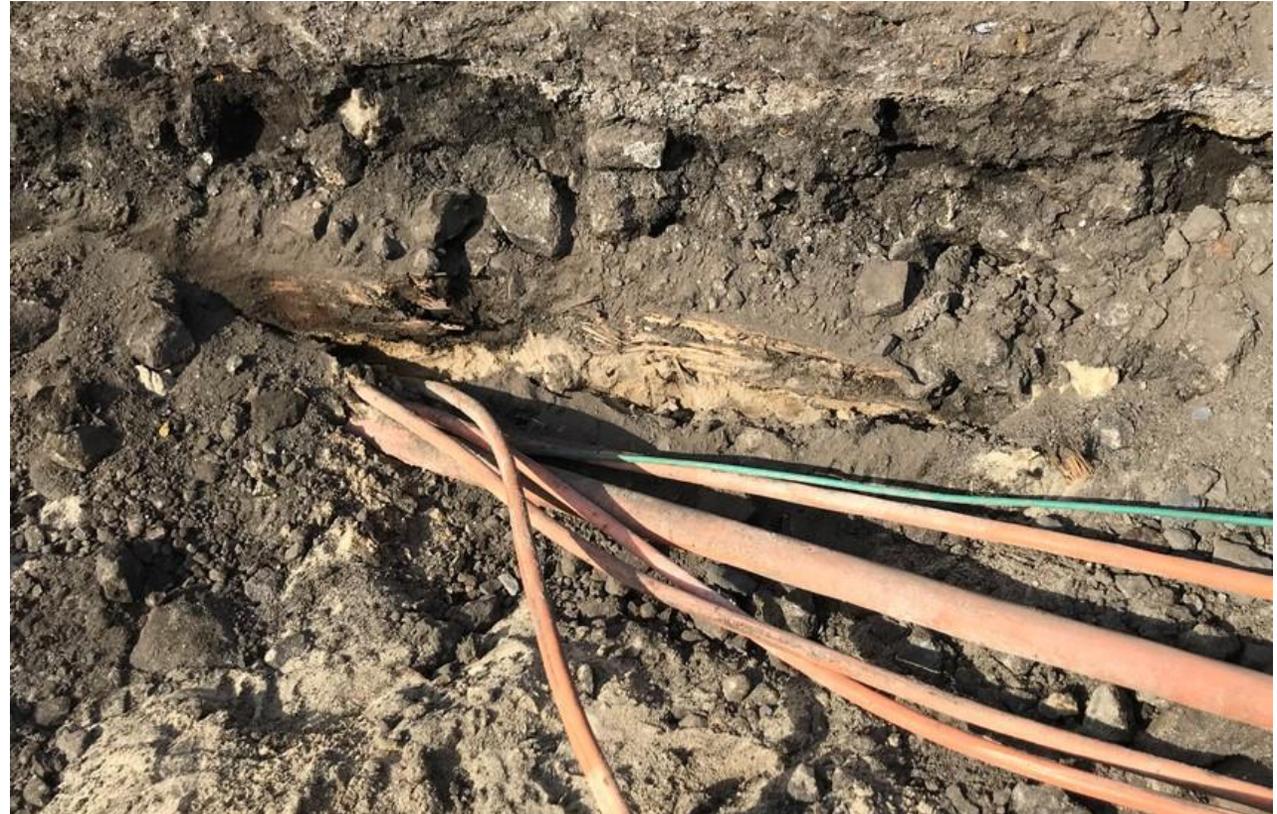
A close up view of the old installation method with the cables buried correctly in sand and then protected by timber sleepers but there is no indication above the timber to indicate cables buried below.

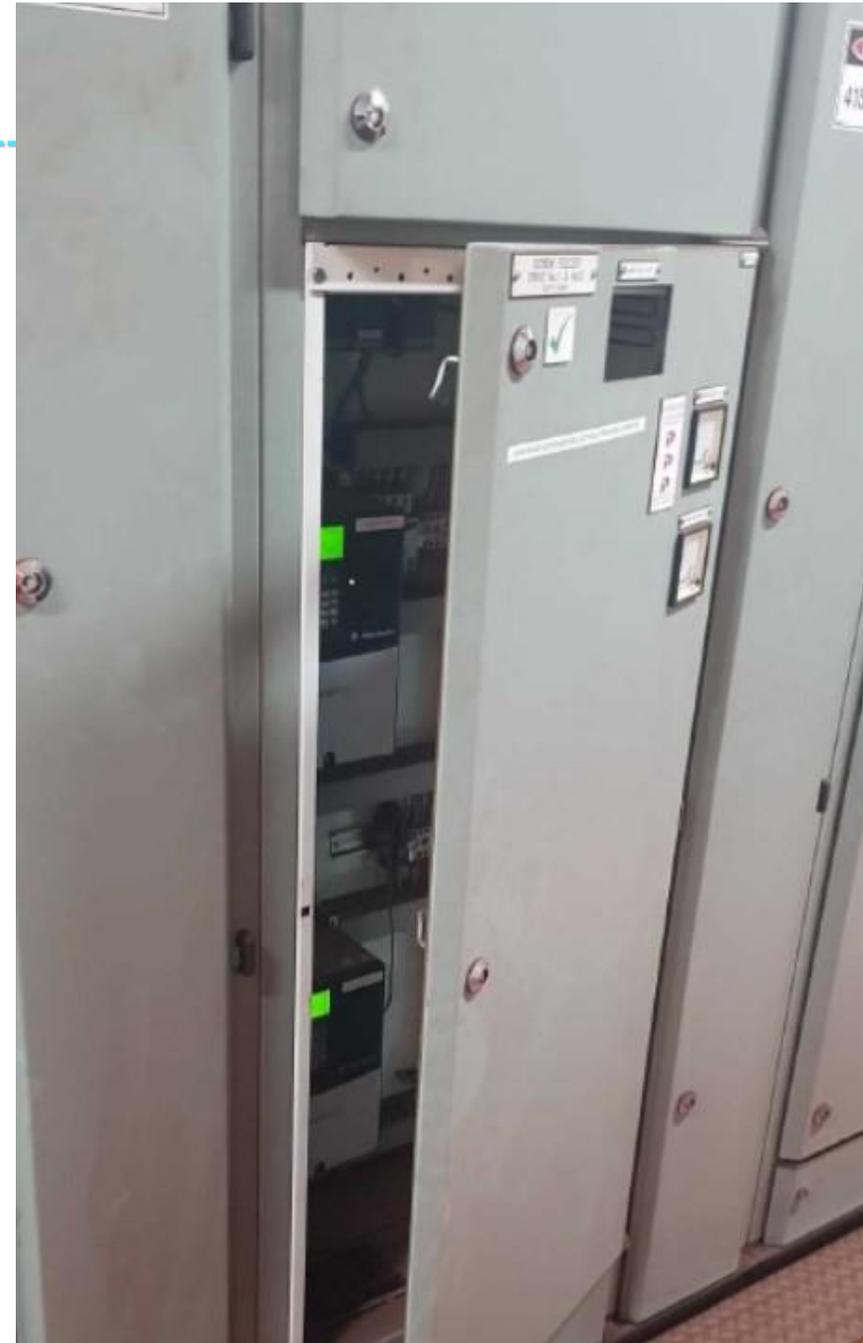
An electrician accessing a switchroom to conduct isolations has found the door of an MCC starter containing 2 by 5.5kW drives open with the main isolator in the ON position. Most MCC panels are specified and manufactured to form 3B to segregate the internal parts of each cell with respect to other cells, the busbar system and outgoing cable zone. Main isolators should only be operated with doors and covers secured to protect against arc hazards.

How the door of the MCC cell was found

As per Electrical Safety manual 1.4.8.2 electrical stations or panels may contain equipment connected to high fault levels. To manage this risk all equipment doors and covers should be secured appropriately with the securing devices provided.

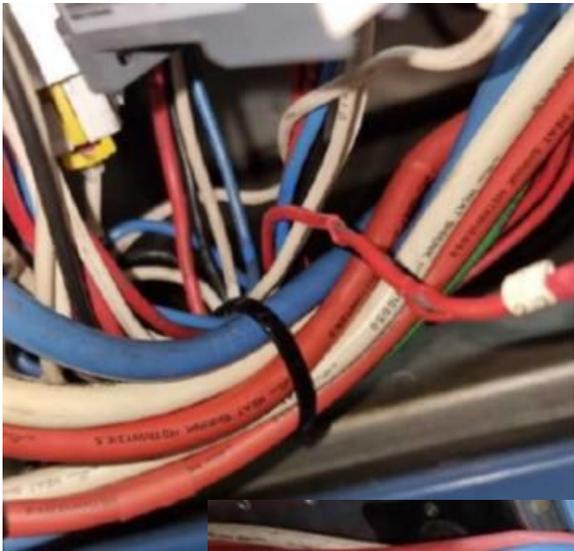
An electrician was called to investigate why a dryer fan would not run in Auto and there was no feedback indication. Whilst fault finding in the MCC cell red insulated cores in a cable loom were found to be brittle and with exposed conductors. The red wires ran from the cell to a terminal strip in the cable launder for the 24V dc PLC control system. This MCC was installed in the early 1990s during a period where defective single insulated red building wire was manufactured, the defect was known as 'Red wire syndrome' as it affected red insulation and resulted in loss of plasticity and insulation becoming brittle. This issue had been identified within the MCC about 15 years ago however only the 240V ac control circuit wiring was replaced, leaving all the PLC control system 24V dc wiring in service.

Close up views of the brittle red wire with exposed conductors

Switchgear and control assemblies manufactured from the late 1980s to early 1990s should be checked for damaged insulation in red building wire. Damaged wiring must be replaced.

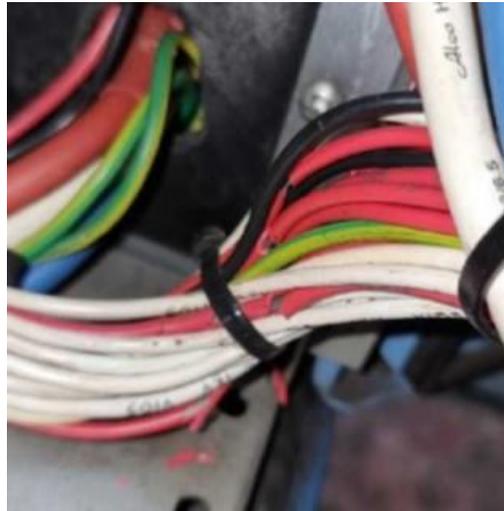
The terminal strip in the cable launder. The white wiring on the left is the 240V ac control circuit replaced 15 years ago. Behind is the PLC control system wiring still with red insulated wires

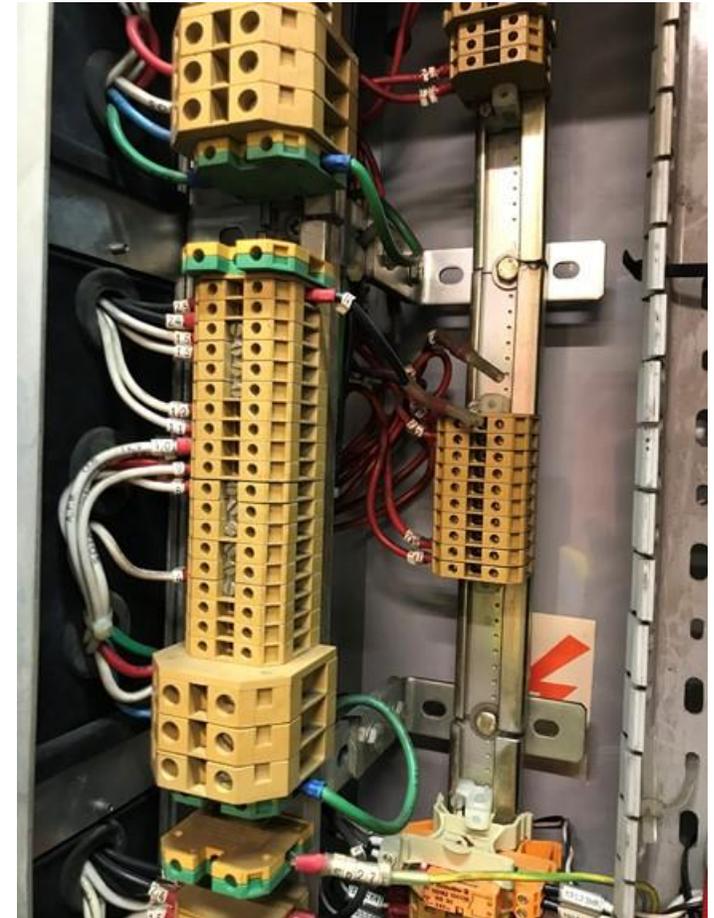
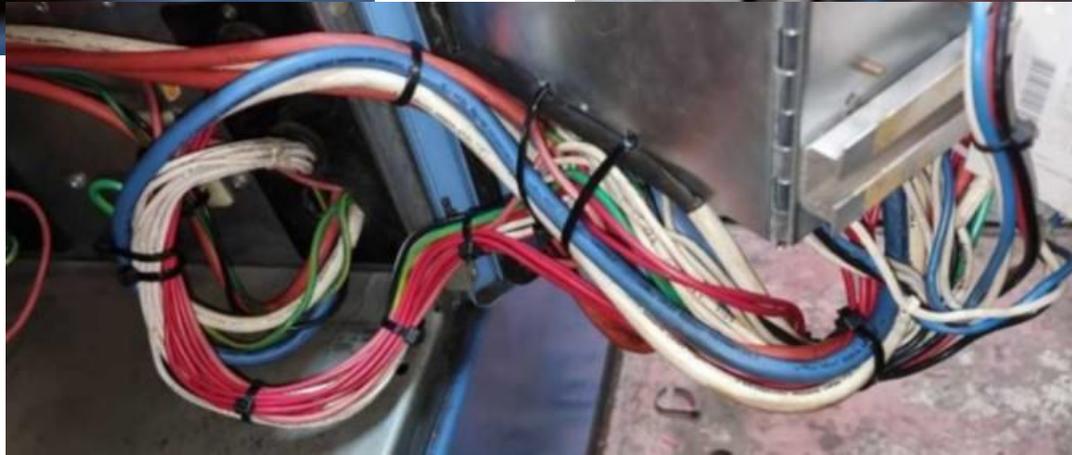
The wiring loom within the MCC cell

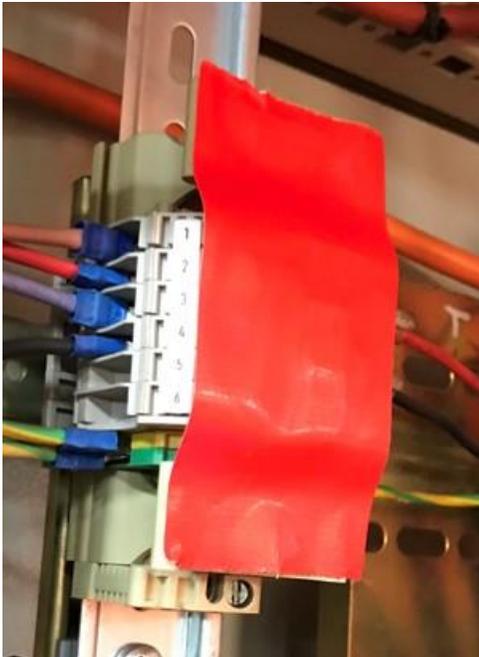
An operator trying to place the manipulator back on the mudgun near No.1 Casthouse floor taphole could not use the remote control unit (RCU). A shift electrician found the circuit breaker which supplies the receiver for the RCU to be in the off position. Once this was reset the RCU operated in the correct manor. At the same time Contract electricians were installing new equipment for upgrading the No.2 Casthouse floor RCU. The RCU control units for all three cast house floors are mounted within the one cabinet and this circuit breaker was accidentally tripped by the electricians installing in a new cable within the cubicle.

An example of the barriers used to cover energised terminal strips, however no consideration was given to cover over the circuit breaker

As per electrical safety manual 1.3 and 2.4.5 a minimum safe working distance of 500mm must be maintained if an electrical worker is considering work near live conductors or equipment where there is a possibility the worker, or any object the worker may handling may contact live parts or initiate an arc fault. A risk assessment must be conducted and adequate controls such as protective barriers put in place before work can commence.

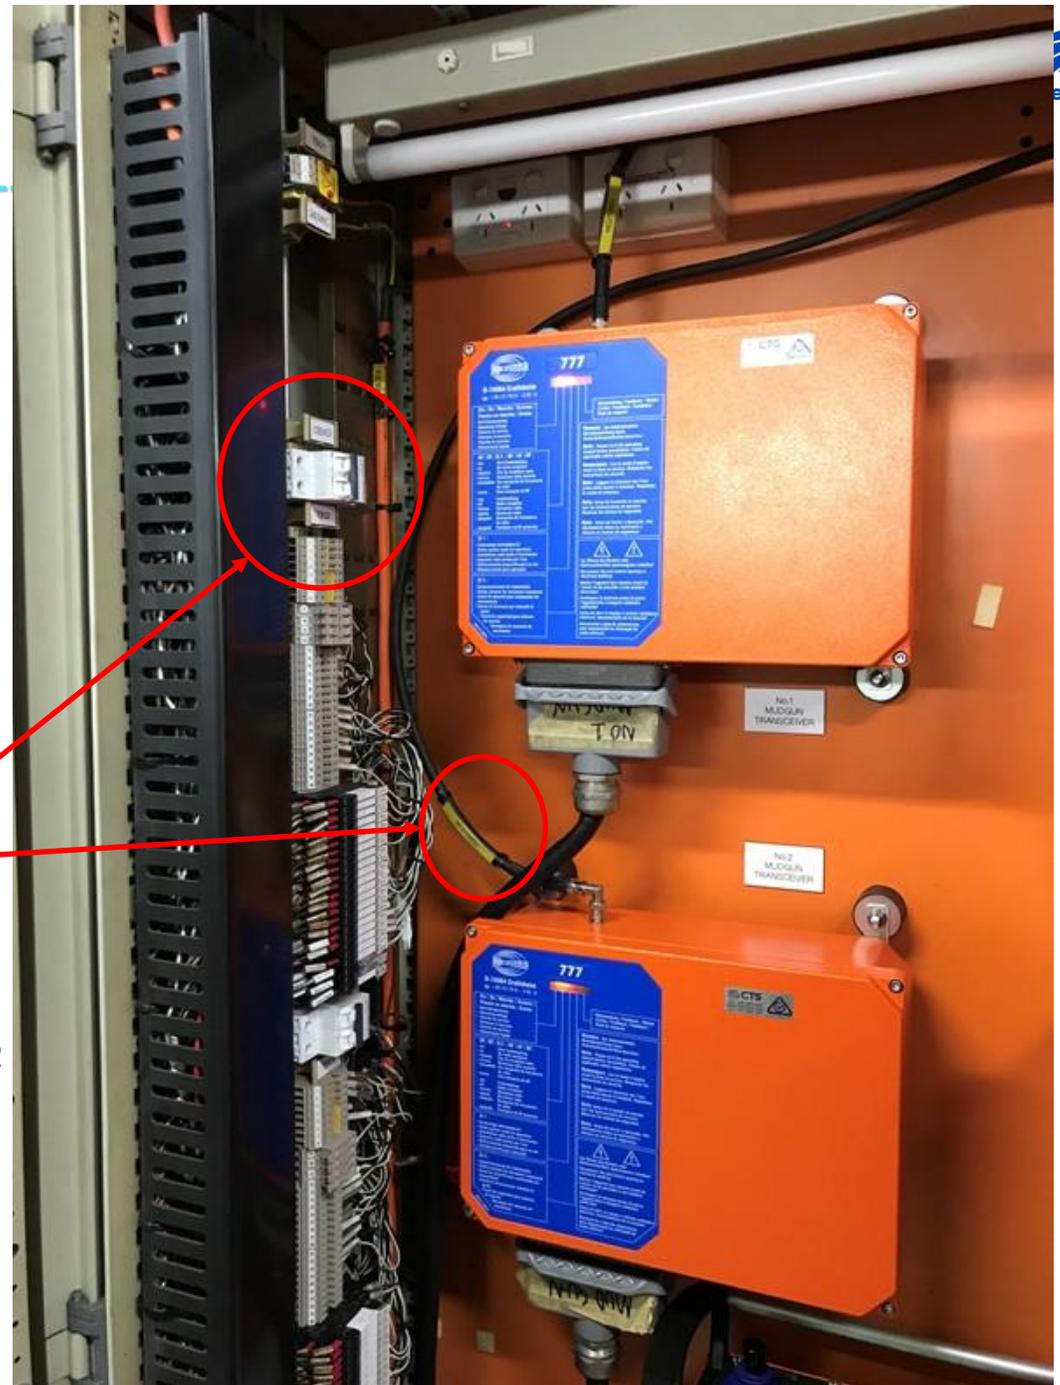
The circuit breaker which tripped

The cable which tripped the breaker

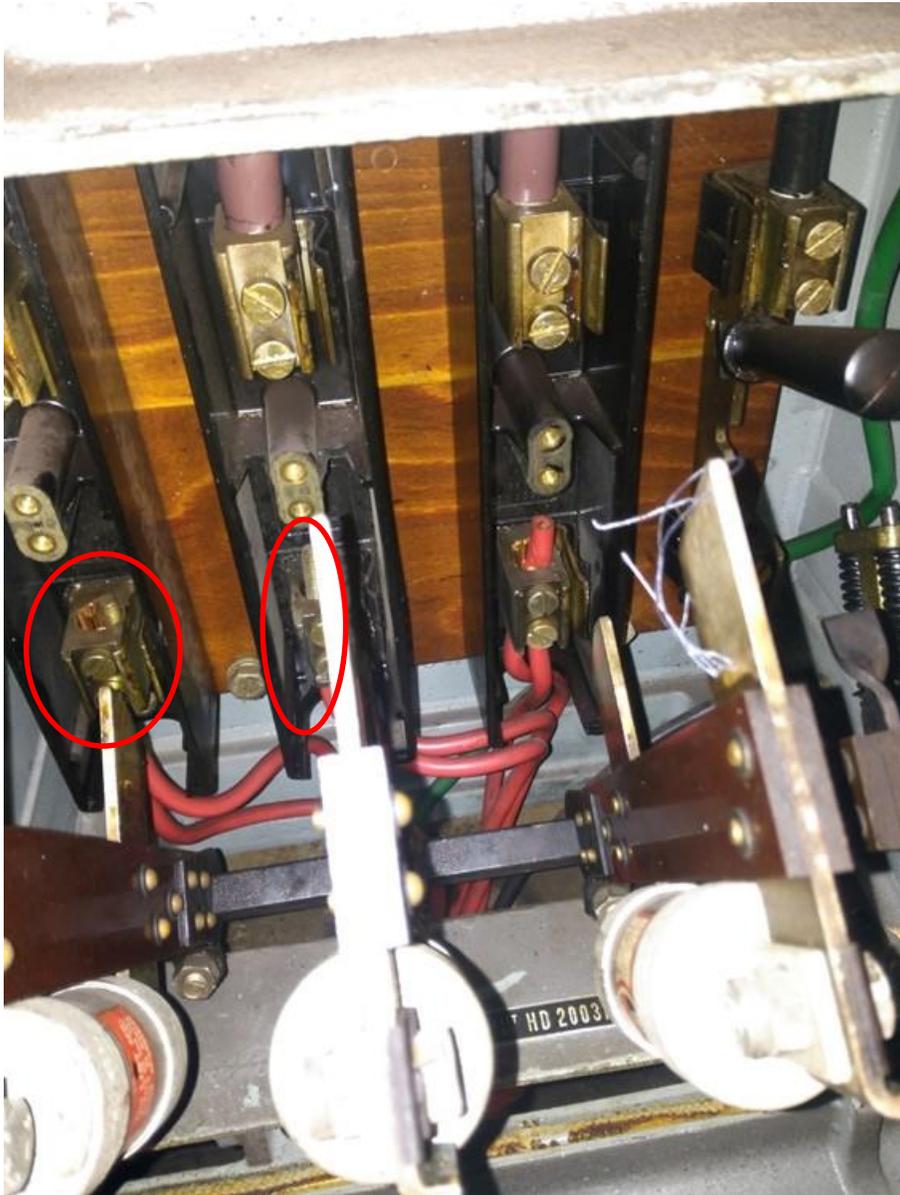
Unsecured brass screws were found installed in the bottom poles of a CFS switch where the internal wiring conductor cross section was considerably smaller than the terminal housing. This was identified during planned work to remove asbestos components from the switch. Remarkably the screws had remained secure and there was no evidence of high resistance.

Inside the CFS switch with the asbestos covers removed the double screwed connectors show brass screws used in an unconventional way

Ensure correct lug for the conductor size is used to avoid potential hot joints.

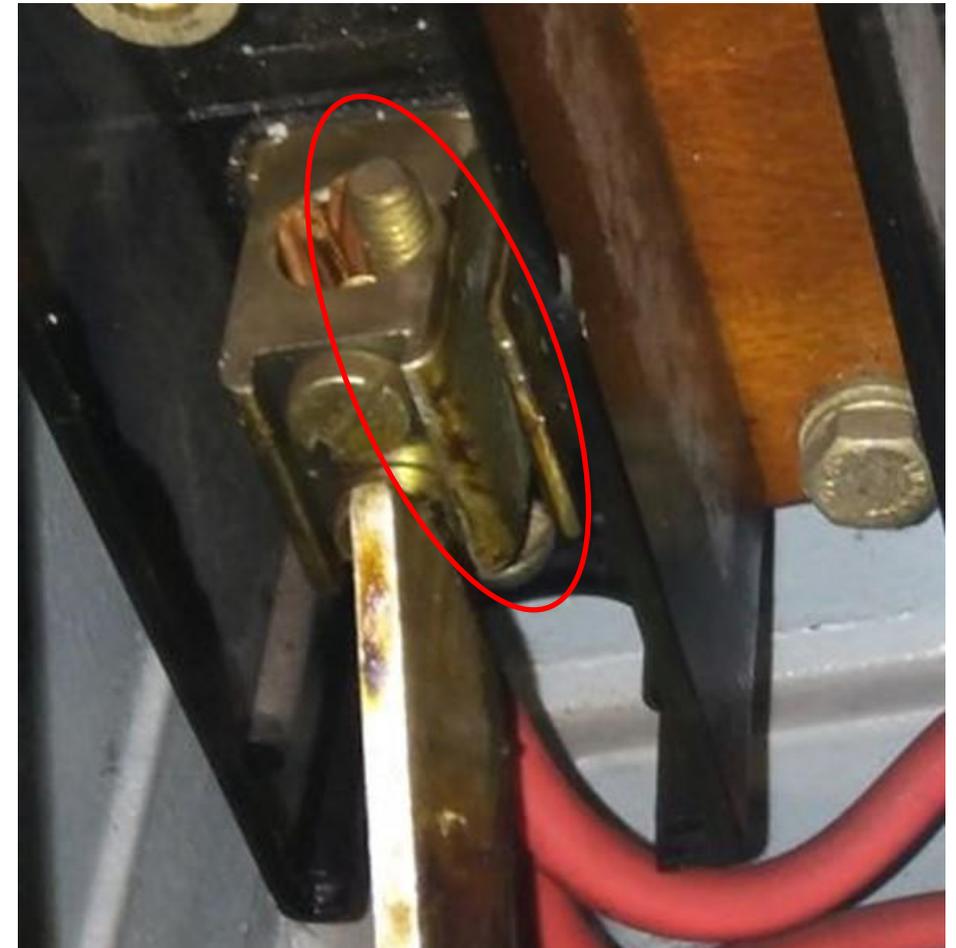
A close up of the brass screw in position

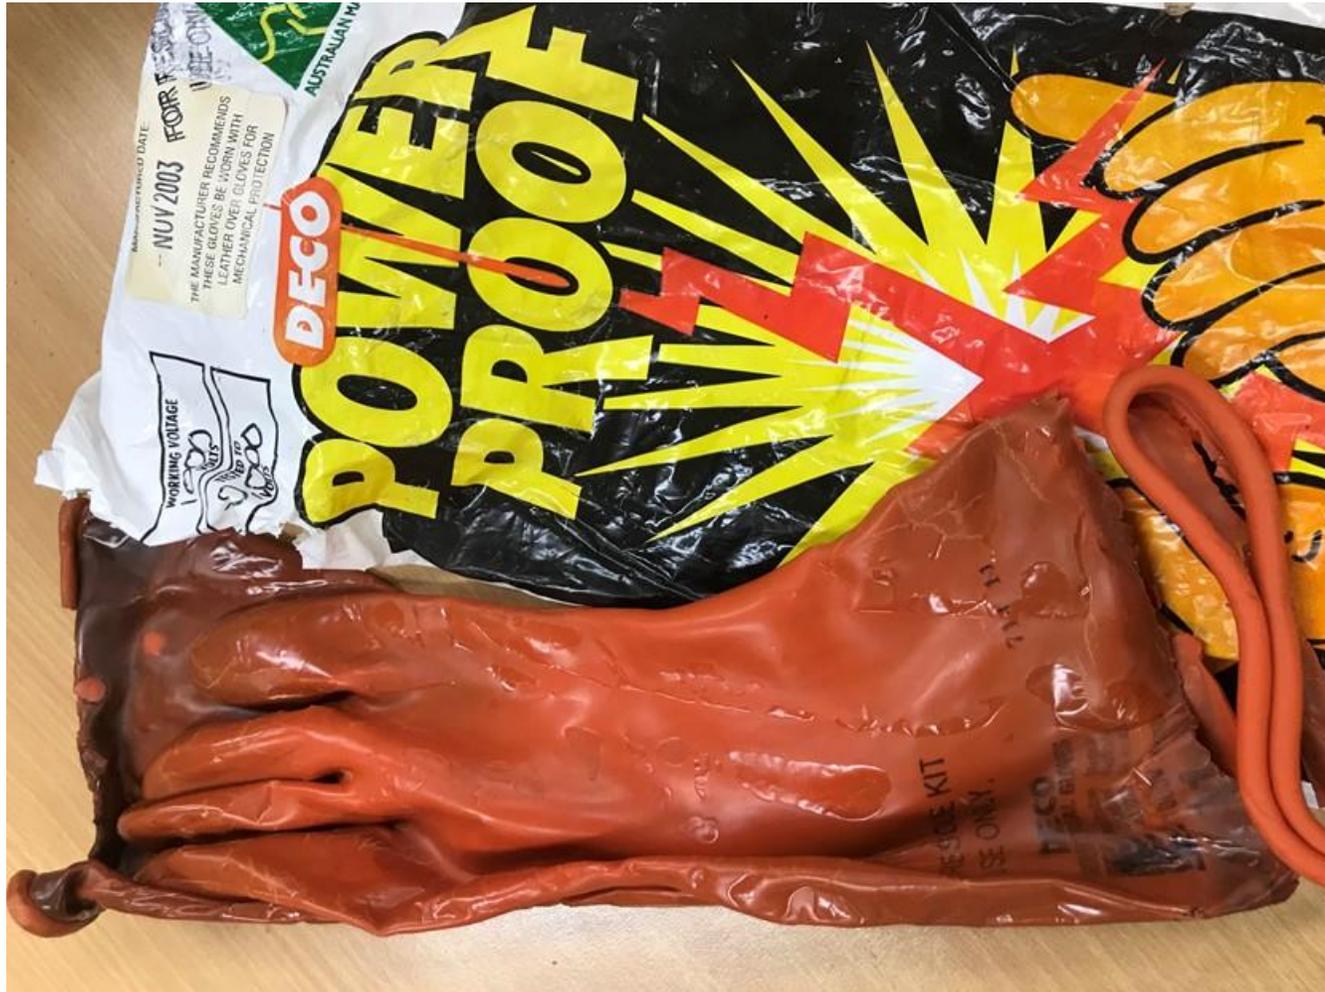
During the inspection of the rescue kit in the switchroom the 1000V insulated gloves were found to be severely damaged from heat, partially melted together and brittle at one end. The manufactured date on the gloves was NOV 2003.

The gloves as found out of their bag. Both gloves are melted together and at the end the brittle sleeve has broken off.

Rescue kits need to be periodically inspected as compliant and all the equipment is fit for service. In the case of an emergency the equipment has to be readily available and fit to be used for the particular purpose at that time.
