MONTHLY ELECTRICAL INCIDENTS

ASP Manufacturing

July 2021

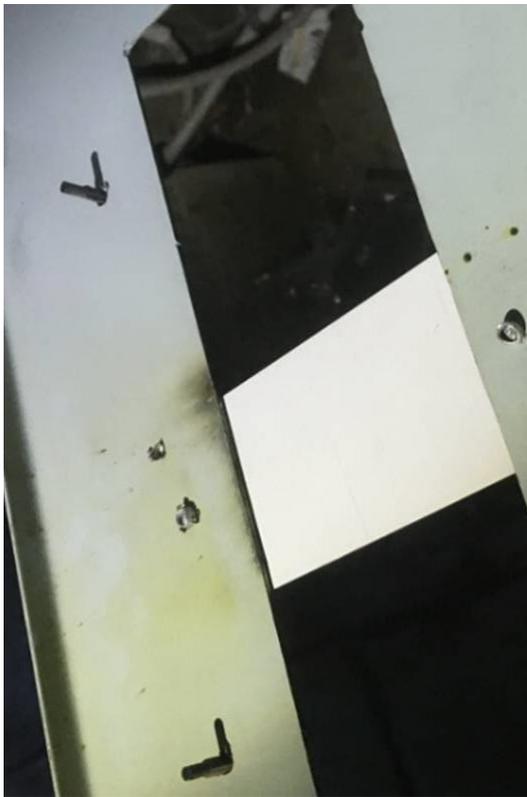
An electrician noticed a distribution board escutcheon plate was missing pole fillers where circuit breakers had not been installed, potentially allowing access to exposed energised parts of the busbar. Unable to obtain propriety style pole fillers, the electrician manufactured a metal plate to cover the hole and secured it with metal pop rivets. An Arc Flash occurred as the escutcheon was returned into position over the circuit breakers while the board remained energise, the incoming 160 A circuit breaker operated to clear the fault. Burn marks were evident on the rear of the escutcheon where the rivets had exceeded the required clearance.

The reverse of the escutcheon showing the arc burn marks

BSL policy is we do not work on or near exposed energised conductors or live conductive parts as per Electrical Safety Manual 1.4.3.6

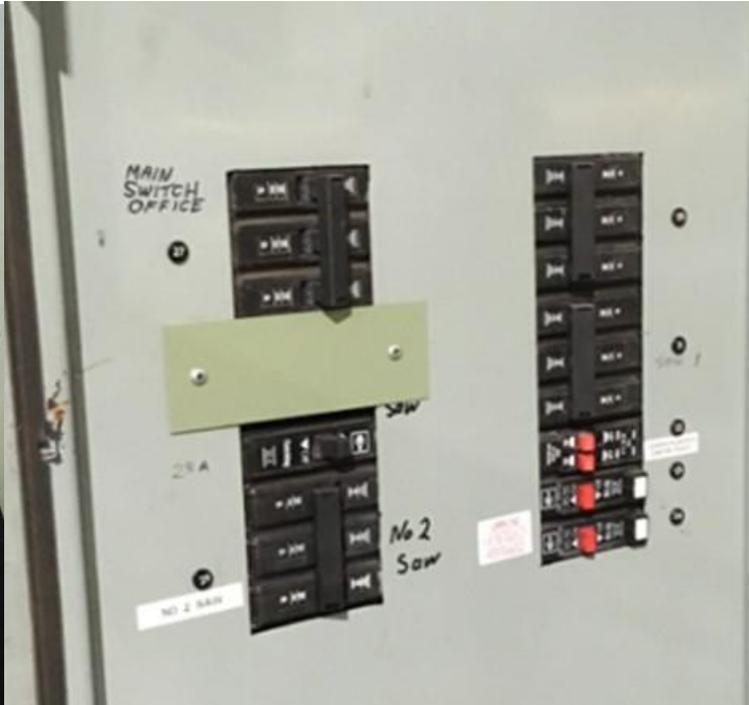
The front of the escutcheon with the metal plate pop rivetted in place

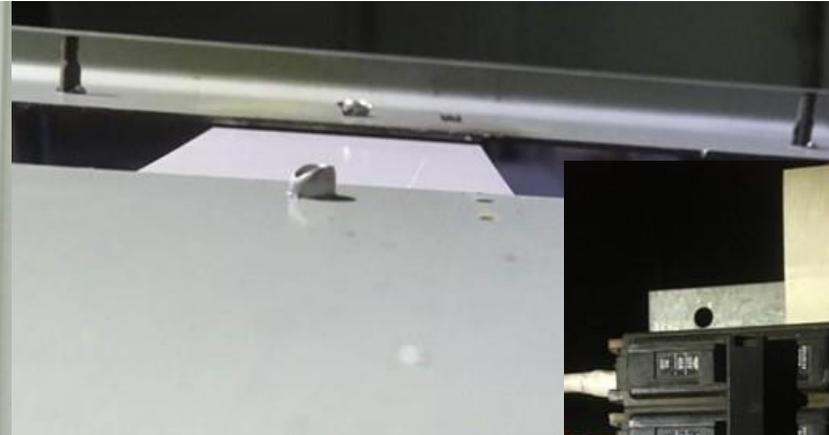
The reverse of the metal plate with the pop rivets protruding through

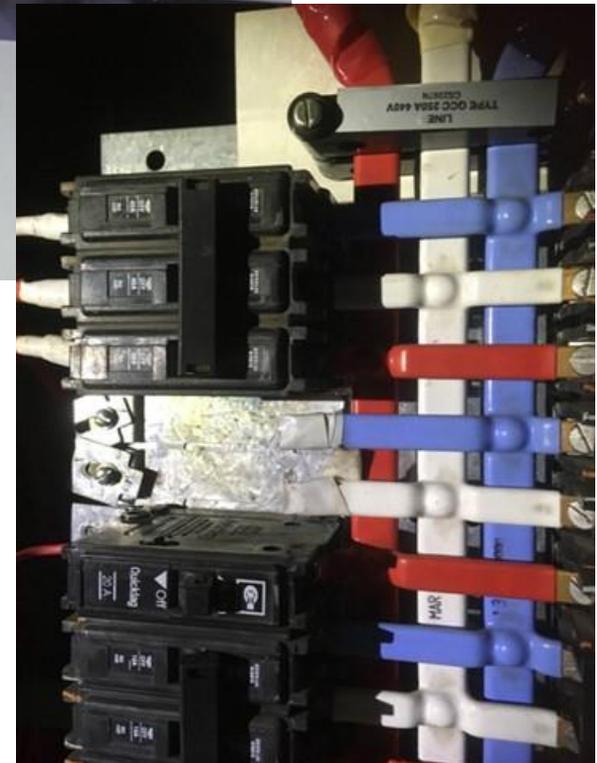
The board internal busbar comb and missing circuit breaker

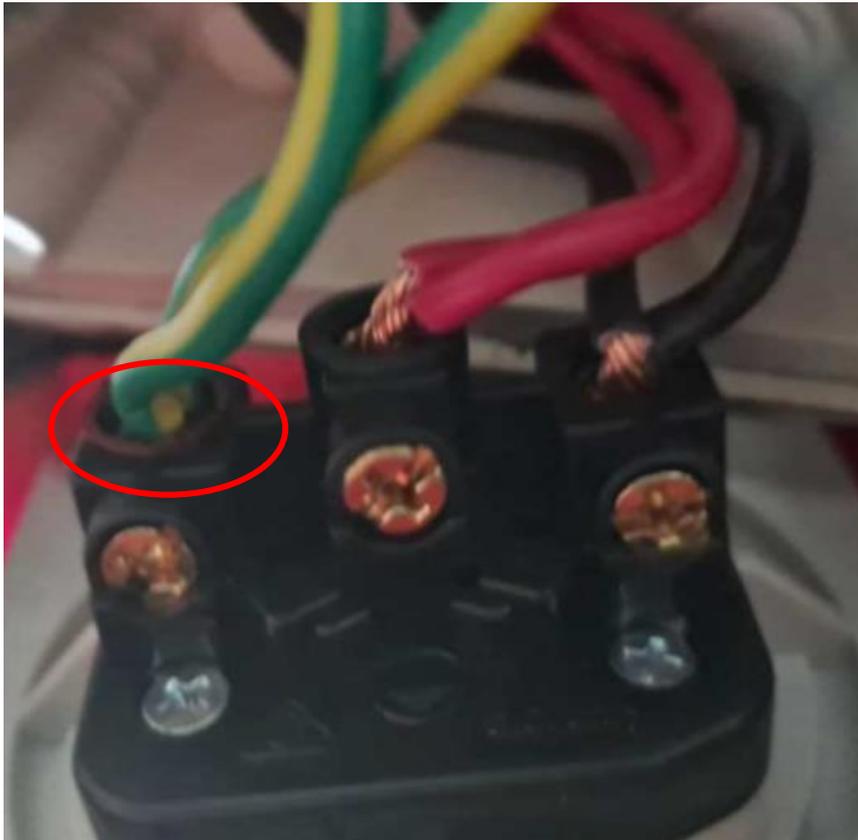
Electricians installing a plug-in LED floodlight into an unused lighting outlet found it caused all the lights in the area to go out. After unplugging the light fitting it was found the outlet earth and active conductors had been transposed. Fortunately the fitting was mounted on an earthed frame at the time it was energised and no one was touching the fitting. The outlet was installed prior to 2000 without RCD protection in an area of plant which had been shutdown for a number of years and clearly had remained unused since original installation.

The transposed wiring on the back of the outlet. The earth wires are clearly in the termination point which is indicated RED.

Mandatory inspections and tests are required to ensure electrical installations are verified safe and comply with requirement of AS3000 before allowing energisation. Installations found to be unsafe must be removed from service until rectified and verified safe. Refer AS3000 section 8 Verification for the minimum inspection and testing requirements.

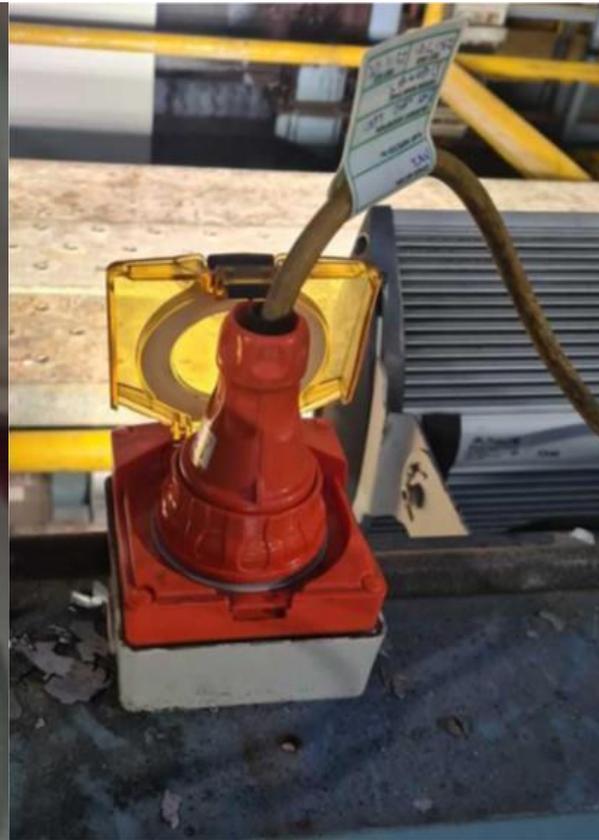
The outlet

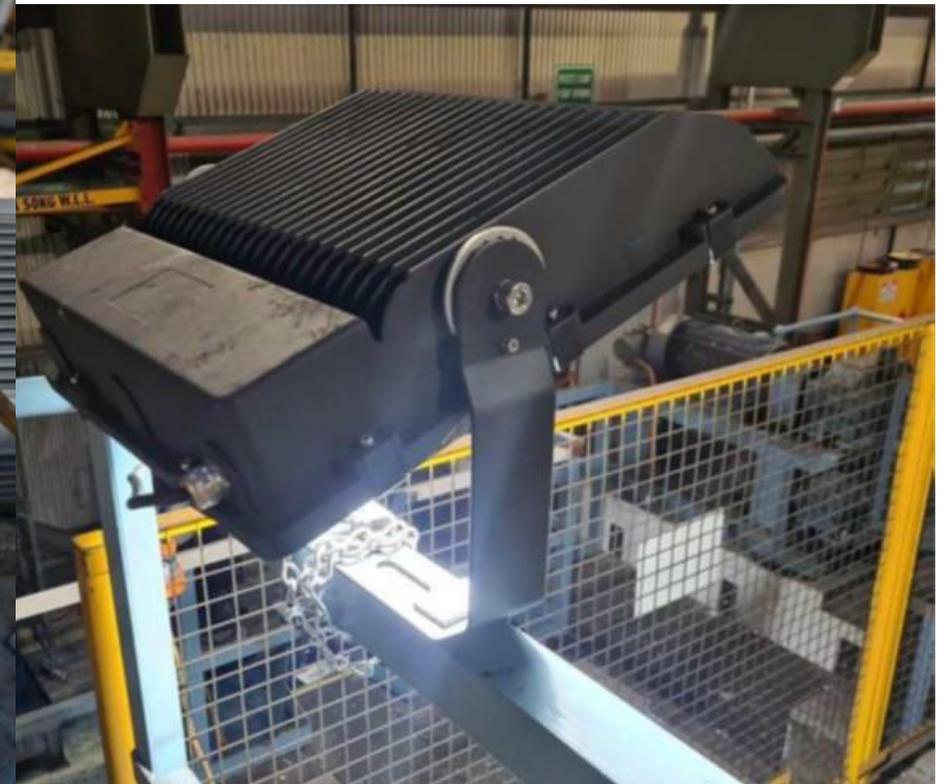
The light fitting mounted on an earthed frame

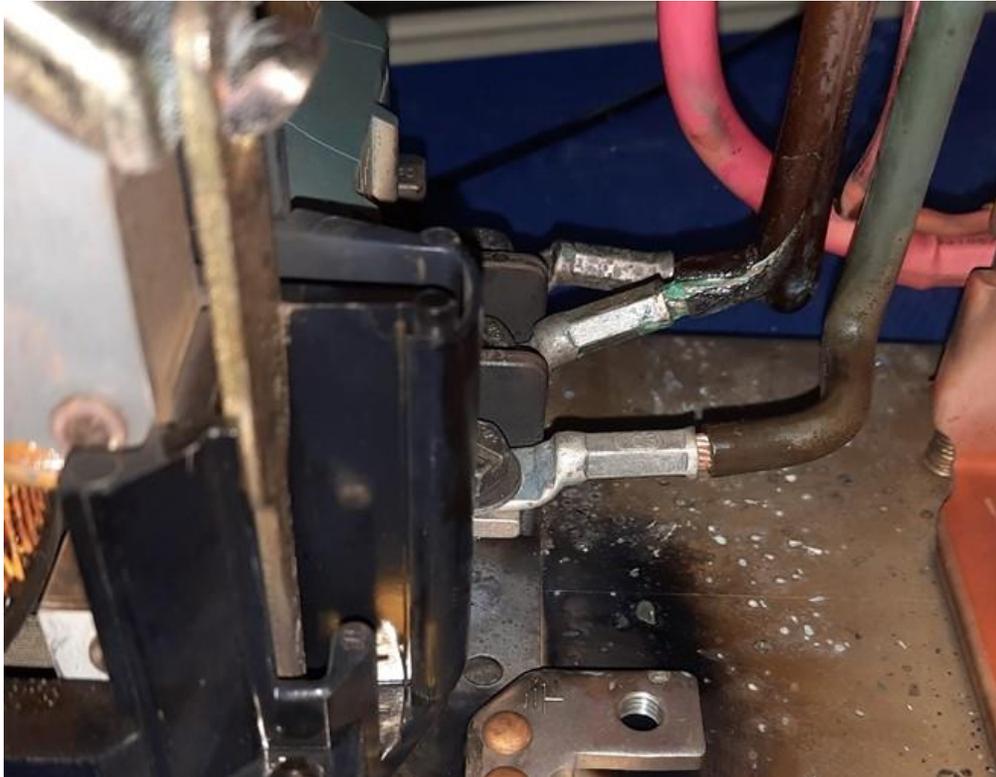
A 30kW drive tripped blowing all three main fuses. When electricians meggered the motor, cabling and MCC starter all was ok. A visual inspection was carried out, no obvious signs of faults were found except for some cabling showing signs of heat and age. The complete starter unit was replaced and the drive started successfully. The original starter was bench tested for circuit continuity and meggered at 500V, no faults were found. It was then dismantled to reveal tracking and burn marks on the steel base below the blue phase connections to the main contactor. The original fault is believed to have been the result of dust or dirt build up resulting in tracking at the base of the contactor.

How the contactor base was found. It is believed the cable damage was a result of the arc incident and was not the root cause.

This is high fault level equipment, the incident serves as a reminder of the importance of ensuring cells and covers are secured before performing switching operations or motor starting. It is essential MCCs and switchboards have an effective management system, including inspection and testing, to prevent similar faults.

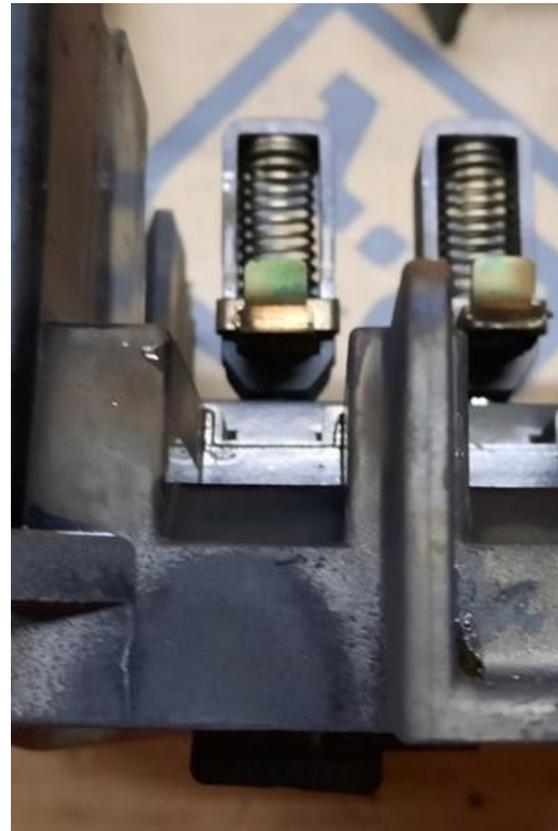
Arc tracking marks below the blue phase connector

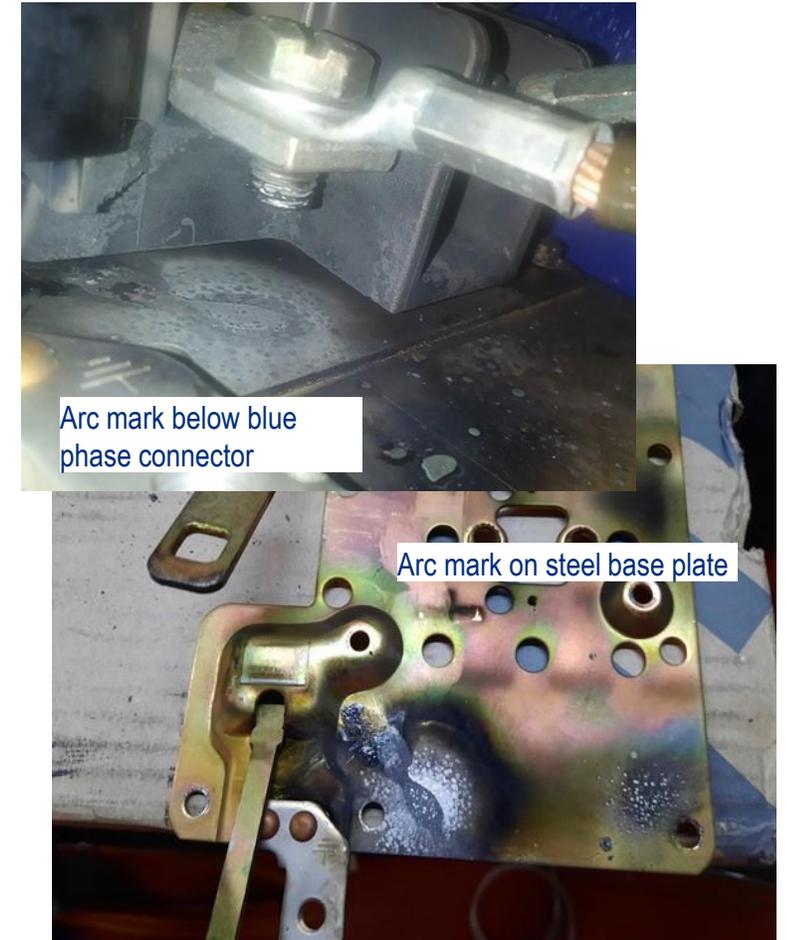
Arc mark below blue phase connector

Arc mark on steel base plate

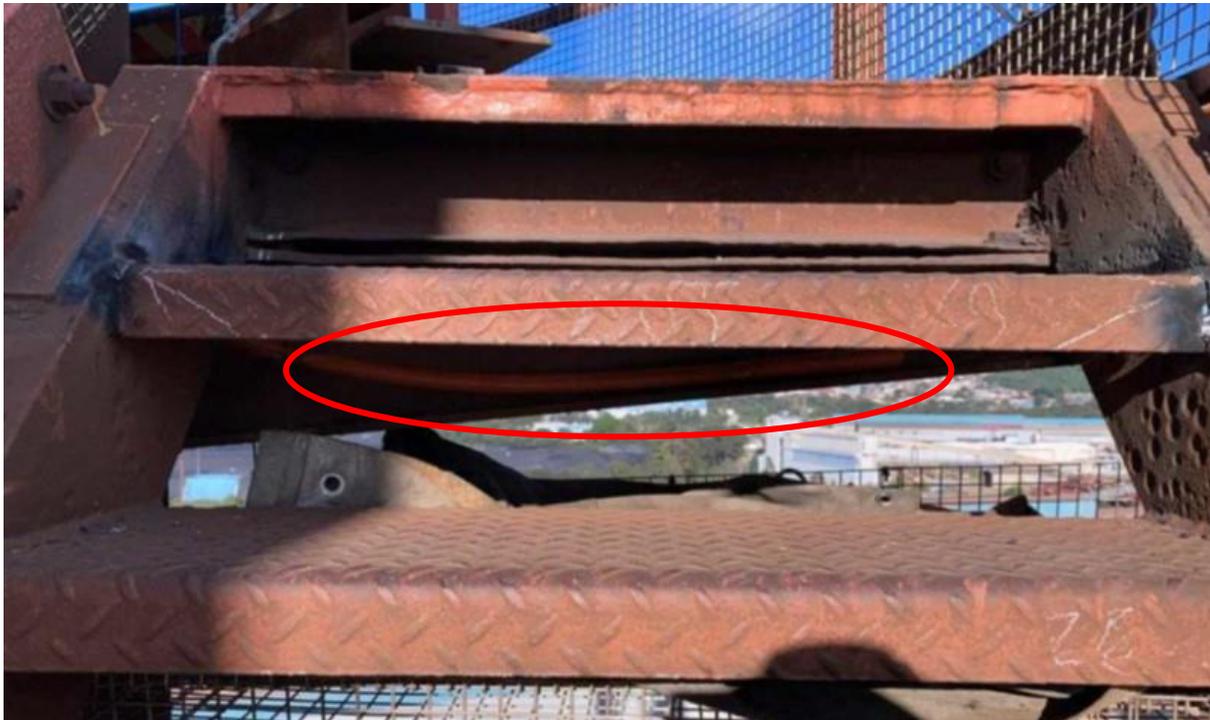
A boilermaker doing structural repair work on the stairs of the excess gas bleeder cut through a cable with an angle grinder. The cable was a 24v dc signal cable going to an instrument. Other cables identified on another level of the bleeder were included in the JSEA. The JSEA was not updated, nor was the area inspected prior to cutting at this location.

The work area involved with the steel plate step being replaced. The old step was cut from above, with the unseen cable below now visible.

It is imperative installations are checked for services and made safe before similar cutting, removal or welding work is performed. Electrical personnel should be consulted as part of the clearance checks.

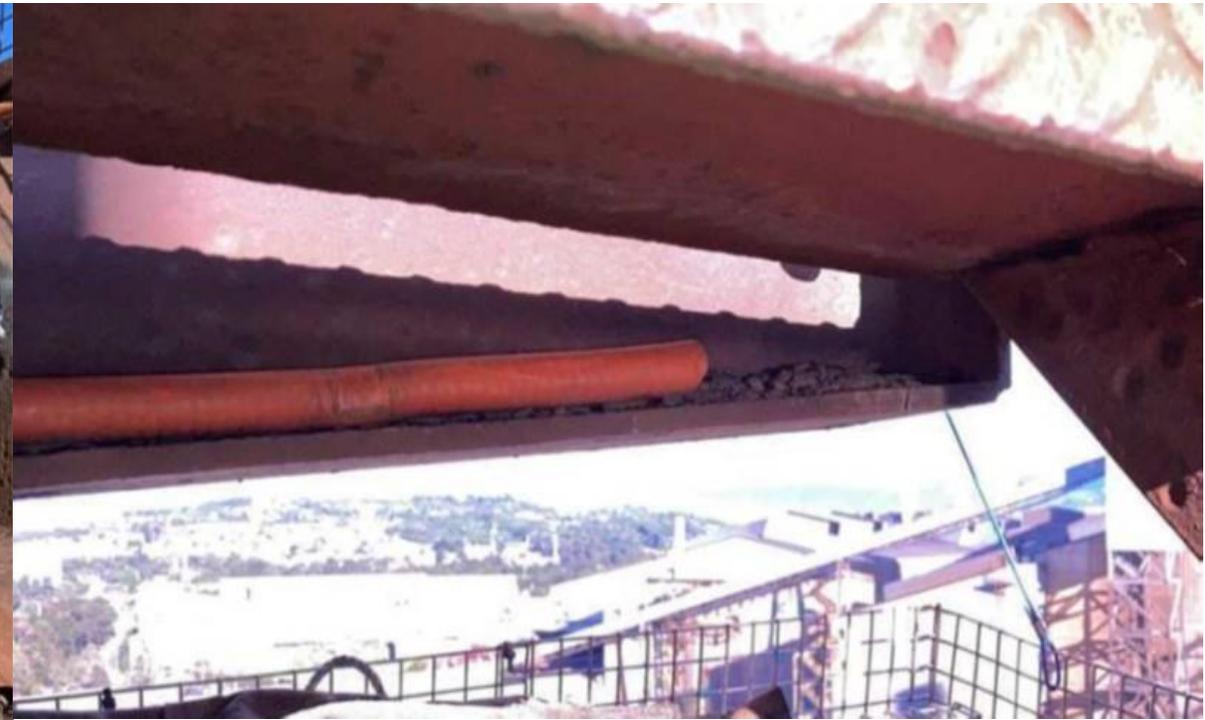
The cut cable and flexible conduit underneath the step

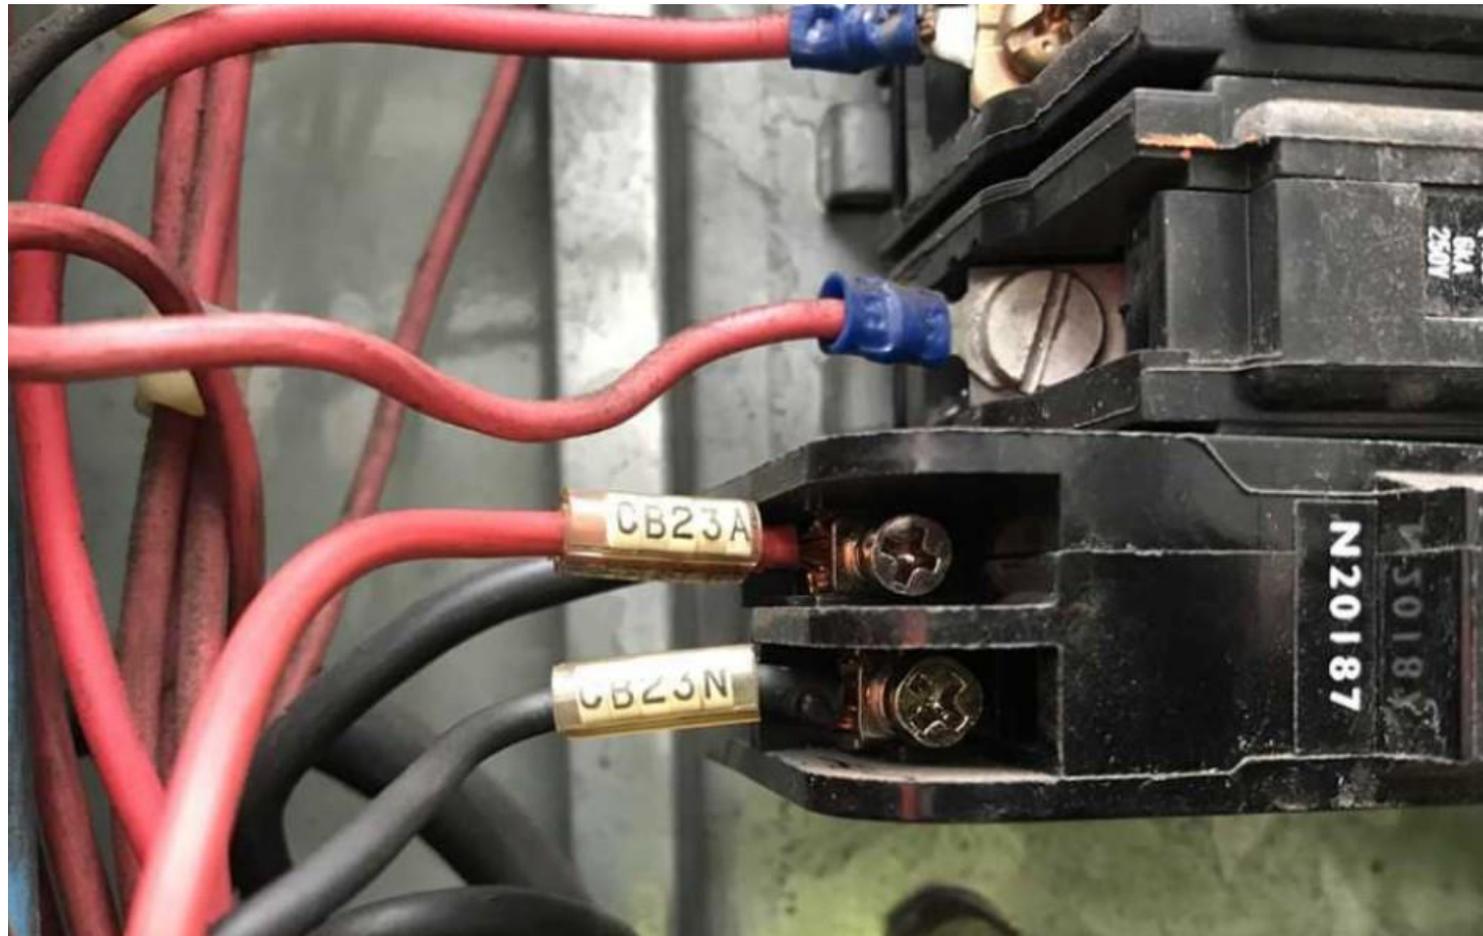
An RCD power circuit was found to be wired incorrectly when disconnecting redundant circuits during an office renovation. The active and neutral conductors were found transposed at the RCD breaker terminals, resulting in the black core of the TPS cable becoming an active conductor and the red core the neutral conductor. The it would be switched at each of the outlets. This contravenes AS3000 Section 2.3.2.1.2.

The wiring to the QuickLag RCD breaker, clearly showing the red wire in the terminal above the black neutral reference conductor for the breaker. Even the core numbers indicate it to be the active conductor

Mandatory inspections and tests are required to ensure electrical installations are verified safe and comply with requirement of AS3000 before allowing energisation. Installations found to be unsafe must be removed from service until rectified and verified safe. Refer AS3000 section 8 Verification for the minimum inspection and testing requirements.

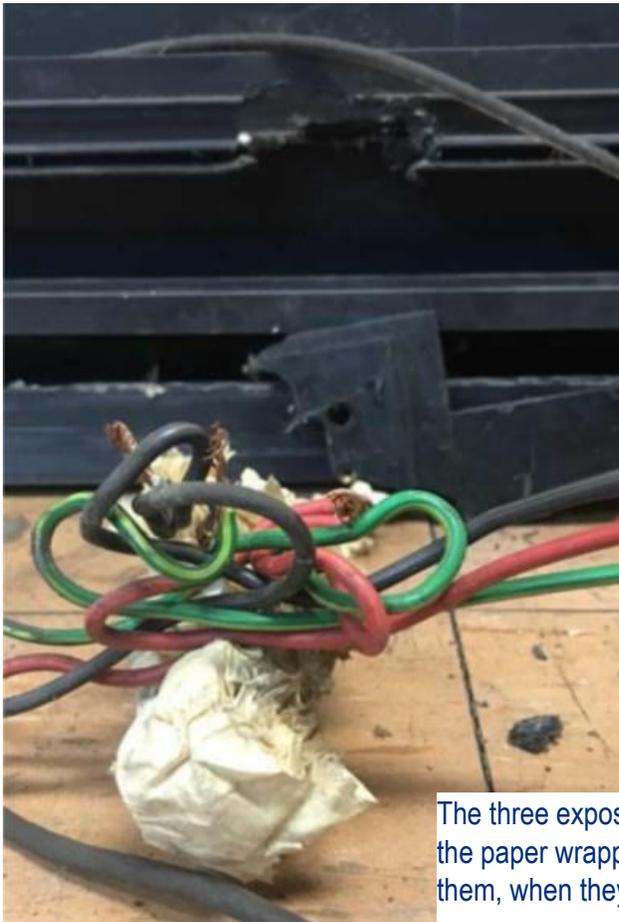
- Exposed, unterminated conductors were found stuffed inside paper towel within floor mounted SKN ducting at an outlet mounting bracket. The conductors would have been energised before work commenced.
- Cables were found with damaged insulation in the corner section of wall ducting behind a plastic container lid jammed into position. Conductors were likely damaged by vermin.

The three exposed conductors and the paper wrapping which covered them, when they were energised

In both cases a deliberate actions had been taken which put others at risk of electric shock. All incidents like these must be reported and the installation made safe.

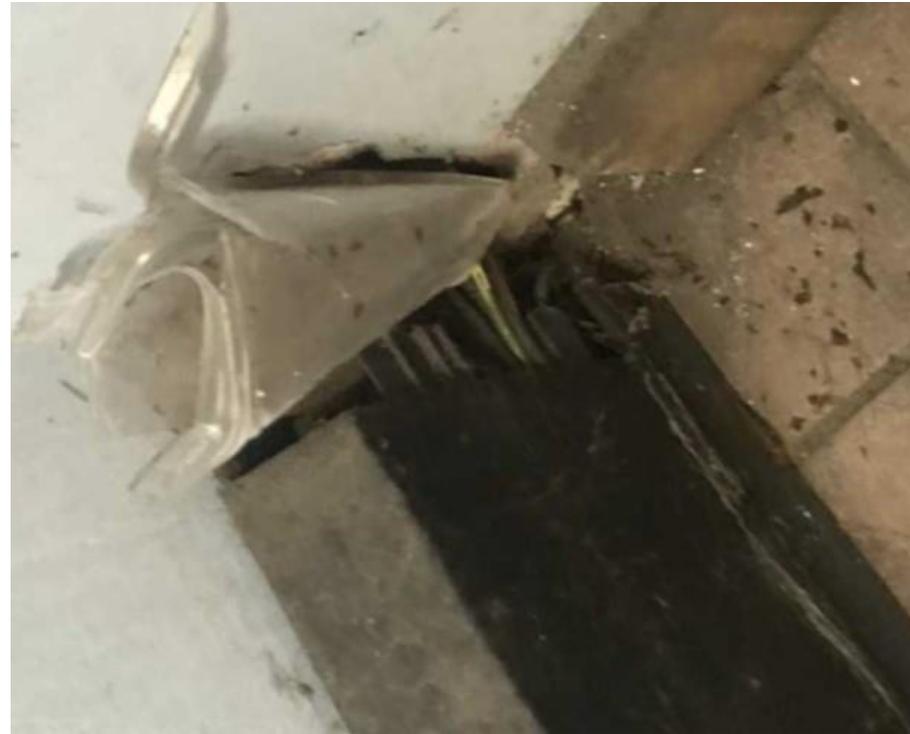
The temporary plastic container lid cover and the exposed conductors behind which were energised

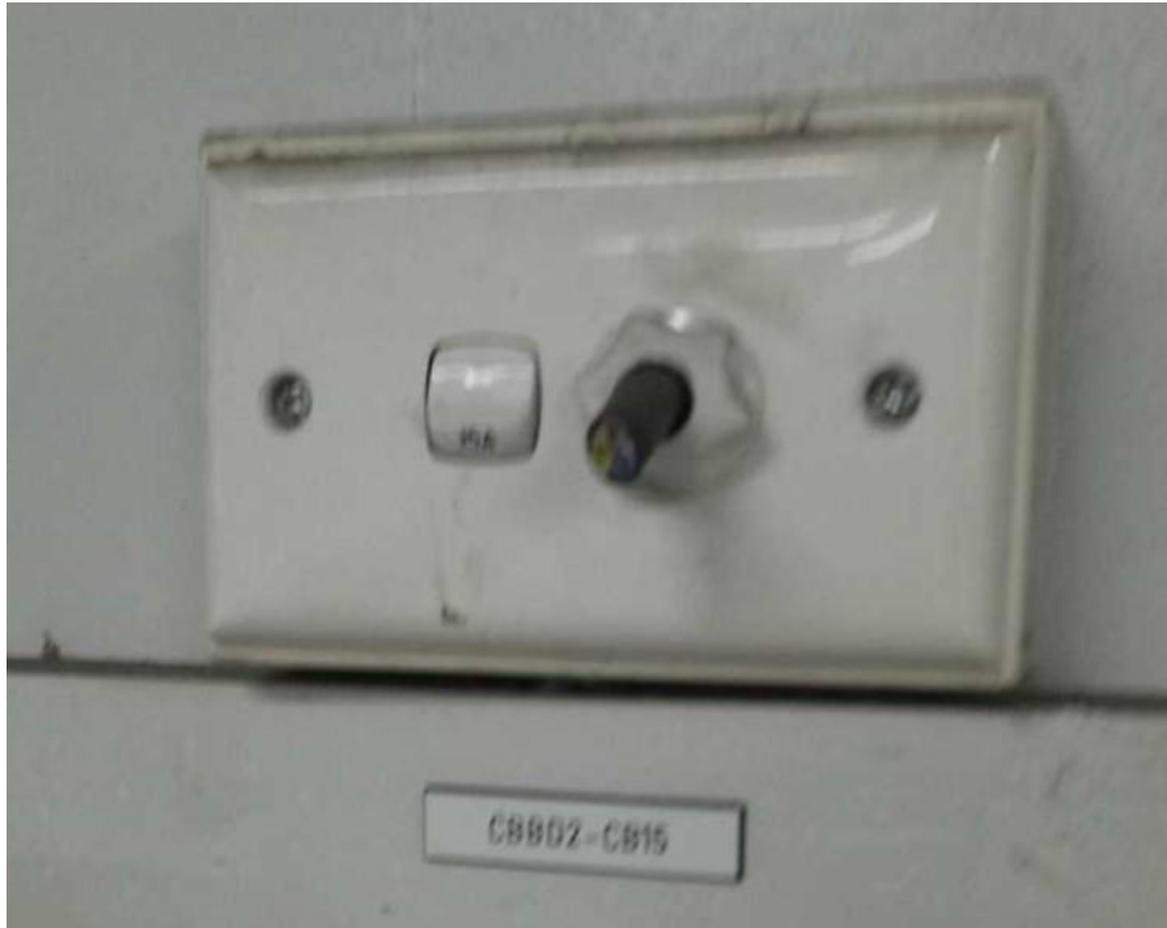
Electricians investigating an issue in a mechanical crib room found two hardwired wall plates with the appliance cables cut off at the wall plate leaving exposed conductors. The outlets remained energised at 240V ac and were fed from non-RCD protected circuit breakers. There was no record of what the outlets supplied.

The two hardwired wall plates with the energised three core cables coming from them with exposed conductors

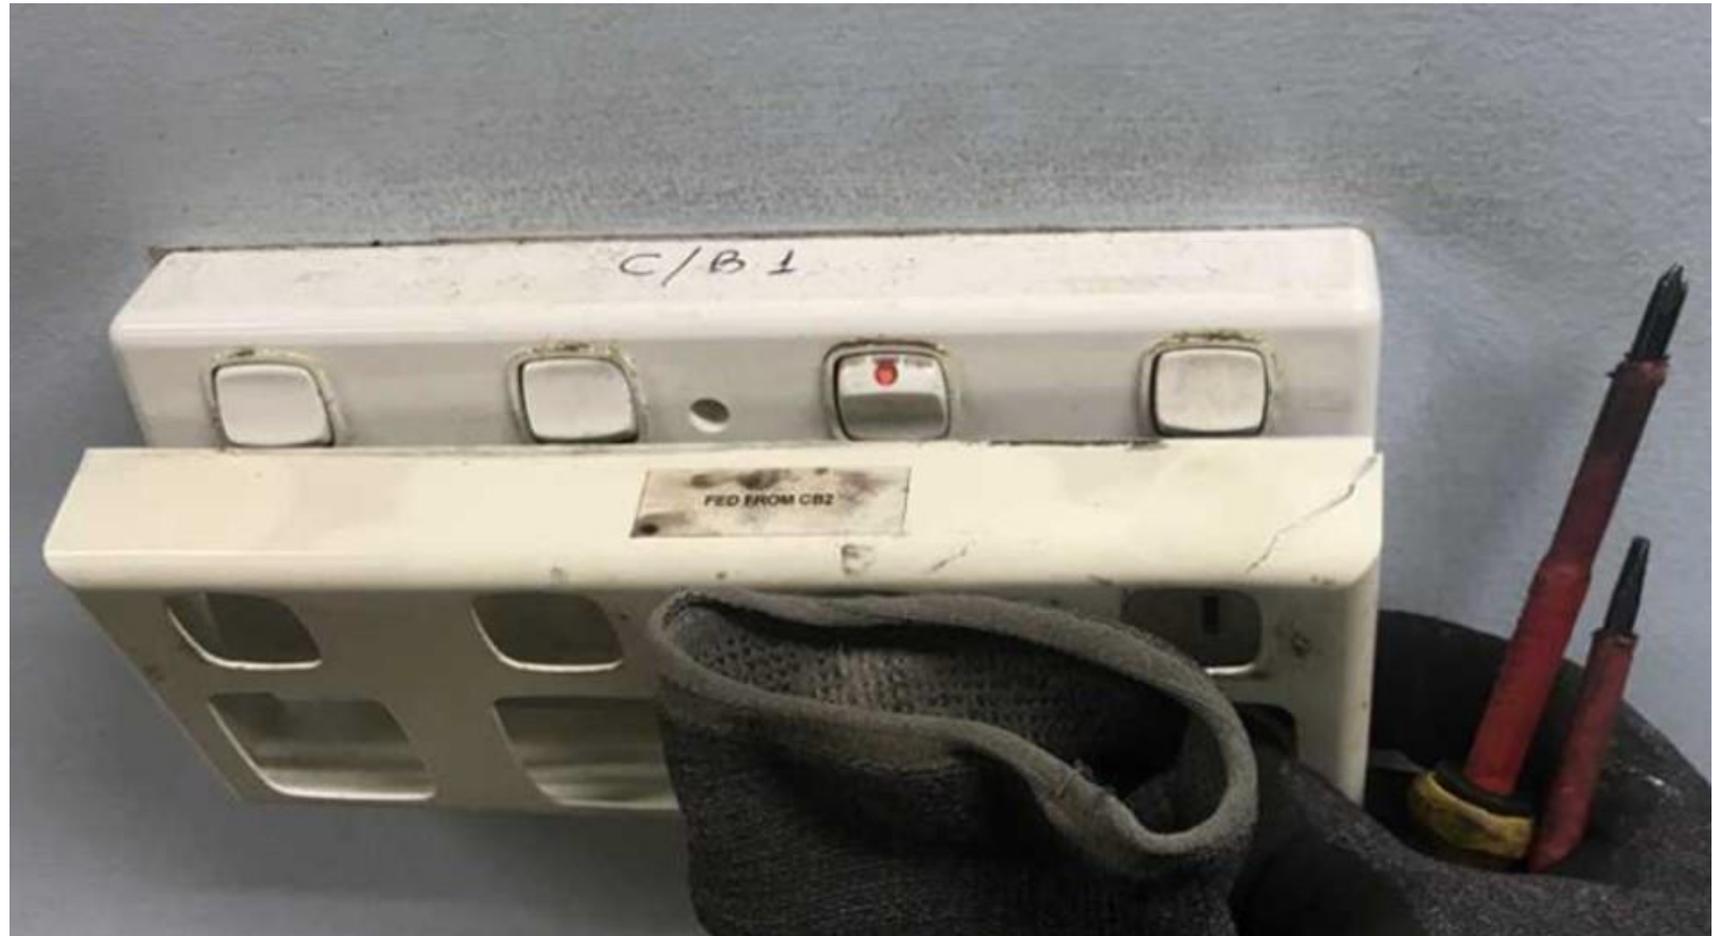
Electricians removing a four gang outlet have found the labelling to be incorrect. The cover plate label indicated the outlet to be fed from CB2 but when CB2 was isolated 240V ac was still on the outlet. A different source, CB1, was identified once the cover the plate was removed, this was isolated and verified to be the correct source using Test Before You Touch.

The two conflicting labels on the outlet and outlet cover plate

This incident highlights the importance of accurate labelling and the critical need to thoroughly Test Before You Touch.
