MONTHLY ELECTRICAL INCIDENTS

ASP Manufacturing

August 2021

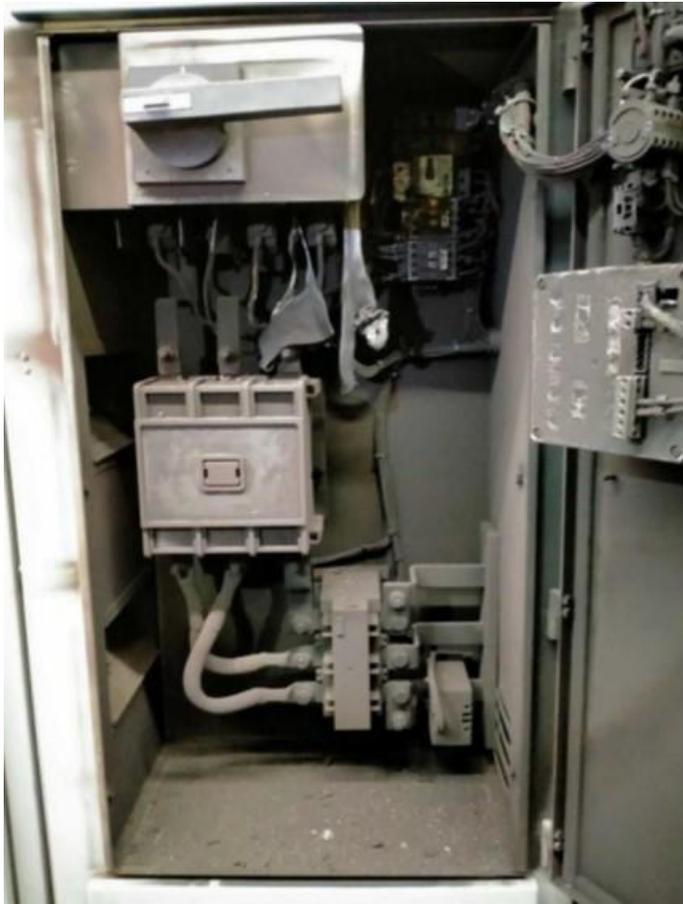
The 400 A main isolator of a 150kW motor starter failed resulting in an arc flash incident during commissioning of a replacement motor. The switch was initially closed to bump test the motor direction and then isolated to correct the direction. Once rectified the switch was again closed and the motor remotely started from PLC control. As the motor was running up to speed the starter began to make arcing and crackling noises, it was then stopped remotely but the arcing was heard to continue.

No one approached the MCC and the 800 A ACB supplying the MCC tripped before attempts were made to isolate the remotely. The arcing fault within the switch was contained inside the MCC cell due to the design of the board and the cell door being secured correctly.

The inside of the MCC starter where the arc fault was contained

As per electrical safety manual 1.4.3.7 performing operating work in close proximity to live equipment may result in arc blast and flash burn injuries. Always wear the correct PPE when performing switching operations, never approach a board under fault conditions and if attempting to isolate ensure the switchgear is rated for operation under fault current conditions. Use remotely operated switchgear where available.

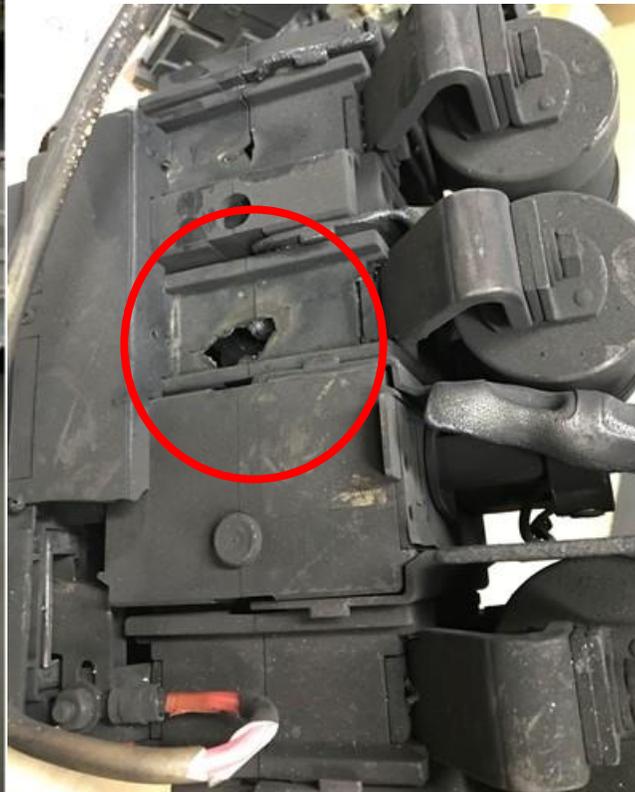
The internals of the main switch showing clear damage to the pins on the white phase. These pins make contact with a sliding plate when the switch is operated. This is where the arc fault originated.

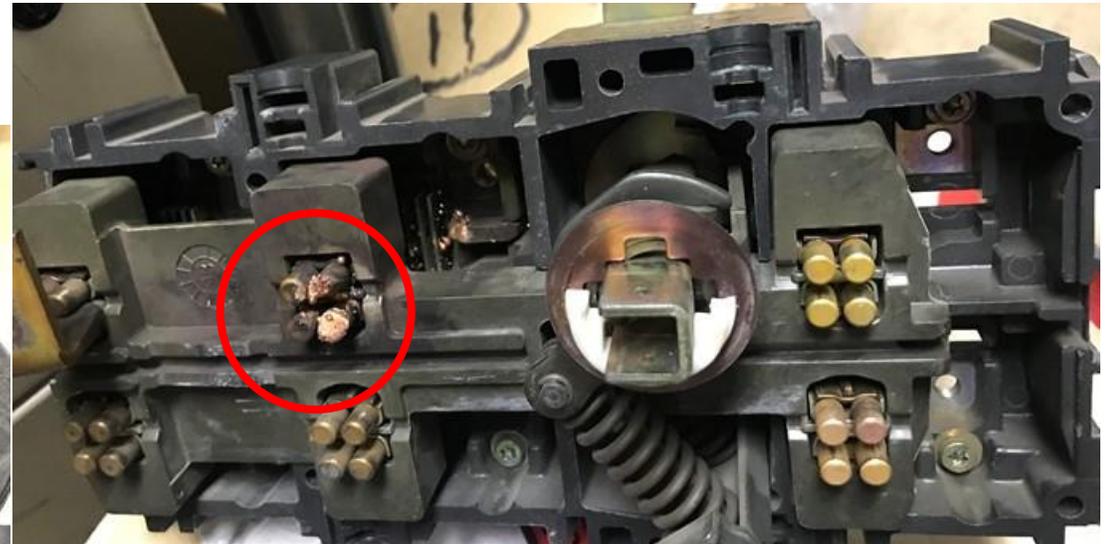
The top of the main switch showing a blow out on the top of the arc shield of the white phase

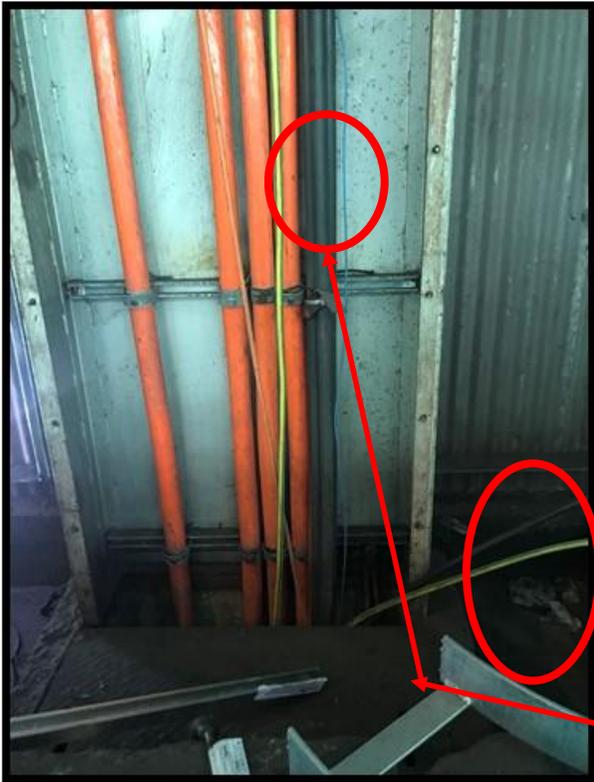
Electricians found a 150mm² SDI and 70mm² earth cable with exposed, rough cut ends, after removing covers from a cable launder. Inspection of the cable racking above the cable launder found the same cables cut approximately 50 metres away, the cut cables are believed to be part of an attempted copper thief.

The rough cut 150mm² SDI cable

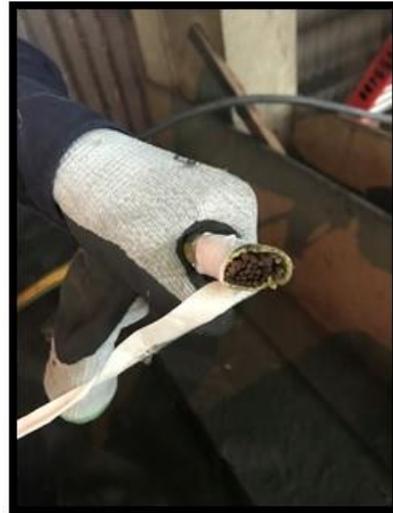
The SDI cable cut on the cable racking above

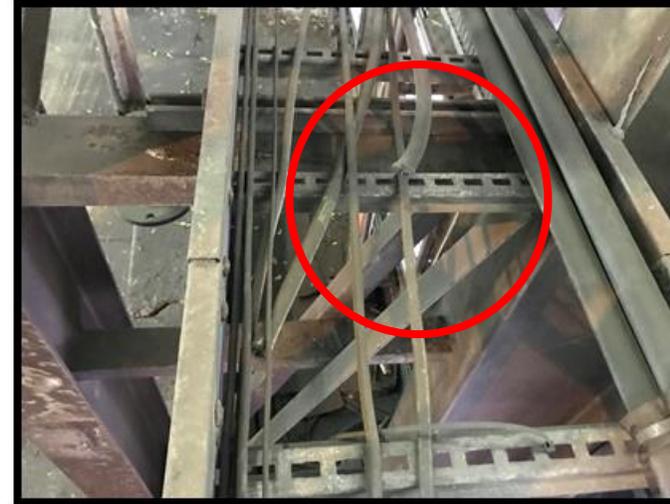
The two cut cables hanging from the cable launder. Above are the other 3 SDI cable for the 3 phases of this circuit

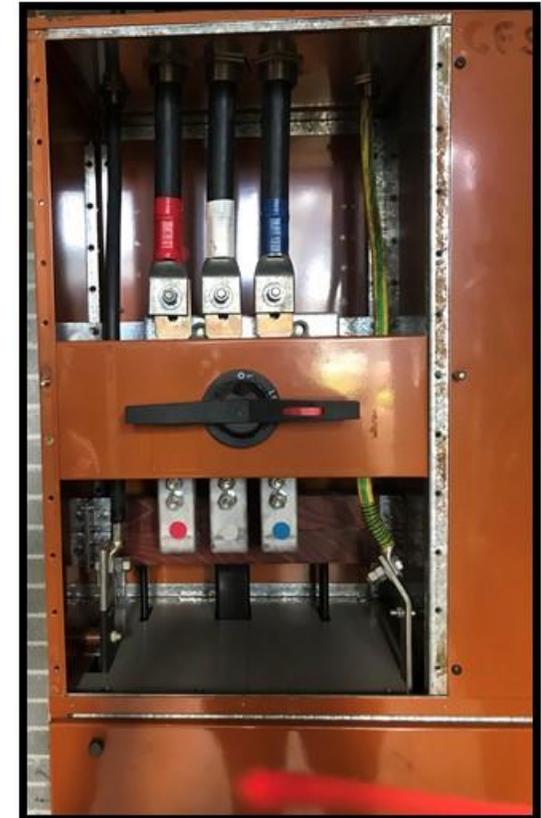
The cut cables were confirmed to be the neutral and earth conductors of the supply to a main distribution board, the three phase supply was still in service. A number of single phase loads supplied from this switchboard remained operational despite the neutral being disconnected due to incorrect earth neutral bridging within a light fitting.

Inside the distribution board where the neutral and earth cables were terminated and where 5.3V ac was measure between the two bars.

As per AS3000 ensure all neutral conductors are only bonded to earth at one point, the Neutral Earth connection, as close as possible to the source of supply and ensure a continuous electrical earthing conductor is connected to all devices of an electrical installation.

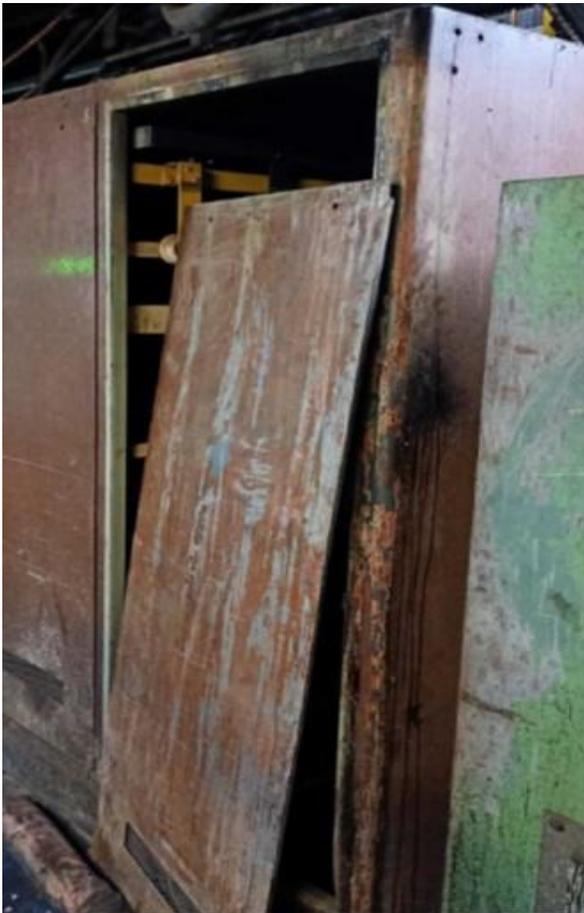
A fitter noticed the rear door of the pre-melt pot panel had become dislodged and was leaning inside towards the exposed energised 415V busbar, the panel cover was only 50mm from the high fault level busbar. The cover looks to have been either knocked or pushed from its securing position as the base section is bent out. The panels are in the basement of the MCL with the rear doors facing a walkway used infrequently by operators.

The rear door of the panel leaning into the panel with energised exposed busbars in close proximity

As per electrical safety manual 1.4.2.3 and 1.4.8.1, to ensure persons do not accidentally or inadvertently gain access to high fault level electrical equipment all removable covers shall be permanently secured correctly to the manufacturers design and are appropriately and uniquely labelled. All electrical stations and field panels shall be secured against unauthorised access

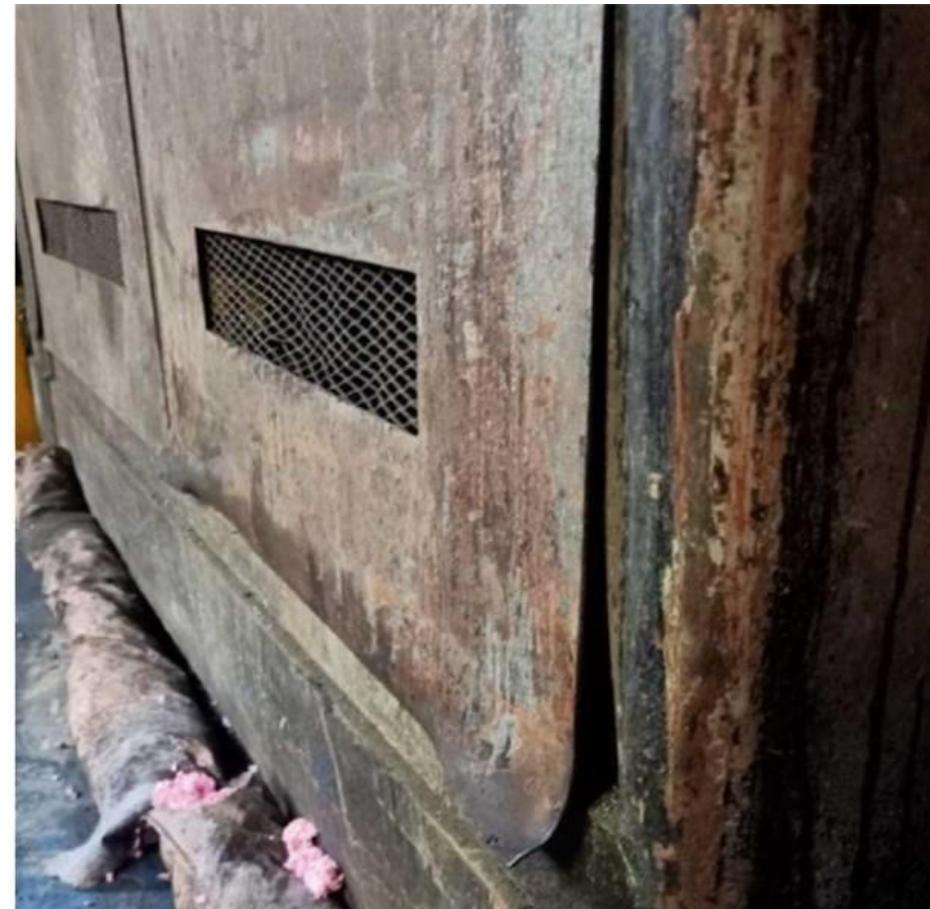
The damaged to the bottom of the rear door

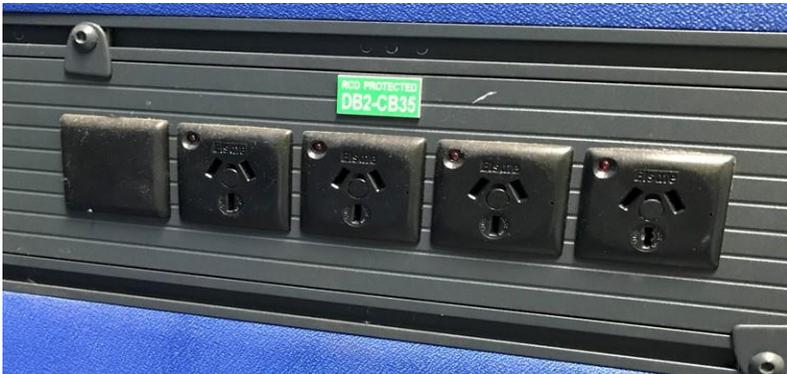
The outlets in two modular office cubicles had no voltage despite the 20 A supply being energised. The outlets are supplied from a TPS cable and plug, and then looped within ducting of the wall units through connectors at each outlet group. An electrician found the plug at the first outlet had come away from the socket resulting in a hot joint, melting the pin on the plug and creating an open circuit in the active conductor. Fortunately the fault did not lead to a fire.

The office modular outlets supplied with the wall units, as found before opening up

Supply capacity should be checked before installation of heavy loads. Office furniture, with in built power circuits are designed for standard loads and diversity, outlets may need to be audited to confirm circuits are not excessively loaded.

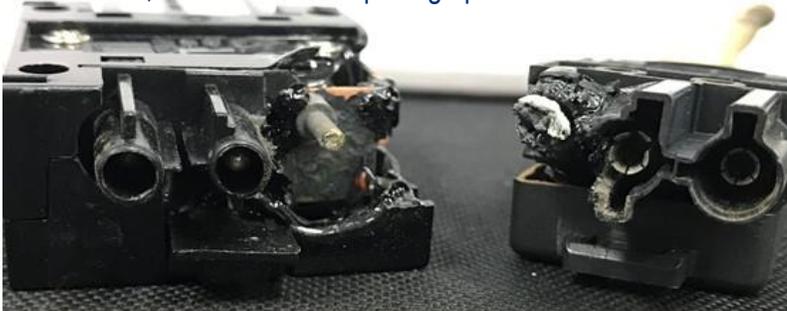
A close up of the damage to the male and female plugs

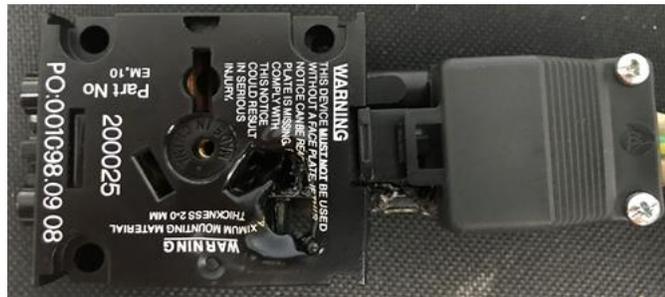
The top and bottom view of the damaged outlet with the female plug connected. Note the melted pin and open circuit in the active conductor

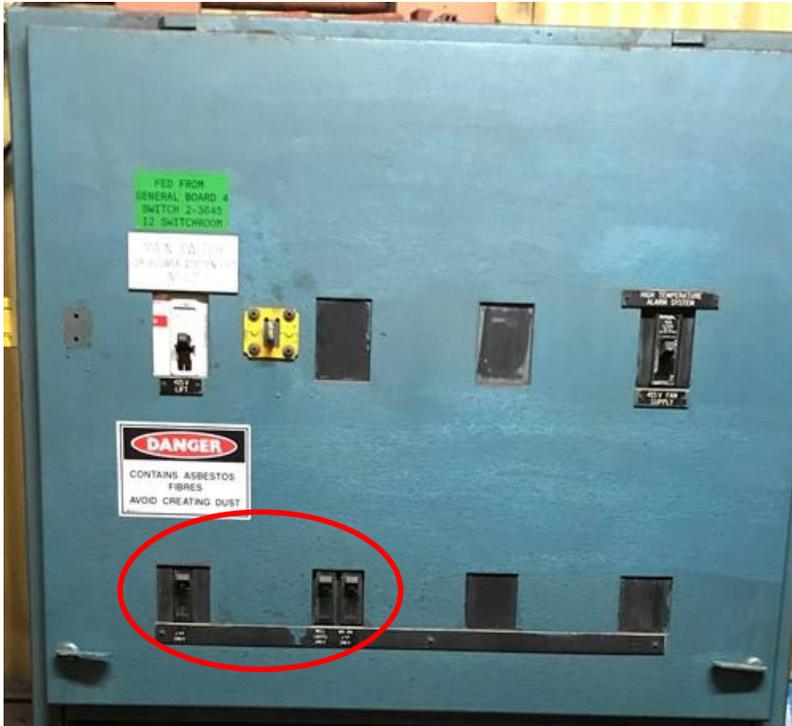
After upgrading a lighting distribution board one of the RCD breakers tripped during testing and commissioning. The cable for this circuit was traced to the main isolator panel for the lift at the No.2 Power house, inside this panel are three breakers for light and power inside the lift well. The active conductor of the cable traced terminated at the first circuit breaker and looped to the others, however all the neutral conductors were connected to the main neutral stud for the 3 phase main supply for the lift. With the 3 phase supply still energised and the lift in service the neutrals connected together formed a common bond which was sensed by the RCD breaker. This common neutral set up a trap for the electricians working on the lighting distribution board.

The lift main isolator panel with the control light and power circuit breakers.
Note no labelling to indicate these are fed from a different supply to the lift power supply

As per Electrical Safety Manual section 1.4.3.3 neutral conductor current sources cannot always be identified and isolated. All exposed neutral conductors shall be considered as live until all neutral conductor current sources are identified, isolated and the isolation verified or it is guaranteed the neutral conductor will remain at earth potential.

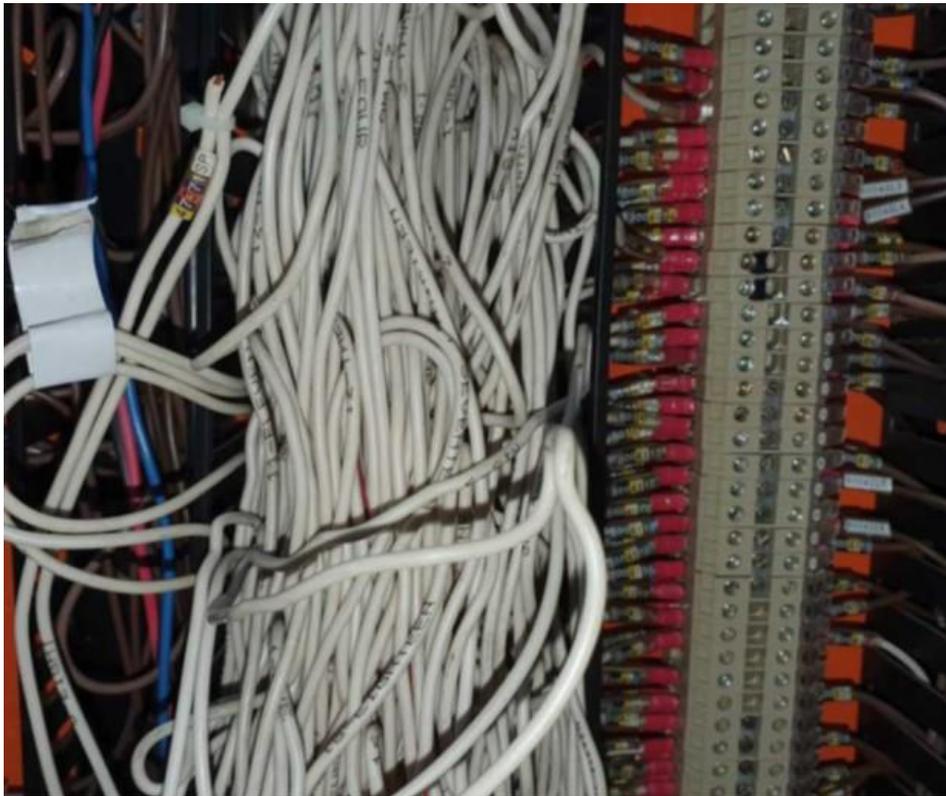
Unterminated control wires were discovered during commissioning of a PLC upgrade at DCL3. Duplicated wire numbers were identified on two cables between E-Stop panel & Exit Tower jog station, as recorded on cable schedules. Three cores of cable 47371 were connected to the PCS circuit in the E-Stop panel, but were not terminated at the Exit Tower jog station. The cores were hidden behind & between the cable loom and the terminal strip with the ends approximately level with the top terminal. The ends of the cores were not insulated, however there was no bare copper protruding from the insulation. This left a potential for one of these core when energised to contact each other or an earthed surface which may have crash stopped the process line.

The terminal strip in the e-stop panel with the wiring wrongly doubled on the terminals

As per Electrical installation manual section 4.7.7 all spare cores of control cabling shall be bonded to earth at the supply end of the cable and insulated from earth and each other at the load end of the cable.

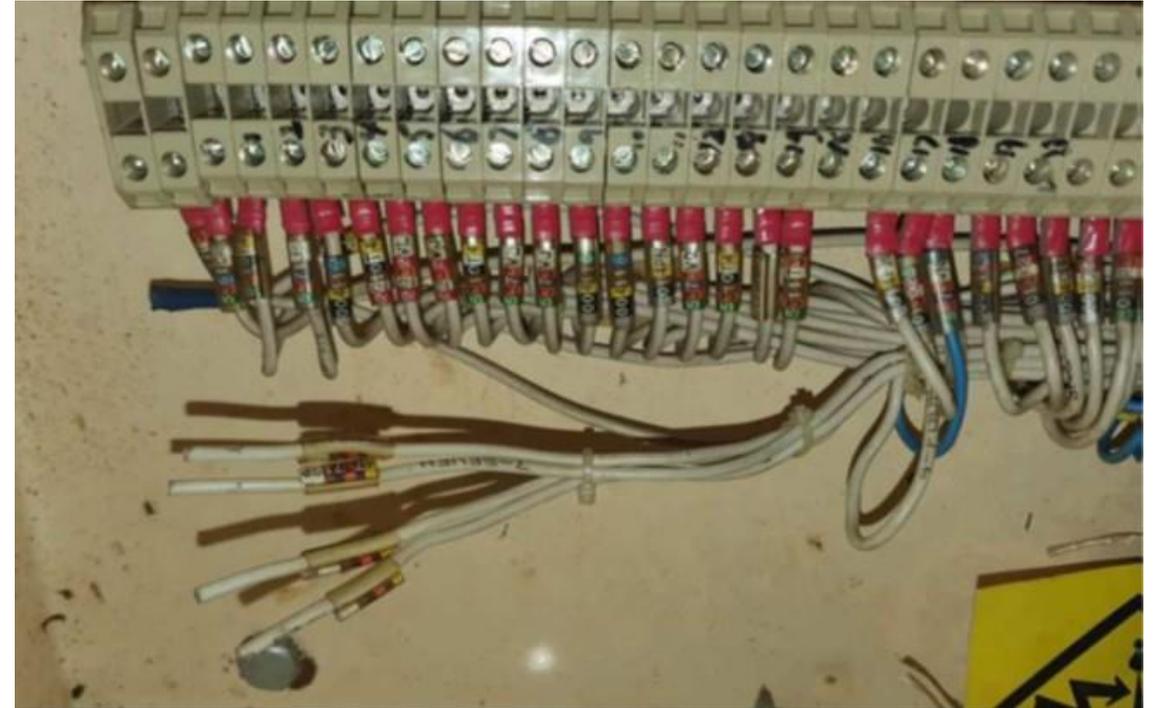
Inside the jog station with the spare cores left cut off and uninsulated. They were found tucked inside the cable loom

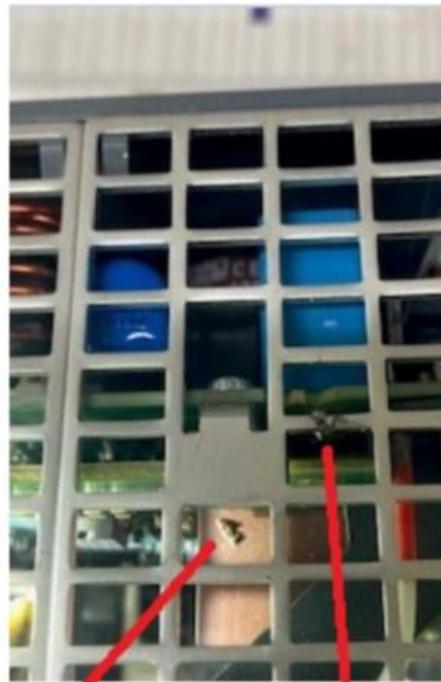
An electrician working in a remote I/O panel placed two terminal blocks (insulation facing down) on top of a SITOP 24V dc power supply, which resulted in the 24V power supply failing and tripping circuit breakers within the panel. A piece of conductive swarf was found on the power supply components after the power supply was removed. It is believed this had been sitting on the power supply cover since the initial installation, and placing the terminal blocks on top of the unit has dislodged the swarf causing it to short the internal components.

Swarf piece

Short area

The power supply

Before energisation of any installation all devices are to be cleaned of all conductive swarf or filings to ensure it is safe and fit for duty.

As per electrical safety manual 1.3 and 2.4.5 a minimum safe working distance of 500mm must be maintained if an electrical worker is considering work near live conductors or equipment where there is a possibility the worker, or any object the worker may handling may contact live parts or initiate an arc fault. A risk assessment must be conducted and adequate controls such as protective barriers put in place before work can commence.

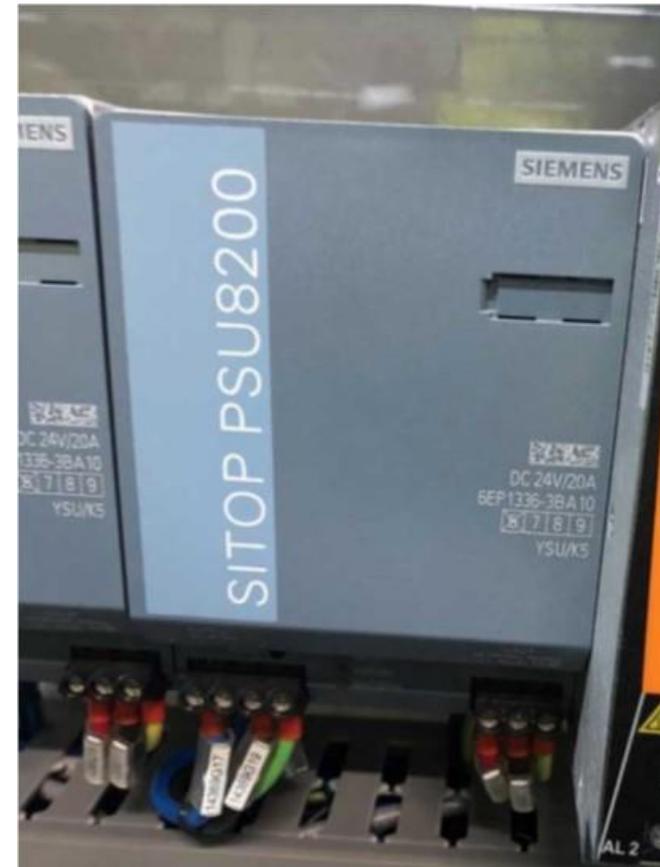
The top of the power supply with the swarf clearly evident

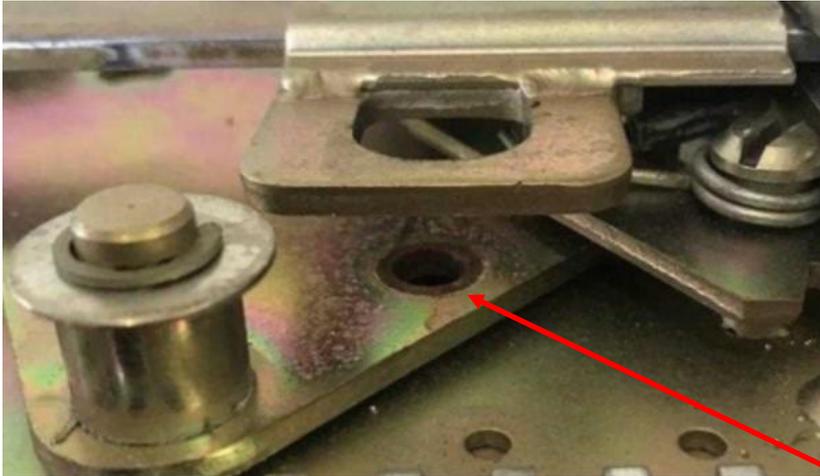
During de-isolation of a 100amp CFS unit an electrician has noticed the switch has failed to close. The switch has failed internally and the fuse cartridge became jammed and could not be removed. When the board was isolated the switch was removed to reveal the drive pin for the switch handle had broken away from drive plate rendering the switch inoperable. This is a similar failure of this style CFS unit from previous incidents which are being investigated.

The loose pin

This is a reminder for all BSL owners of this style of 100Amp or 200Amp CFS unit manufactured after 2005 to investigate if their switches potentially have this failure point.

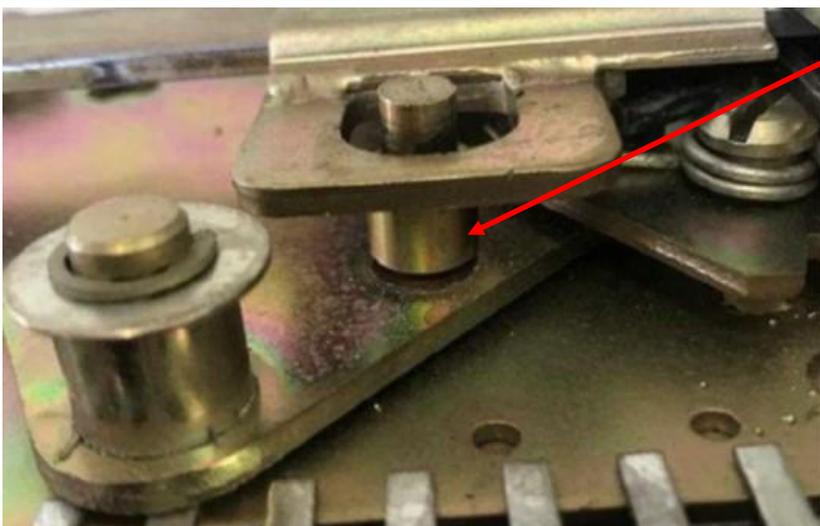
The drive plate without the pin in position and with the pin where it should be.

Note neither the drive pin or the holding pin have an evidence of welding on the top of the drive plate

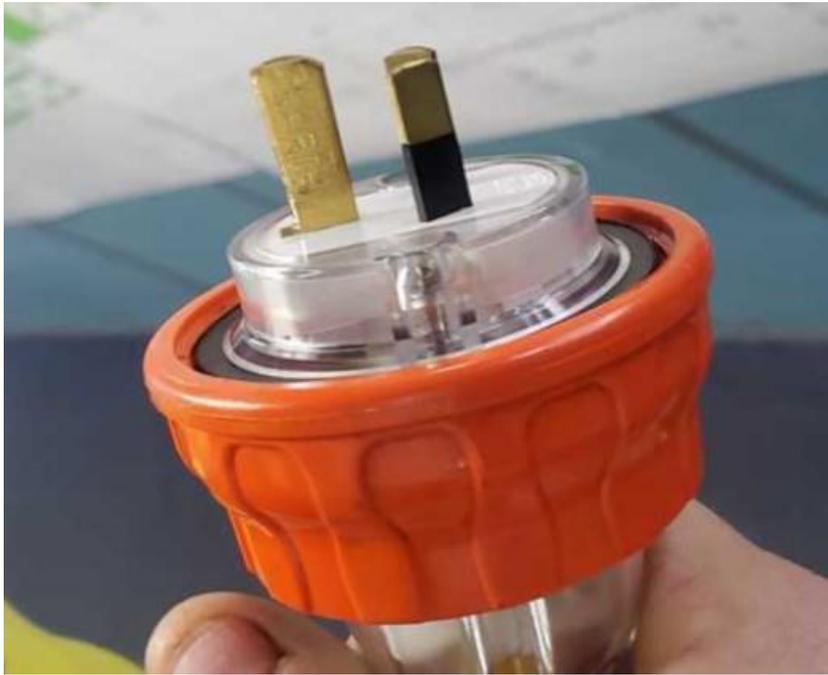
A roofing contractor supervisor returned a 15amp lifeguard power board because his firm could not use it due to the plug being 15amp and there only being 10amp outlets on site. The electrical supervisor with whom the board was returned noticed the 15amp earth pin of the plug had been modified. It seems an attempt had been made to reduce the size of the earth pin to fit into a 10amp outlet. The attempt failed when the cut in the pin was only on the shaft of the pin not the top part of pin, still not allowing the pin to be inserted in the 10amp socket. No one has admitted to modifying the pin.

Two views of the earth pin of the 15amp plug. Clearly the pin has been modified and reduced in size at the base of the pin, however, the top of the pin has not be reduced

Incorrect modifications to or repair of an electrical appliance may result in an electric shock or arc blast and flash injury. All appliances should be visually inspected by a competent person every time they are used and tested as fit for duty on a regular basis.
