MONTHLY ELECTRICAL INCIDENTS

ASP Manufacturing

September 2021

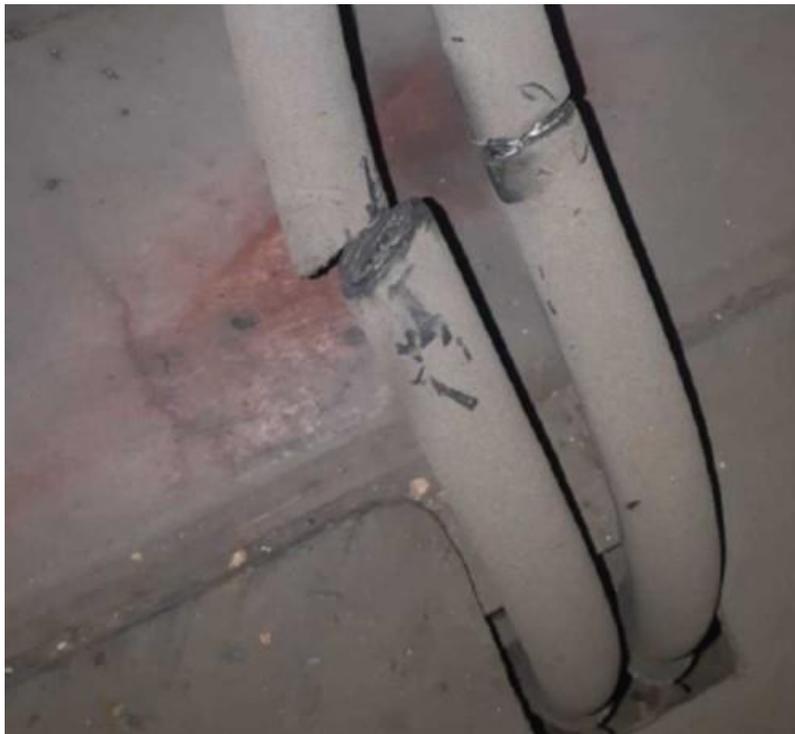
Power control officers trying to close 11kV switchgear after a down day discovered the 230Vdc closing was missing. The control supply circuit breaker had no voltage at the top of the breaker, further investigation found the 150mm² SDI supply cables at the bottom of the DC flatback panel had been cut. There is evidence of an arc blast on the concrete at the cut location, with molten copper droplets evident. One of the cables is half cut through while the other cable is completely cut with one end showing signs of melting from an arc. The supply cables were traced back to a 500amp Superform switch with one of the 500amp fuses blown. This switch is fed from the standard 230V dc shop supply with a floating supply. Investigation believe this is the action of a copper thief who has cut the positive leg first and then in the action of cutting the negative leg has shorted the two cables to create the arc flash.

The cut cables as found at the back of the DC flatback panel coming through the floor.
Note the flash mark on the concrete floor below and copper droplets

As per electrical safety manual 1.4.2.1 working in close proximity to electrical equipment introduces the risk of electric shock or arc blast and flash burn injuries and any item shall be assumed to be live until verified otherwise. Also as per 1.4.2.3 to prevent persons accidentally or inadvertently gaining access to electrical supply equipment all electrical supply equipment shall be suitably secured and only accessible to appropriately trained and experienced persons.

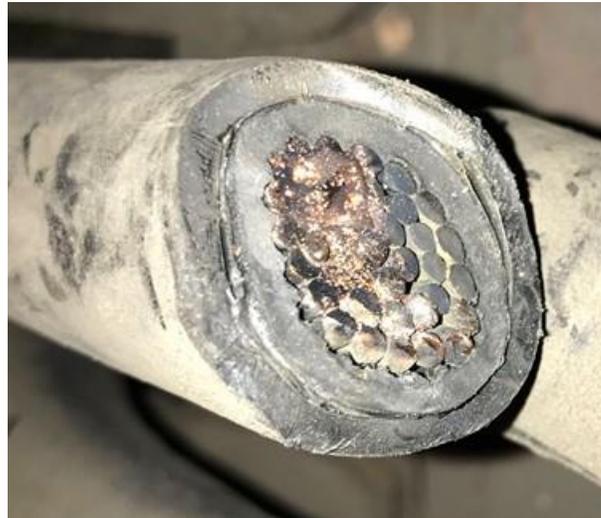
The cut positive leg cable with melted conductors from the arc flash

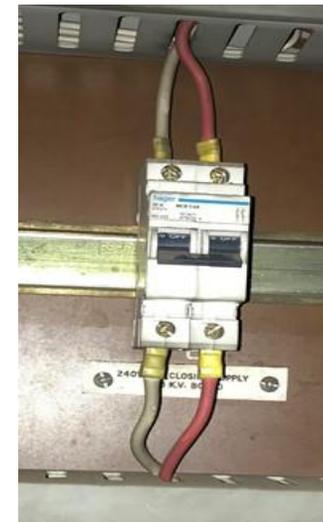
The supply 16amp breaker for the HV closing supply

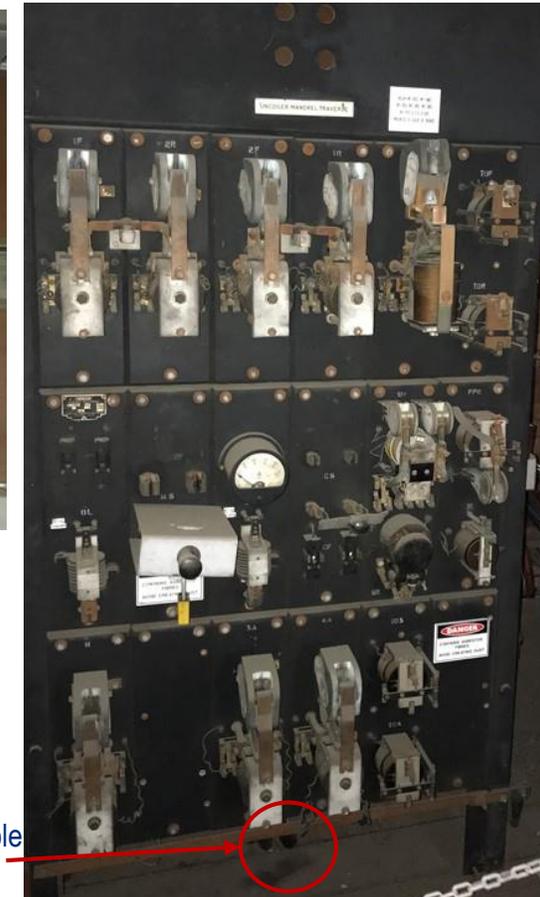
The old DC flatback panel where the breaker was mounted on the back.
Note the incoming supply cables visible coming from below

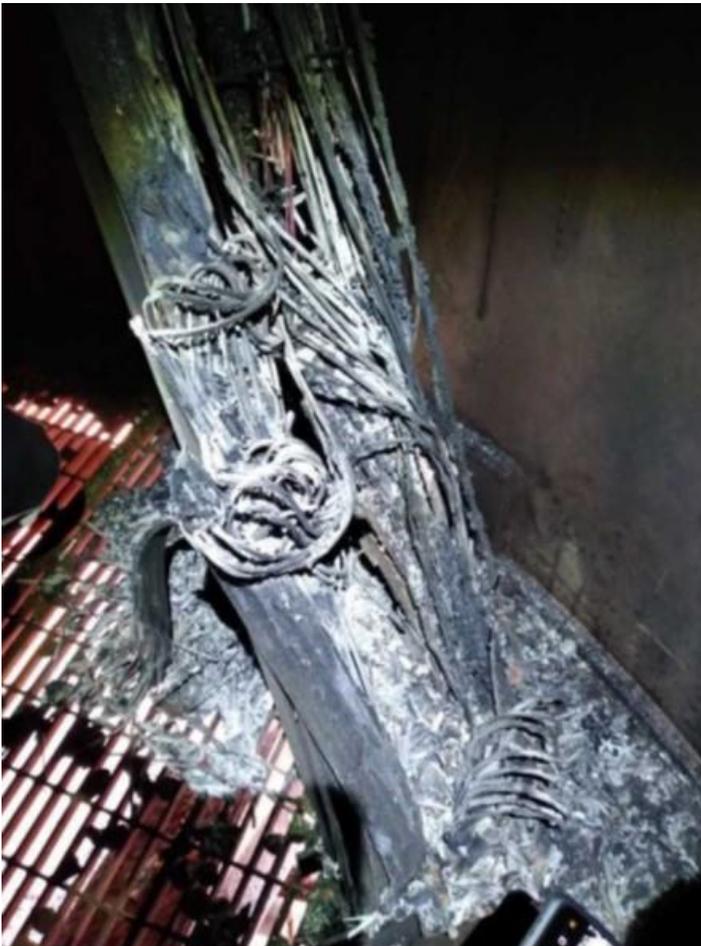
A shift electrician has been called to No.2 stacker reclaimer machine to investigate why the machine was stopped and had no communications and GPS faults. A pile of ash was observed at the base of the boarding steps, looking up burnt cables were observed entering the slewing turret which contains the main catenary. All cables entering the turret from below were completely damaged by the fire. This catenary has the main 415V ac supply cables to the switchroom and the dc long travel motor cables. Fortunately the fire only propagated along the cables to the first catenary trolley where it has extinguished. It is believed due to the large amount of grease in the turret and poor mechanical protection of the cable, one of the dc motor armature cable's insulation has failed causing an arcing incident initiating the fire.

The first trolley of the catenary where the fire has stopped, mainly due to the clapping arrangement

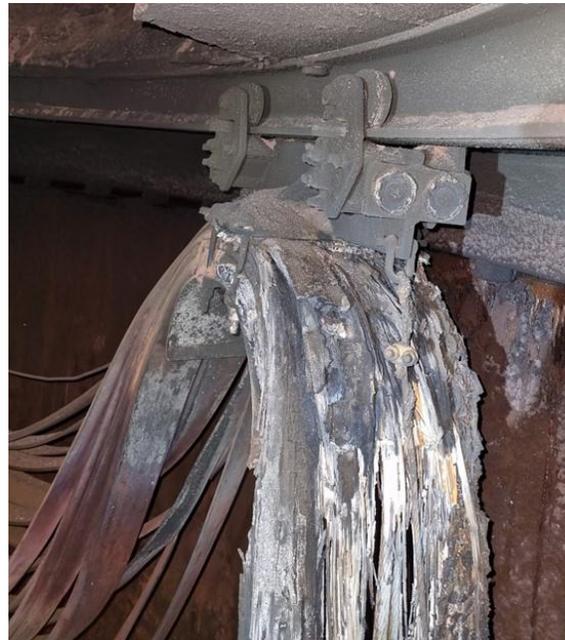
Inside the turret showing all the burnt cables and the point of entry where the fault is believed to have started

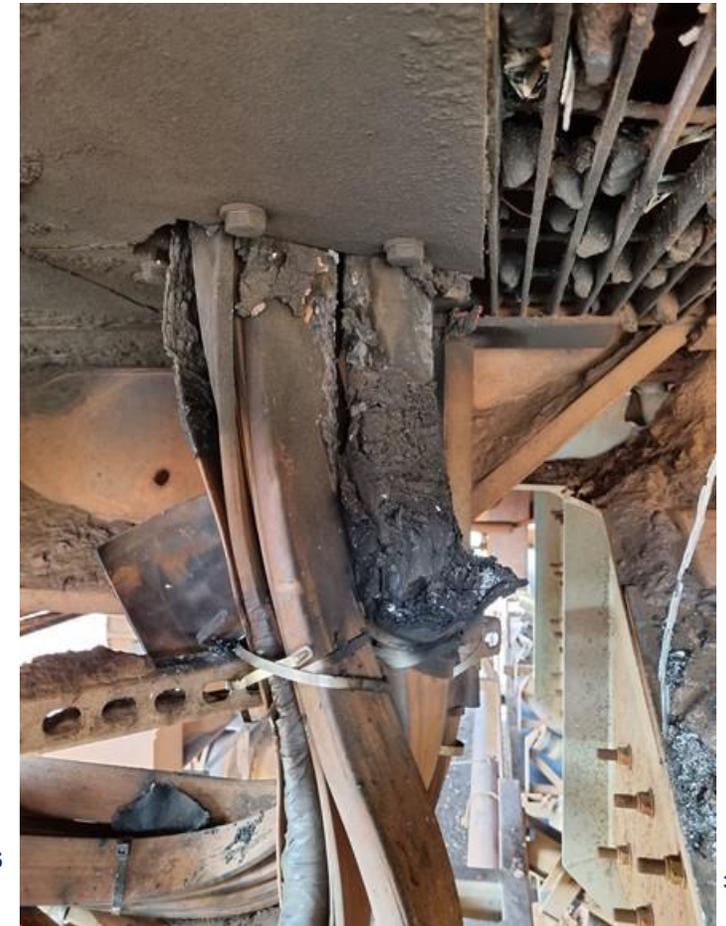
The bottom entry to the turret where there is minimal mechanical protection for the cables and the only support is a couple of cable ties

As per the electrical installation manual all cables passing through an opening in a metal structure are to be properly mechanically protected and adequately supported before being fire stopped.

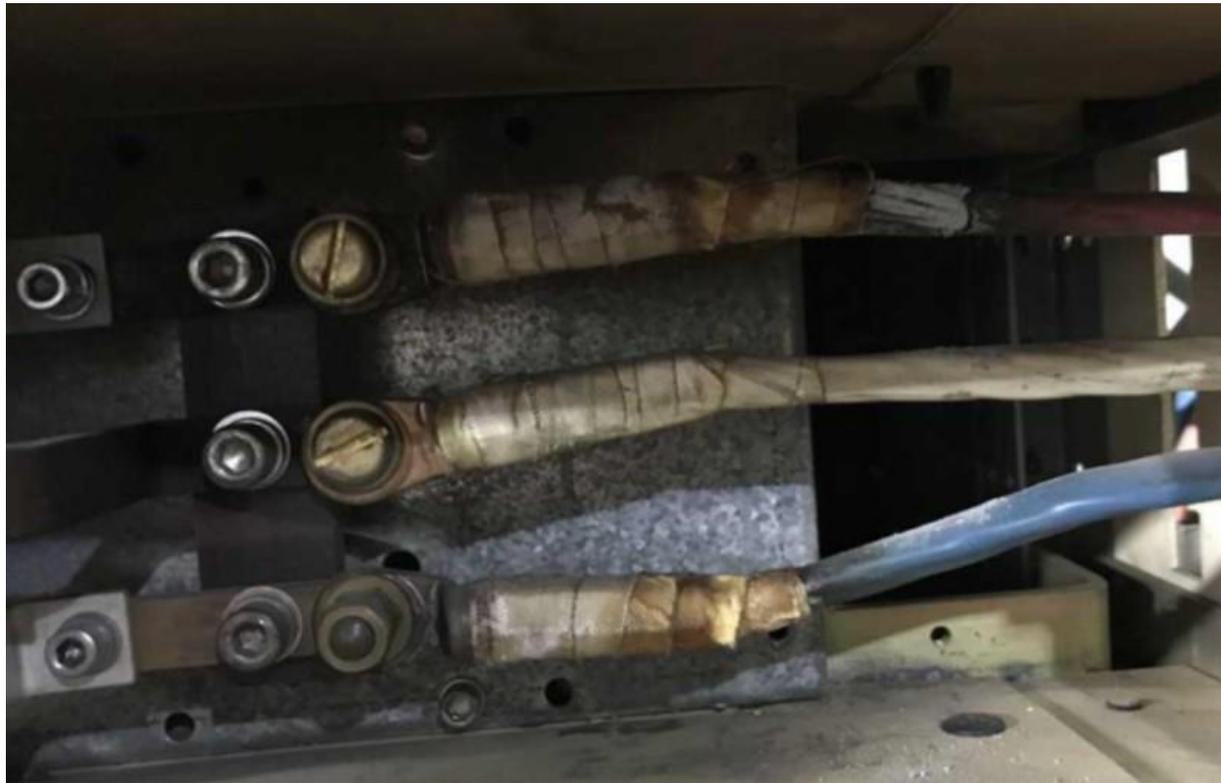
A hot joint was discovered on the load side cable connections of a 100amp CFS switch for an air conditioner system during a plant stop and routine maintenance of a distribution board. All three cores of the 50mm² aluminium cable show signs of a hot joint at the bi-metal lugs. Previous measure had been taken to repair insulation damage at this location, however the cause of the hot joint had not been addressed. Hot joints will become worse over time if not adequately addressed, and may result in significant equipment damage.

The three aluminium cores covered with glass tape and showing signs of heat damage

It is imperative with power cable terminations the correct cable lug for the type and size cable is used, then crimped correctly to the manufacturers recommendations.

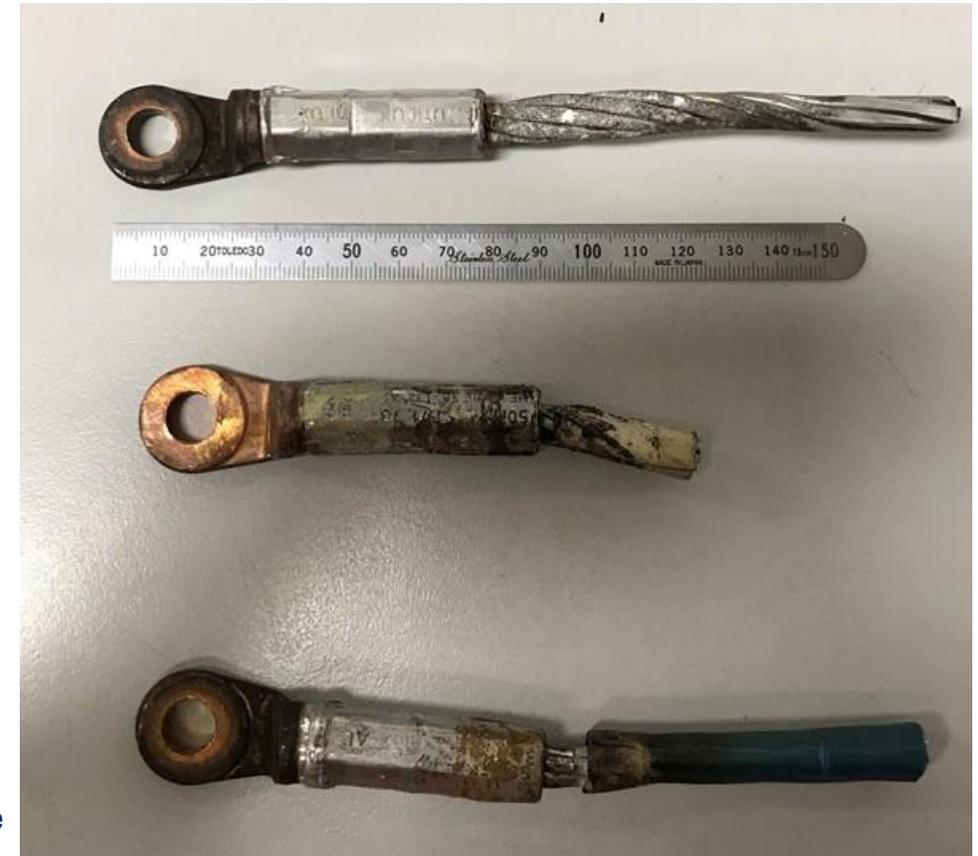
The three aluminium cores showing the bi-metal lugs and the damage to each core

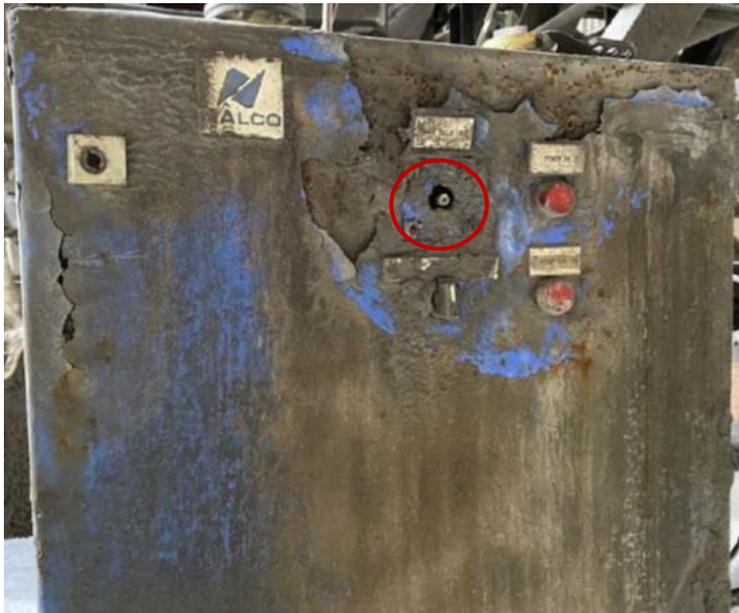
An electrician has found the main isolator of an old control panel to be sitting on the ground of an area of plant infrequently visited. A close inspection of the panel found it to be in a very poor state with the door rusted through in places and the internals showing signs of excessive water ingress. The terminals of the main isolator were found to be energised with 240V ac, despite the equipment no longer being use. The panel is believed to be a redundant part of No.3 Furnace which was de-commission in 2011 and owned by a third party who did not make it safe and remove it at the time. As per the BSL guideline for disconnected cables DIV-ENG-009 all redundant equipment is to be isolated and made safe with all cabling removed, or managed as per the guideline.

The poor condition of the front door of the panel and the position where the main isolator handle came from

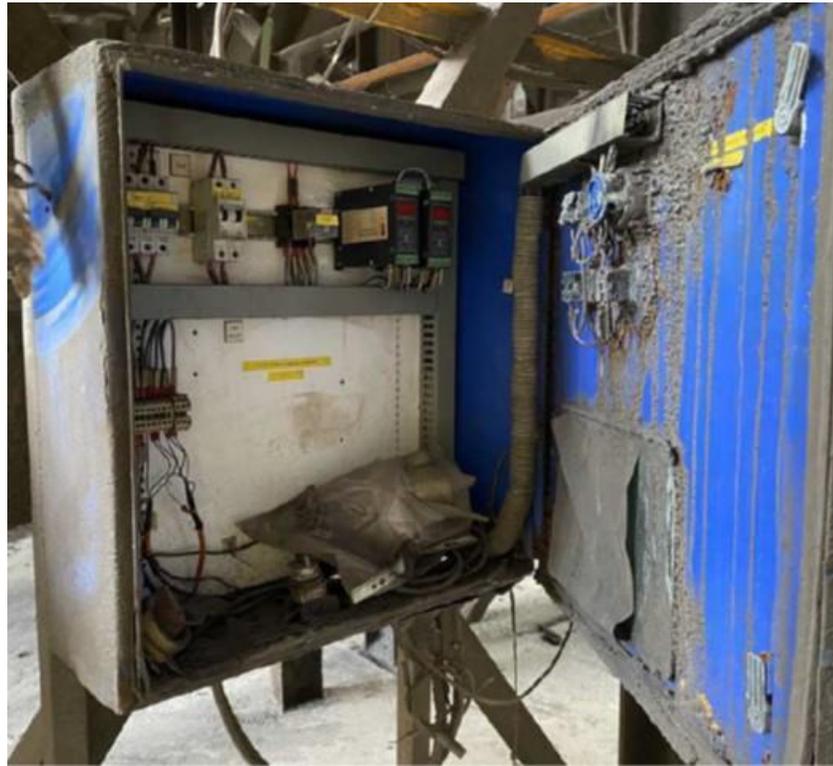
A view of the panel internals and condition

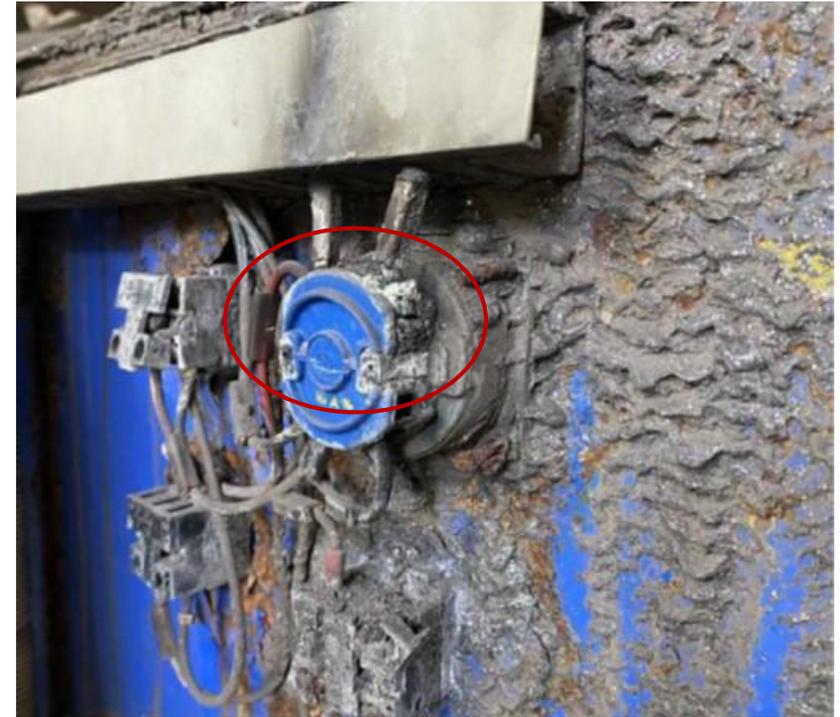
A close up of the door internals with water ingress very evident, also the back of the isolator with the energised terminals

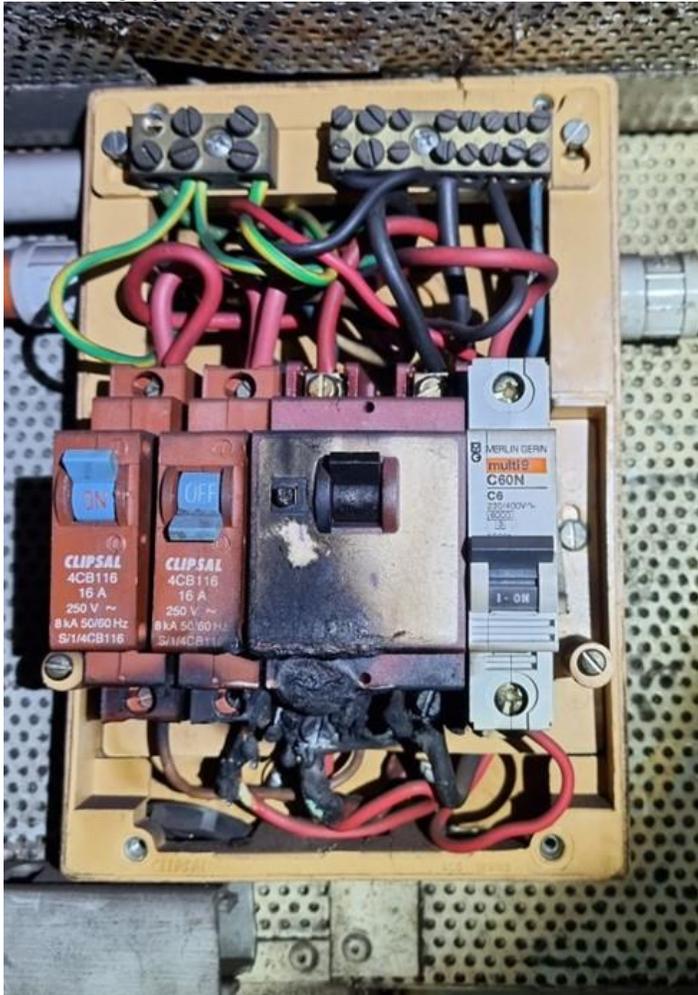
An electrician has noticed the lights and air conditioner not working in an operators cabin. The small distribution board inside the cabin was found with a large burn mark below the main switch and the outer plastic enclosure melted. A hot joint had developed on the active conductor of the RCD breaker which had started to melt the breaker. A large steam leak below the cabin a couple of weeks before the board was discovered may have caused moisture to enter the non IP rated enclosure.

The inside of the distribution board with the hot joint on the RCD breaker

The integrity of all electrical equipment should be checked on a regular basis to ensure the installation is suitable for the environment and conditions it may encounter.

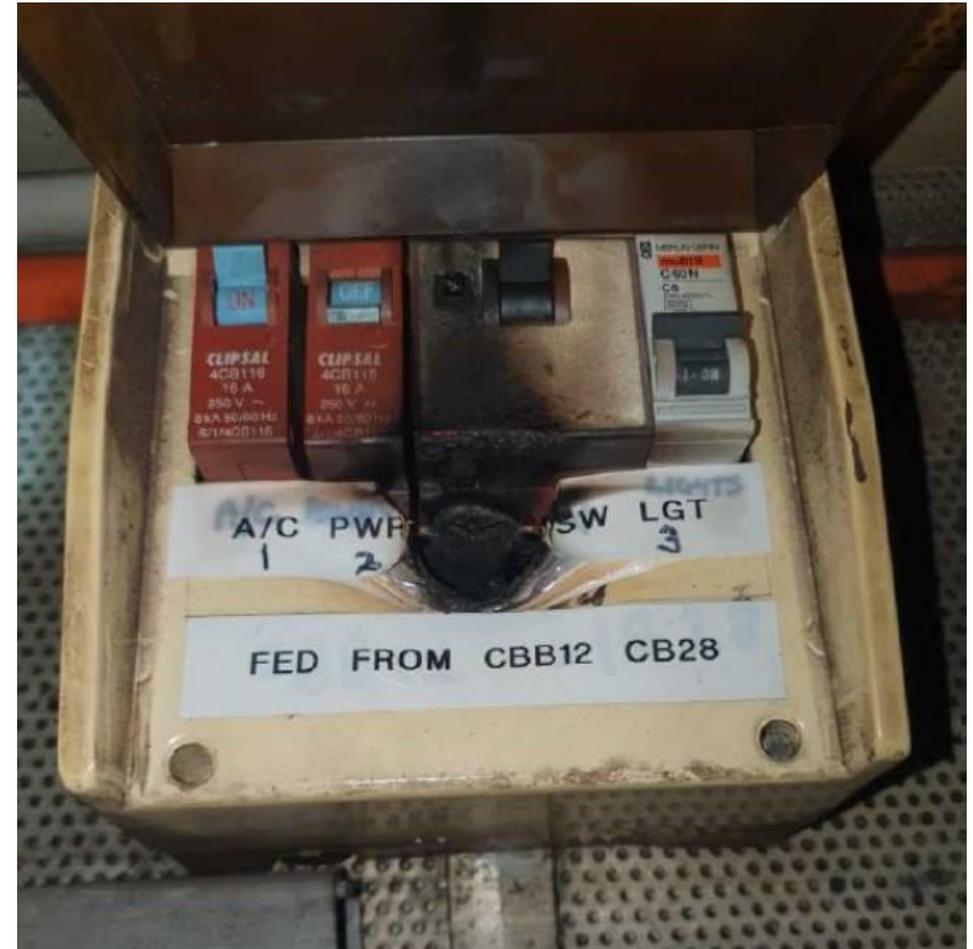
The distribution board as found with the melted plastic section below the breaker

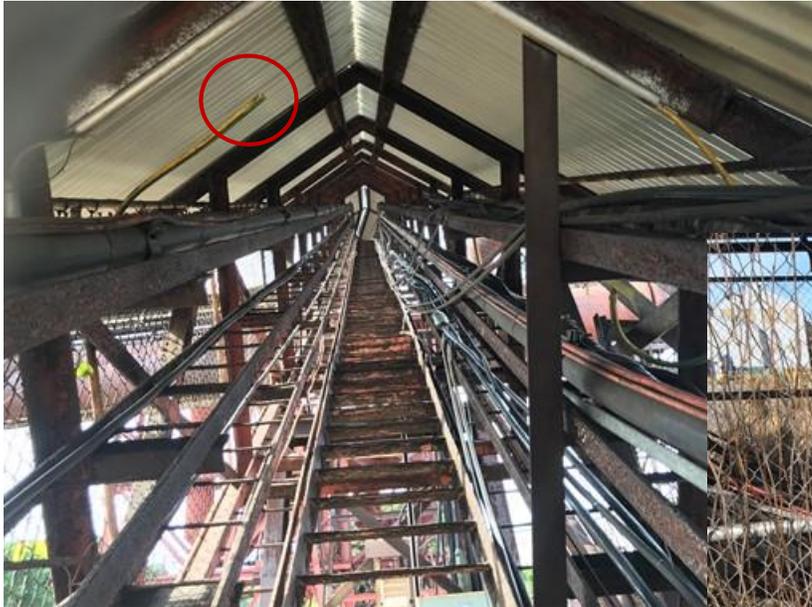
Port Kembla security controller was alerted by alarms when a number fire panel communications links were down. An investigation has found copper thieves have broken into the cable launder and bridge adjacent to A-27 switchroom. A large number telephone cables were effected which provide the backbone for the fire security system and alarming. Other cable cut or damaged were network cables, earth cables and telemetry signal cables.

A number of photos of the cut cables found

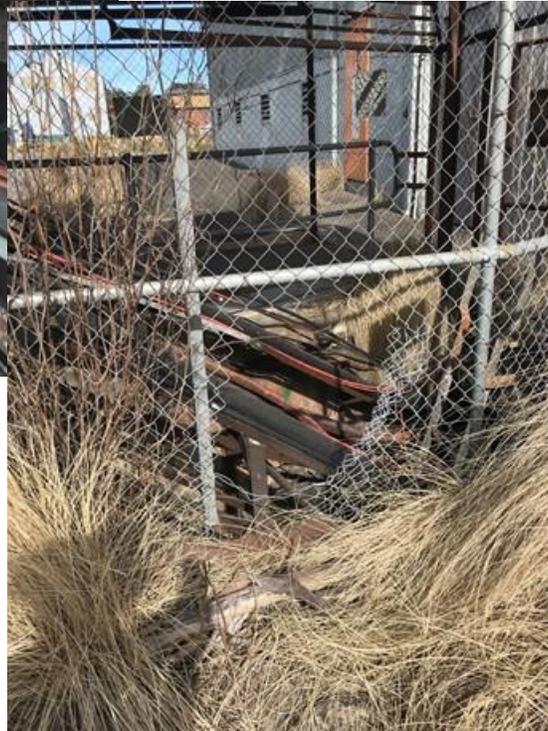
The hole cut in the fence to gain access

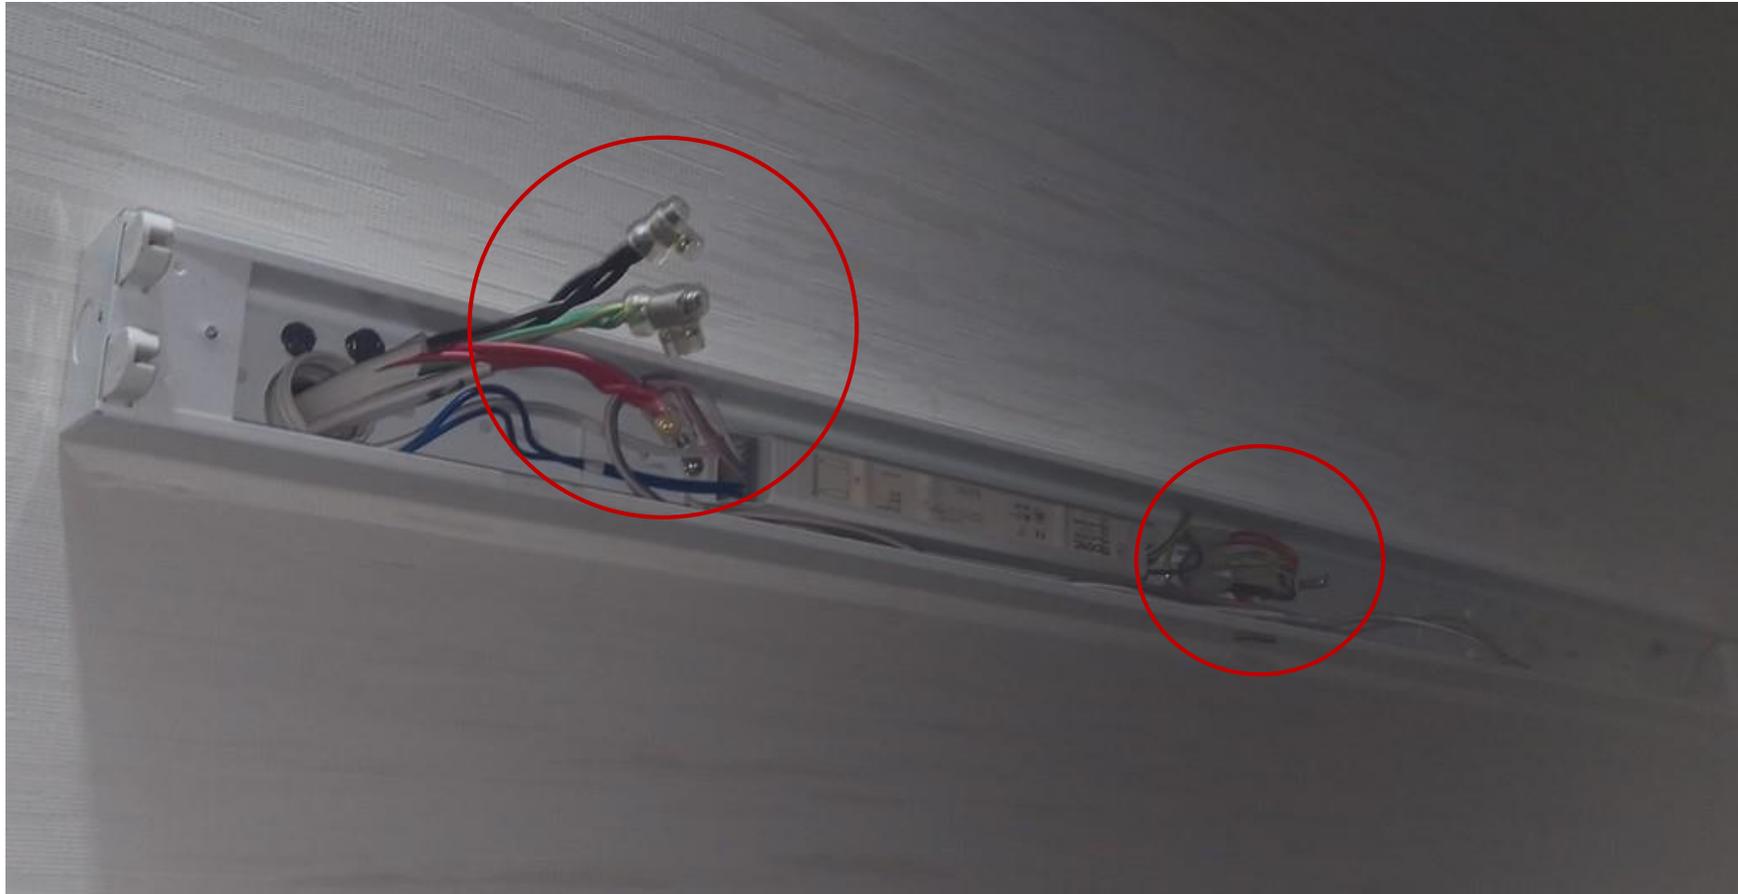
An electrician and an apprentice changing a light fitting have found two supplies in the one fitting. When conducting Test Before You Touch the lighting supply was correctly tested and identified. Also inside the light fitting through a different penetration were two cables PB connected but not connected to the light fitting. TBYT found these cables to be still energised. They were found to be part of an outlet power circuit and the light fitting had been used as a junction box.

The light fitting with two supplies.
In the centre is the lighting supply penetration into the fitting.
At the left hand end is the two looping cables penetration for the outlet power circuit.

It is essential before commencing any electrical work Test Before You Touch must be conducted to ensure all conductors are isolated and proven de-energised.

It is not good practice to run two different supplies into the one device as it is a potential trap for electricians who are unaware of the installation. Multiple supply sources must be clearly identified where used.
