Incident Name	Worker received Extra Low Voltage shock from Rail
Date of Incident	23 <sup>rd</sup> of August 2021 Time: 12:15am
Classification	First Aid Accident
Location of incident	Sydney Metro Northwest Rail Network on Track at Macquarie Park Points 21

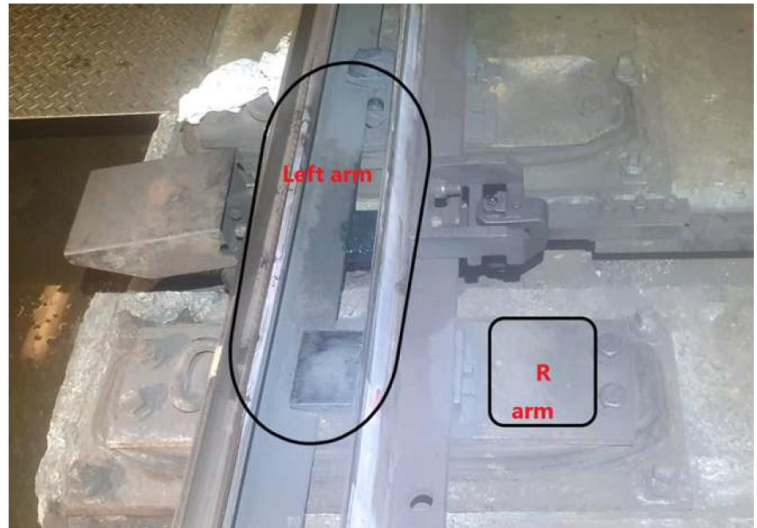
“Photo Above of Location of MQP-PM21 where the Electrician sustained the ELV Shock”  
 “The below photos are additional photos taken by the Alstom Electrical Compliance team representative”
