MONTHLY ELECTRICAL INCIDENTS

ASP Manufacturing

January 2022

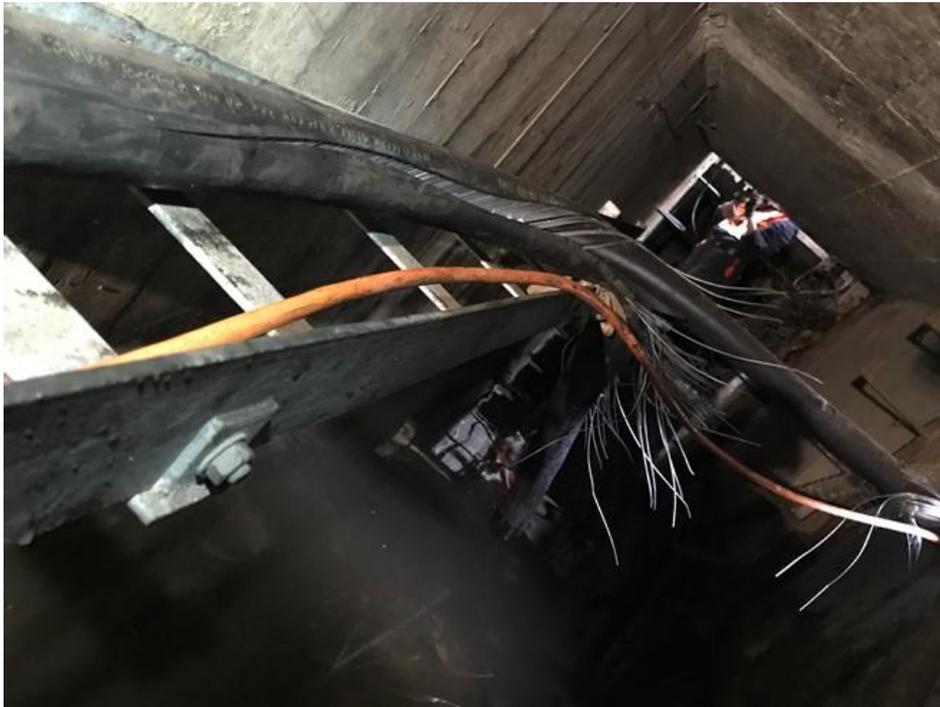
Power control received an alarm for a trip on circuit 4-028 6.6kV with a system earth fault. After isolation of circuit an IR test confirmed red phase shorted to earth. An inspection of the cable inside a cable duct found an attempted copper theft by use of a hacksaw, which was found next to the cable damage. Entry to the cable duct from the adjacent road was made through forced entry.

The scene inside the cable duct after the incident. Note the outer sheath of the XLPE cable has been cut back, the steel wired armour has been cut and pulled away from the cut site

The hacksaw cut site with the internal earthed screen and red phase conductor visible

All electrical supply equipment must be suitably secured to prevent accidental or inadvertent access, only authorised persons can access electrical supply equipment. Refer BSL electrical safety manual 1.4.2.3. Report unsecured electrical equipment and unauthorised persons.

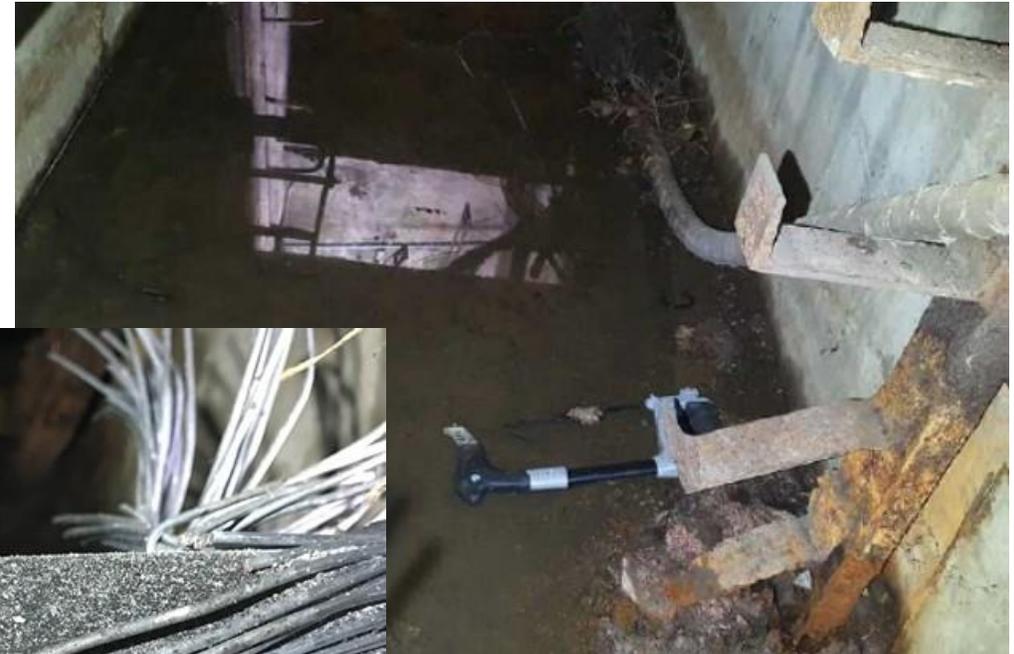
The hacksaw found at the site

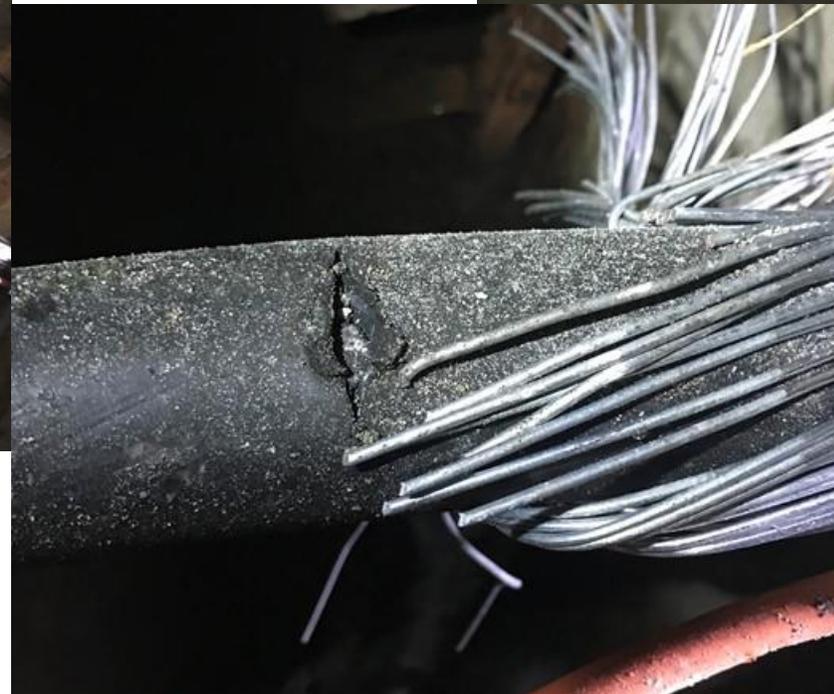
An SDI 95mm² cable was found welded Unistrut support rail during inspection of the cross travel live rail system. The cable's insulation has failed due to vibration and rubbing over a long time creating a short circuit to earth. The dc fault has created an arc which has burnt the cable insulation, and melted a section of the copper conductor but also allow the hoist motor to continue running, which has a FLC of 184amps. As it was the only earth fault on the 230V dc floating system no protection tripped.

Regular maintenance and inspections of electrical equipment and cabling is essential on moving machines to ensure the installation is not compromised by vibration or environmental conditions.

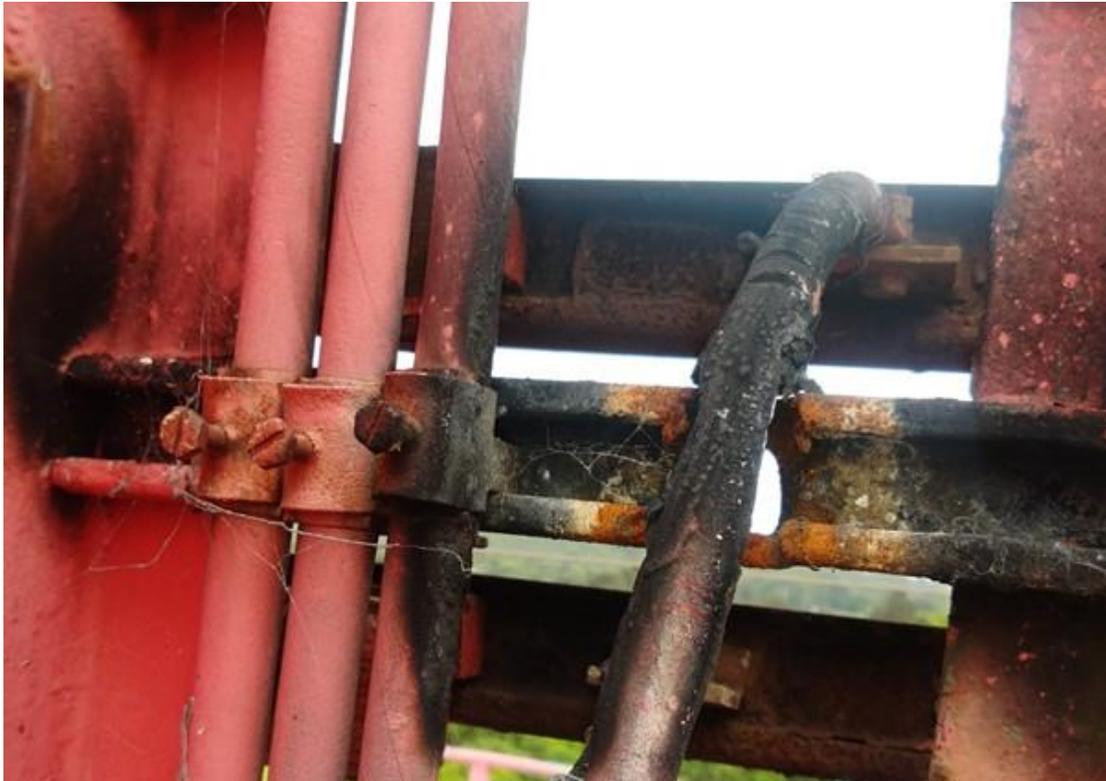
The DC armature cable going to the live rails behind. The cable has lost its Unistrut clamp allowing it to rub on the Unistrut rail

A side view of the cable and how the arcing has melted half the copper conductor and burnt a hole in the Unistrut rail

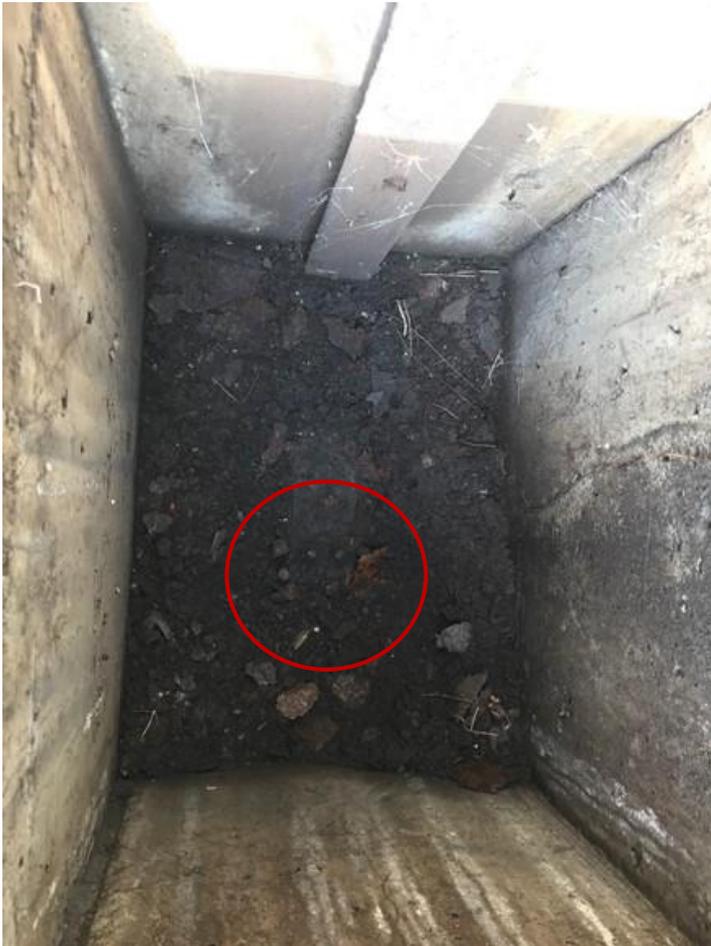
An audit of the earthing system of switchrooms A-21 and A-22 has found the earth piles to be in a bad state. One earth pile is in a pit filled with rust scale and has a busbar which runs into the switchroom connected to the pile with very poor connections. The other earth pile seems to be two driven rods in a pit, with one rod completely disconnected and the other rod only partially connected to the busbar which runs into the switchroom.

The first pit with the rust scale.
The copper busbar coming down into the pit is connected by 4 rusted bolts at the bottom of the pit. With the scale clean away the bolts are just visible

As per AS3000 section 5.1.2 an earthing arrangement shall be installed to enable the automatic disconnection of the supply in the event of a short circuit to earth. To ensure the integrity of our earthing systems there must be regular inspections of the earthing system parts from earth piles right through the protective earth connection on an electrical device.

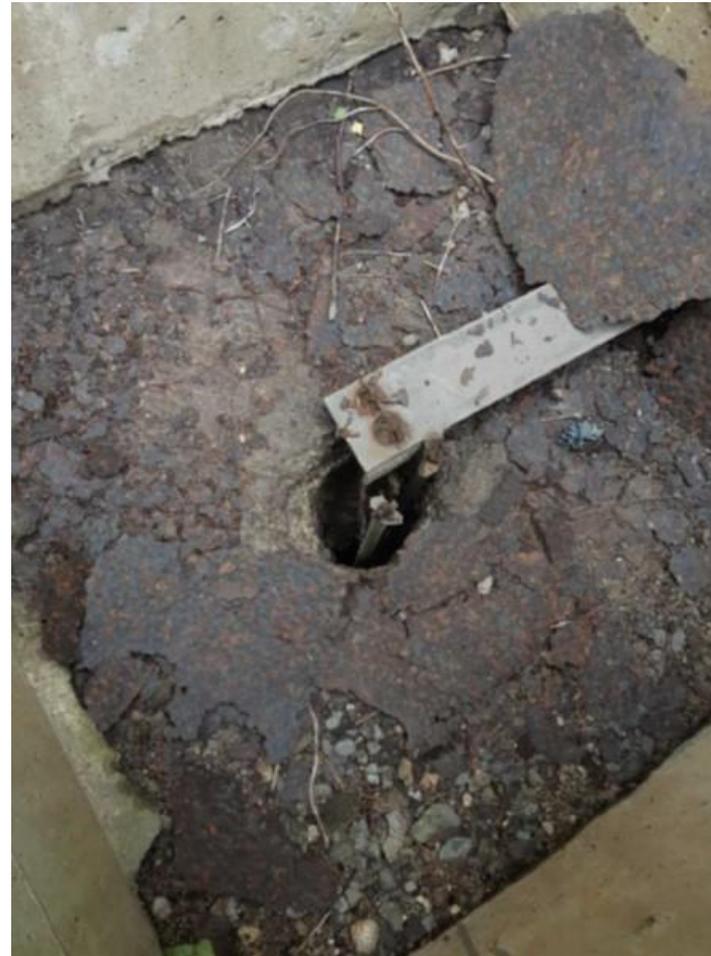
The second pit with the 2 driven rods.
One rod is completely disconnected and the other rod seems to be partially connected to the copper busbar

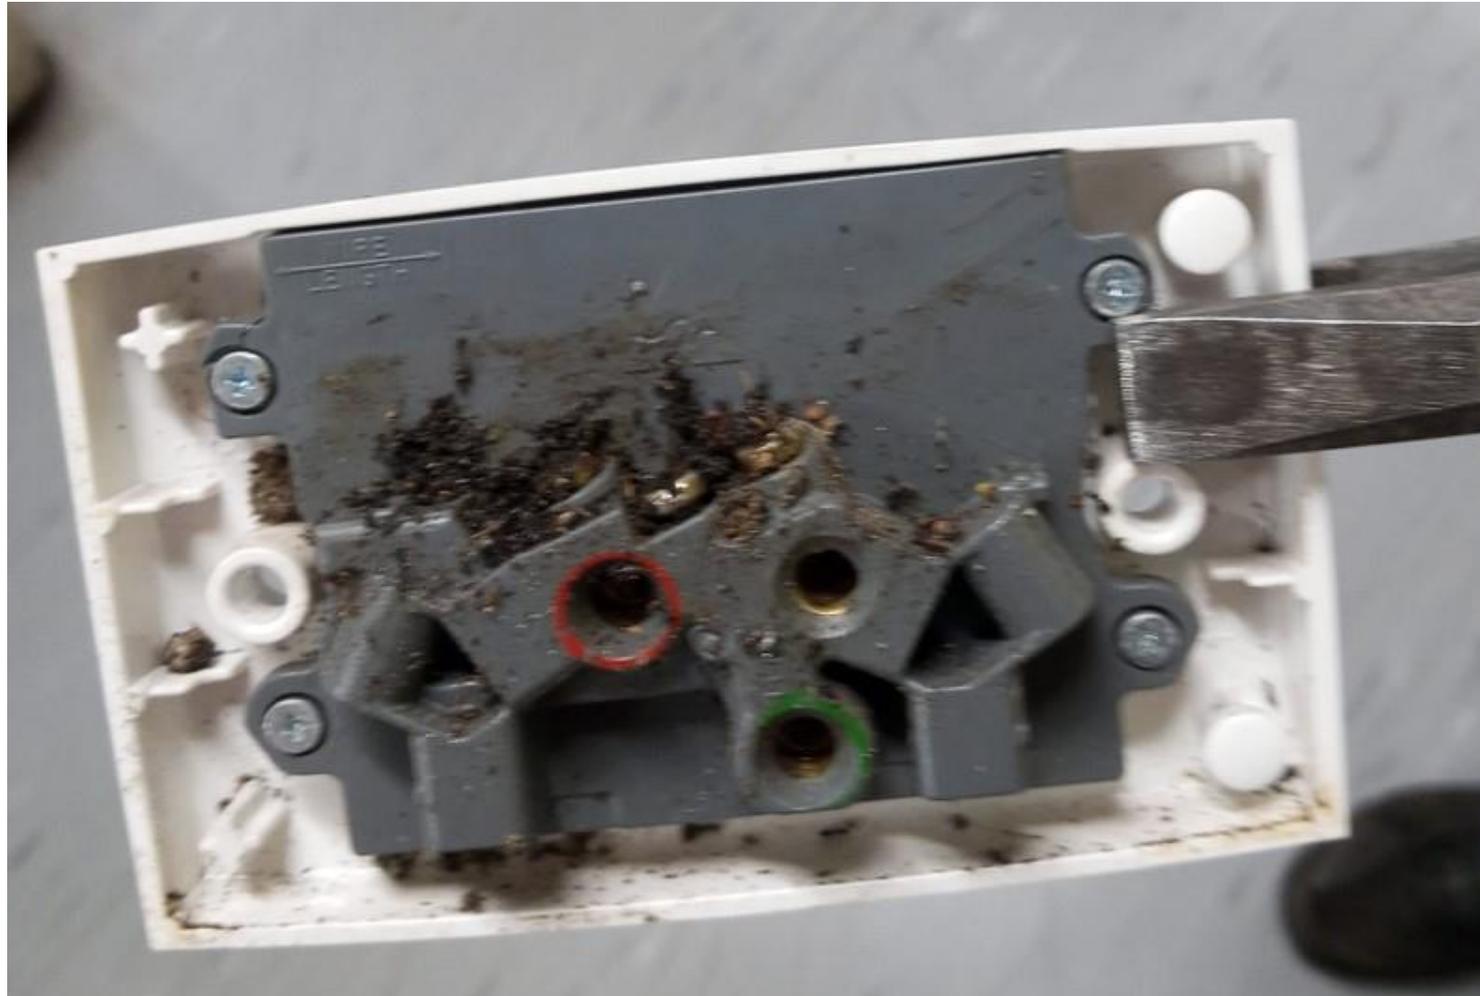
An electrician trying to find why a power outlet circuit RCD would not reset has found an outlet with water ingress. The circuit was meggered to be 0.7 M ohms. Each outlet on this circuit was inspected eventually an outlet was found to be contaminated with termite debris and water ingress.

A view of the back of the outlet with the termite debris becoming like mud across the terminals

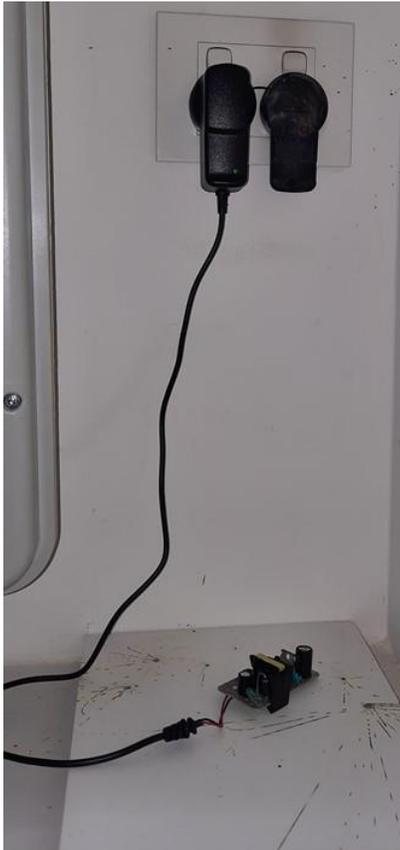
In a unit block in Sydney there is a common system which operates the building network system including phone/internet/TV. Each unit has a network switch that talks to the common system and is plugged into a standard outlet which is housed in a cupboard out of the way. A unit owner investigating why there was no power on the TV unit has noticed one of the breakers in the distribution board had tripped. In attempting to reset the breaker all power to the unit has been lost with the 63amp supply breaker for the unit tripping. Once all devices in the unit were unplugged and/or turned off power was restored to the unit. After a long search the forgotten network switch in the cupboard was found to be the issue. The standard outlet mounted 12V dc power supply for the network switch had blown itself off the wall, leaving the base still plugged into outlet. Major issue was with power now restored the pins of the base were energised with 240V ac and exposed. This is a trap for any inexperienced person and a possible risk of an electric shock if contact was made with these exposed terminals.

How the unit owner found the power supply.
Note the burn mark above the right hand plug in the outlet,
the unit on the shelf and the splatter marks on the white shelf
The power supply on the left was unaffected.

Damaged electrical equipment and circuit breaker trips need to be thoroughly investigated to ensure the installation is safe. Always get a licensed electrician to check and investigate if you have an electrical issue.

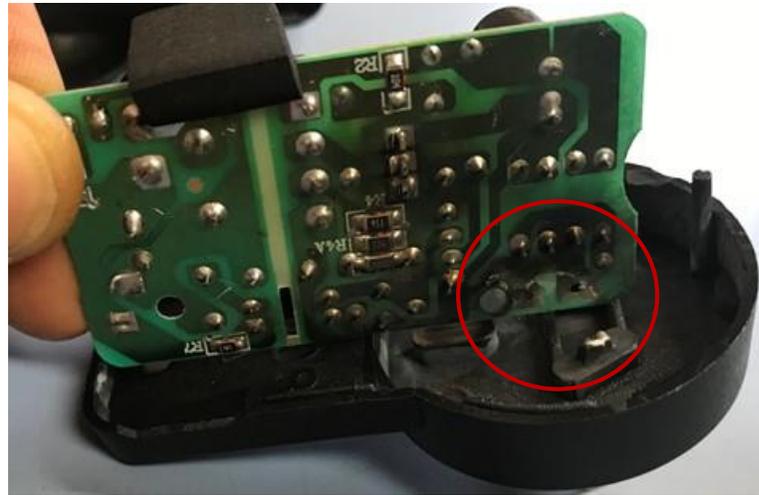
How the power supply was mounted inside the unit.
Note the burn mark on the bottom of the card where the
240V ac cables would have been, these cables were
completely disintegrated.

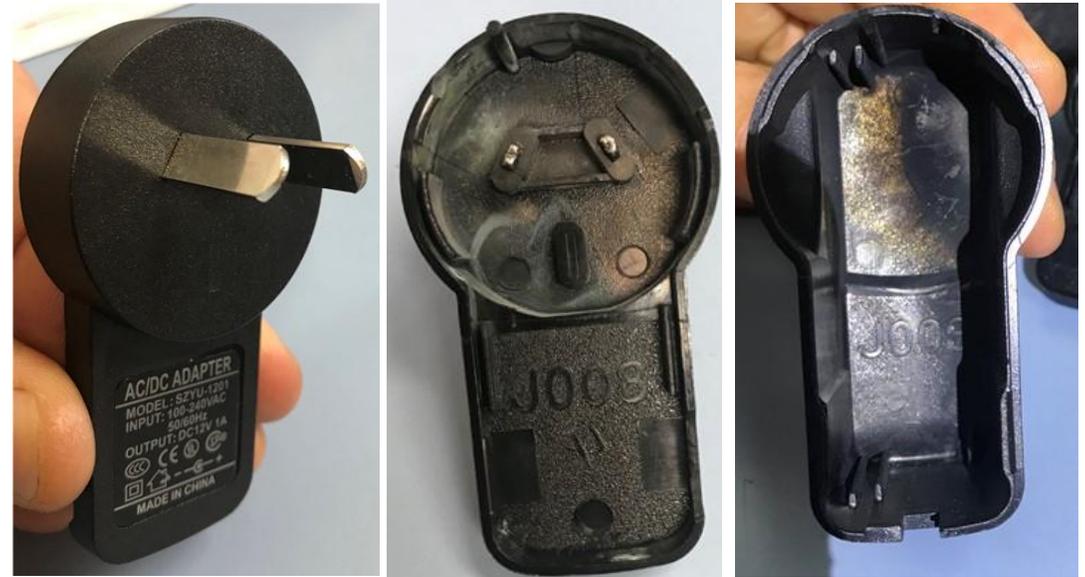
- The casing of the 12V dc power supply.
- * Base plate with 240V pins which were unaffected.
- * The reverse view of the base plate showing the two exposed pins which were energised with 240V ac when found.
- * The housing over the power supply showing the flash burn marks
