# MONTHLY ELECTRICAL INCIDENTS

**ASP Manufacturing**

**December 2021**

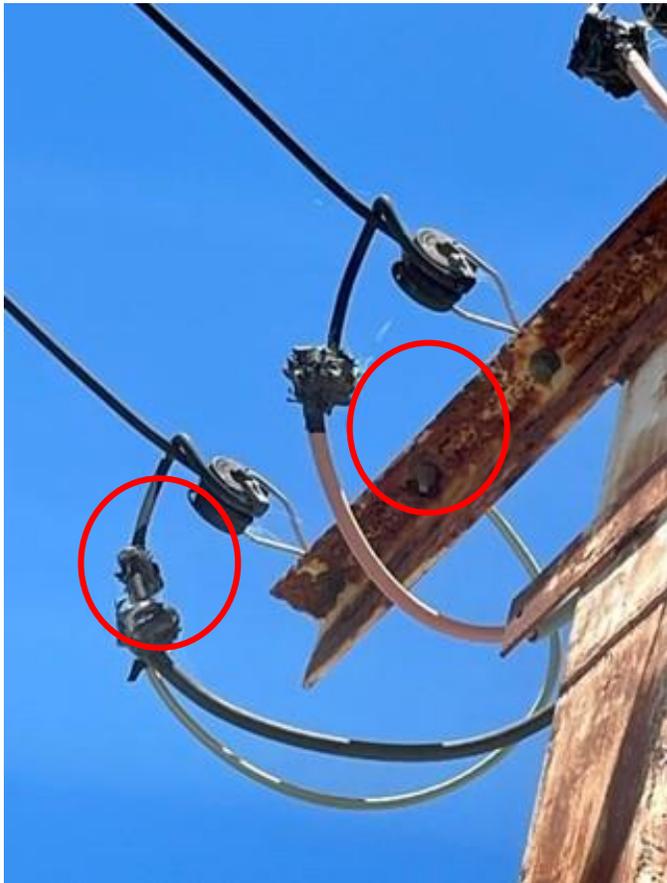
Operators have noticed the main metal pole, for the electrical service to the site, to be sparking at the top of the pole and a loud bagging noise coming from within the pole. Essential Energy have attended the site and found two of the supply 250 amp fuses blown, which are mounted on the Essential Energy wooden pole adjacent. A level 2 electrician has found the four single core single insulated 120mm<sup>2</sup> cables which run down inside the pole and in underground conduit to have had insulation failure. Two of the phases have short circuited together and severely damaged the cables. During repairs the neutral-earth connection was found on top of the pole with one end of an earth cable joined to the neutral connector and the other end connected to the metal support arm. This was removed and placed correctly inside the main switchboard for the site with the pole earthed by a separate earth conductor.

The site metal service pole with the Essential Energy wooden pole behind

As per AS3000 section 5.3.5 every installation shall have a MEN connection at the main switchboard.

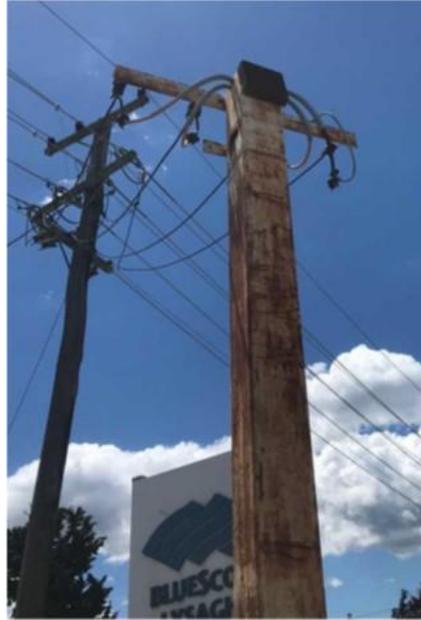
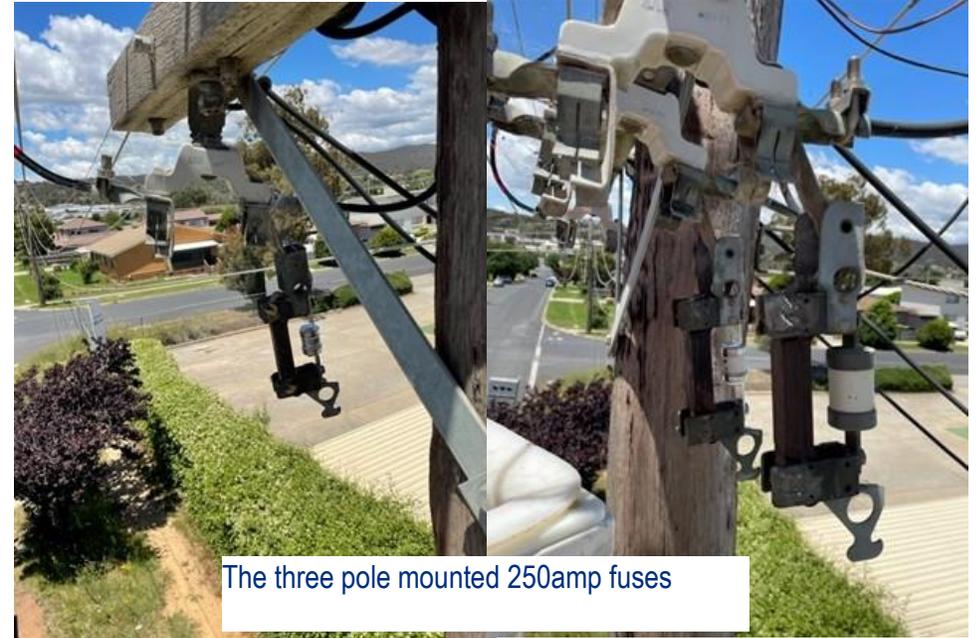
The three pole mounted 250amp fuses

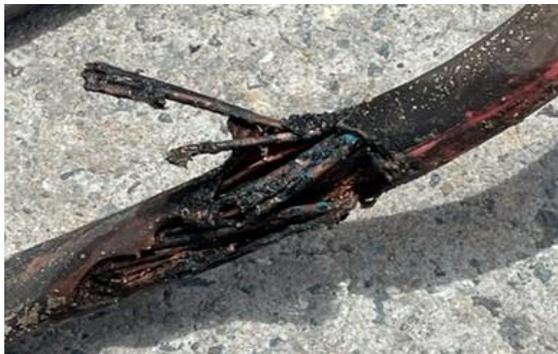
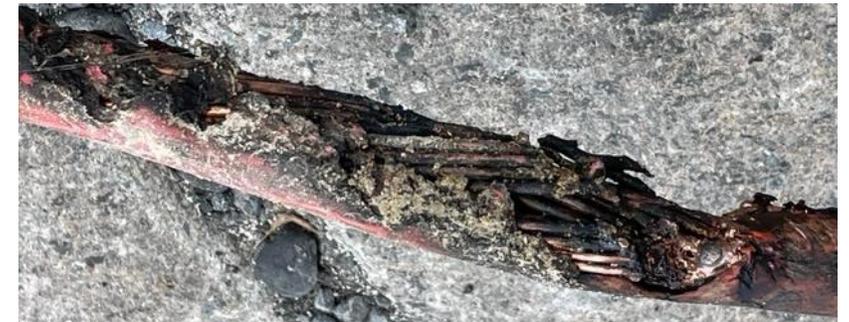
The two damaged single insulated conductors

The neutral-earth connection found with the earth conductor joined to the neutral connection and the metal arm of the pole

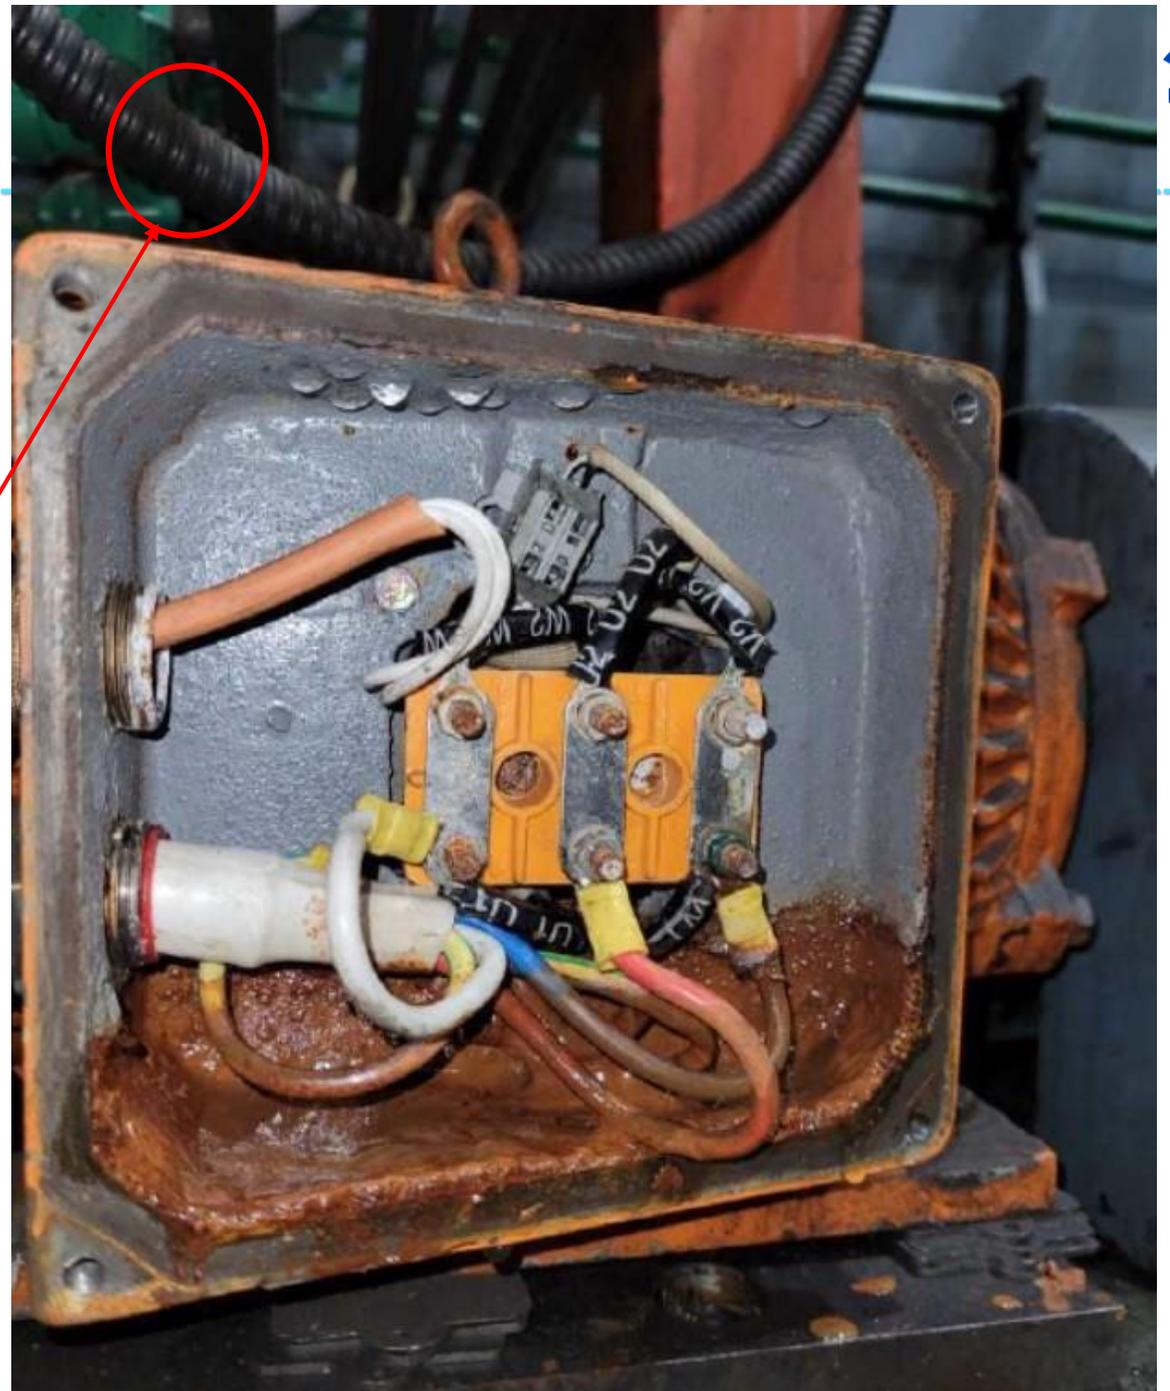
An electrician doing AC motor megger checks has found the Welder traverse motor to have irregular megger readings. An inspection of the motor terminal box revealed water inside the box. The bottom of the box was heavily corroded with rust indicating the water or moisture had been there a long time. As the motor is mounted in a dry indoor area, with the cable glands and gasket of the box in good condition, the only source of the water ingress has to be through the cable flexible conduit. The fact the flexible conduit from the motor sits vertically at the cable rack end with an open end and a previous incident in 2020 where a water main had a major leak and drenched the area near the welder is the likely cause. The motor has been running normally since that time.

Note the motor cable run in flexible conduit from above which possible allow water to run down into the box

The motor terminal box opened up to reveal water dripping from the top, rusted terminals, and a tide line at the bottom.

As per electrical installation manual section 4.5.1 cable protection such as flexible conduits should be installed correctly as to prevent water ingress.

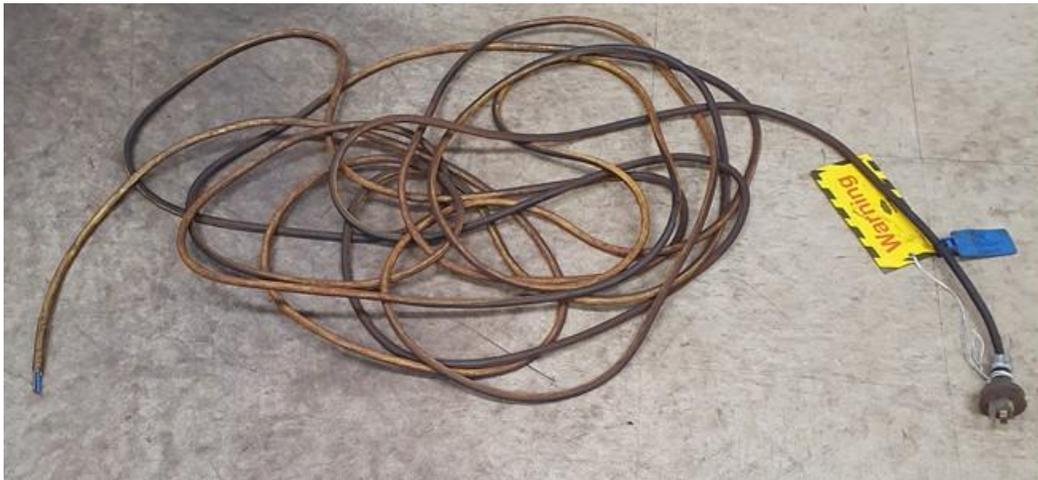
A contract supervisor has found an damaged extension lead lying in a corner of the precipitator during a shutdown with the damage not being reported. The female plug of the lead had been forcibly removed leaving the three internal cores with exposed ends. Potentially this “suicide lead” was left in a condition were an unsuspecting person could attempt to use this lead. The lead had a tag on it which did not comply with AS3760 for compliance and inspection.

The lead as found after the warning tag had been attached

All damaged electrical equipment should be reported, tagged out of services and repaired where practically possible.

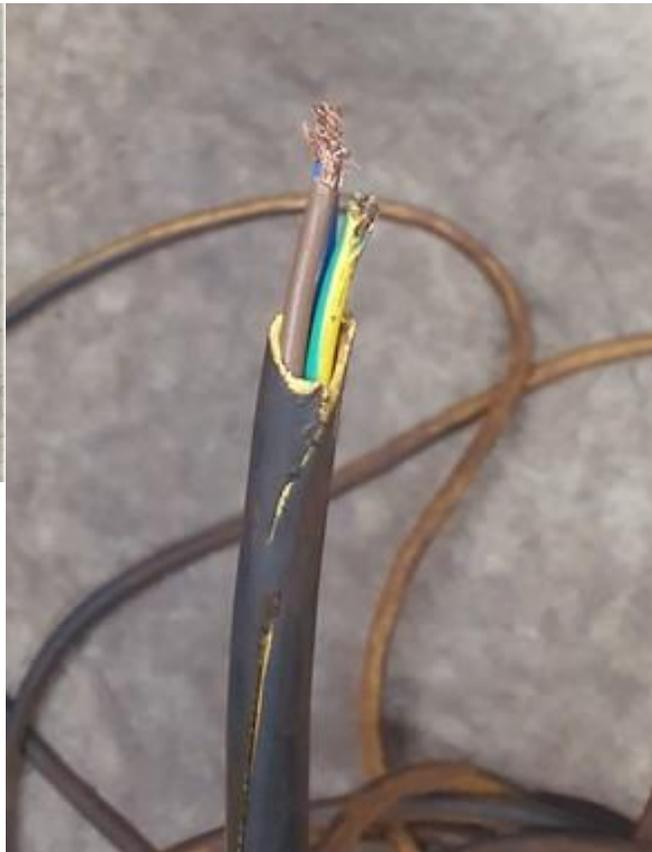
A close up of the end of the lead where the female plug used to be.  
Note the exposed ends and the other damage marks on the lead

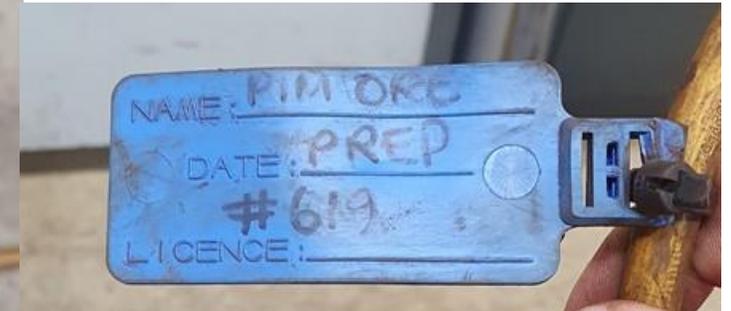
The identification tag on the lead but not an AS3760 compliance tag

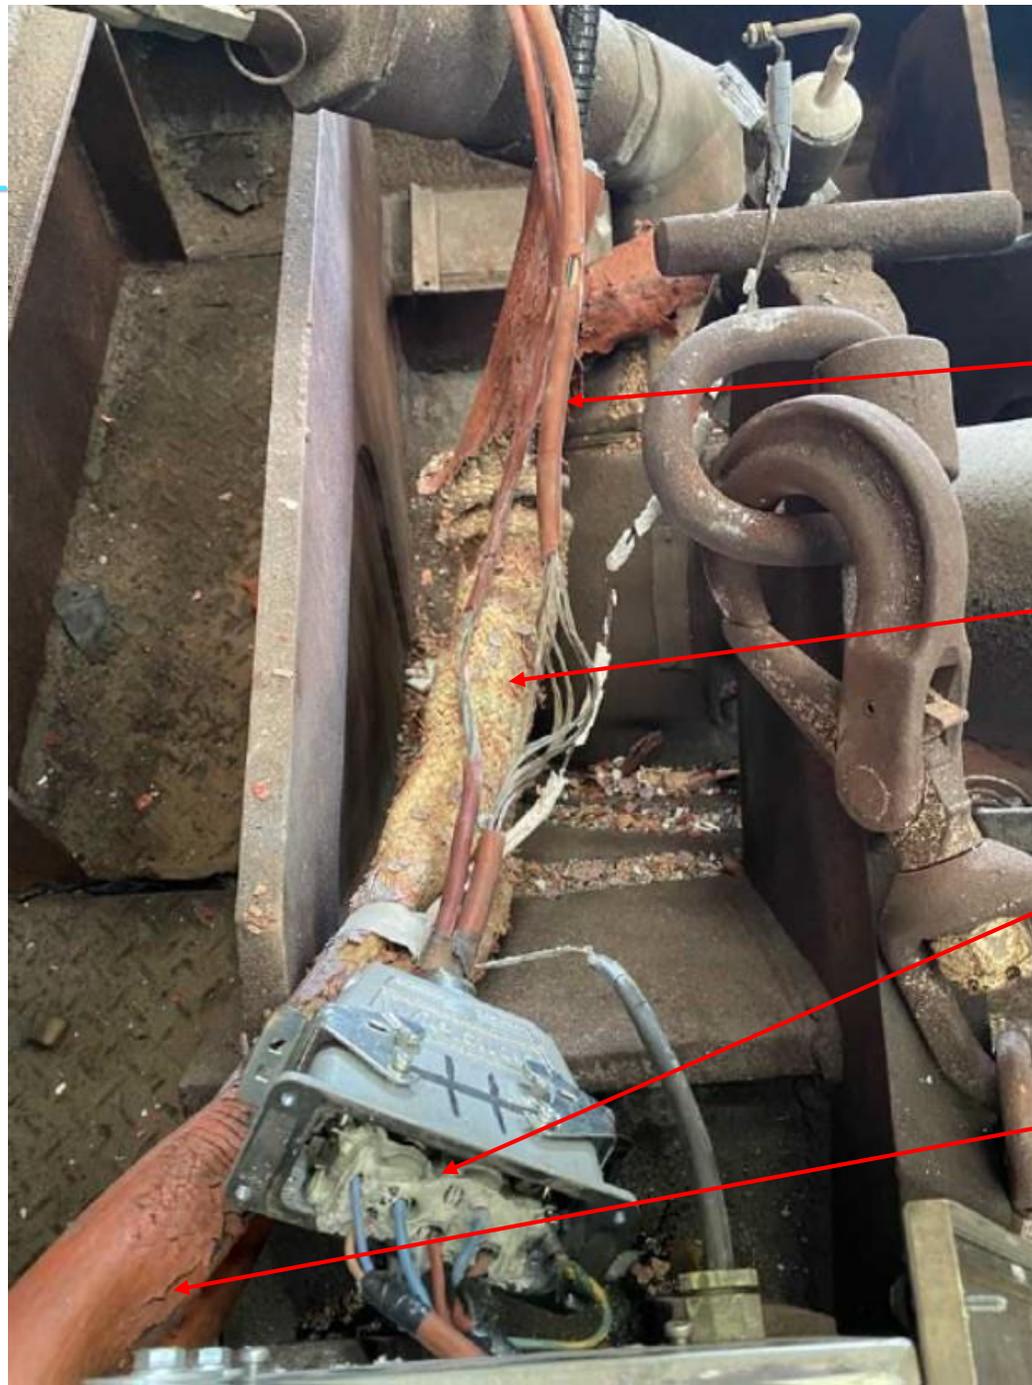
The drying device for the tundish machines would not start due to flame failure issues. An inspection of the device found the cabling to be severely heat affected and the connecting Harting plugs all melted together. This is surprising due to all the cabling being rated to 180 degrees and insulated with high temperature heat socks due to the nature of the process. Further investigation found the three thermocouples used were all placed next to each other at the back of the tundish, rather than being placed in 3 different locations. This incorrect feedback to the drying device compromised the equipment and caused the damage.

The damaged cabling and plugs.

The 180 degree rated cabling

Where the high temperature heat socks have failed

Melted internals of the plugs

The high temperature heat socks used

Correctly rated and installed electrical equipment must be used as it was intended and designed.
