# MONTHLY ELECTRICAL INCIDENTS

**ASP Manufacturing**

**May 2022**

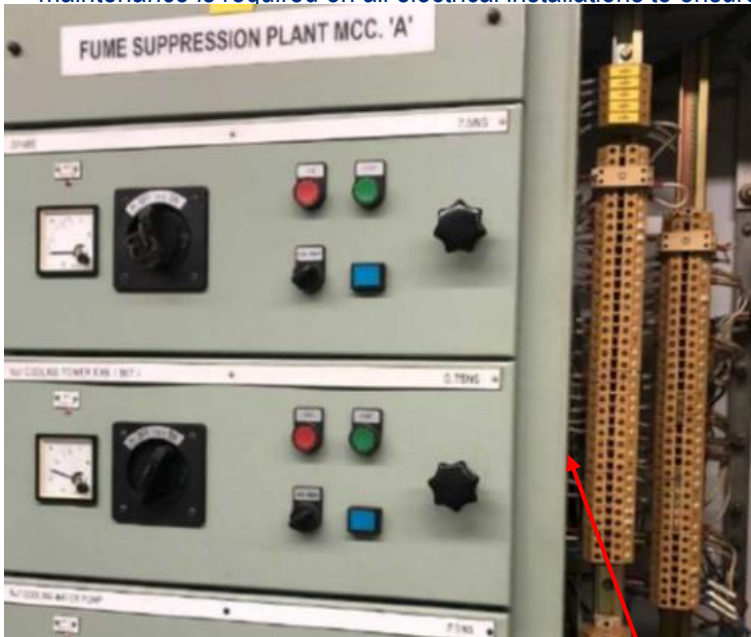
After isolating an MCC cell to conduct an audit on 'Red wire syndrome' an electrician has opened the cell door and created an arc flash inside the cell. An investigation has found the door latch tongue had contacted an unterminated energised control wire. The control wire was traced back to a spare MCC in the cell above which had the 240V ac control circuit breaker in the on position. This control wire was lugged and should have been terminated in the control terminals in the cable launder tier. A closer inspection found the dislodged wire was not visible when the door of the cable launder tier was open because it was hidden behind the side flange of the tier.

The MCC tier showing the two cells and the adjacent cable launder tier. Control wire was hidden behind this flange.

As per Electrical Safety Manual 1.4.22 incorrectly or inadequately maintained electrical installations can create situations which expose personnel to arc blast or arc flash. Regular inspections and maintenance is required on all electrical installations to ensure safety and satisfactory operation.

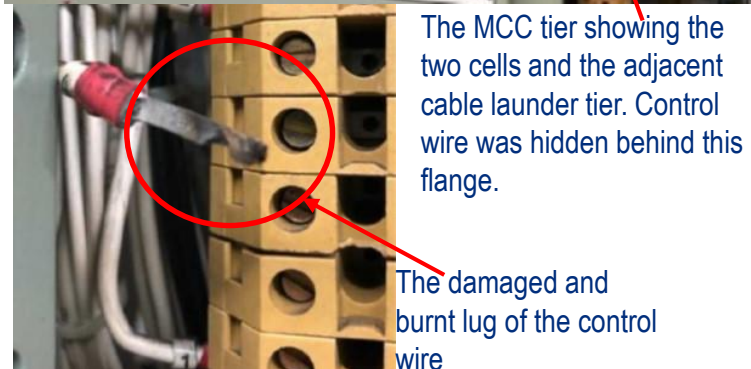
The damaged and burnt lug of the control wire

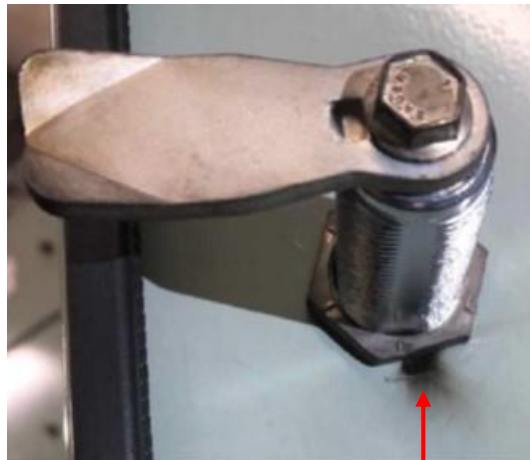
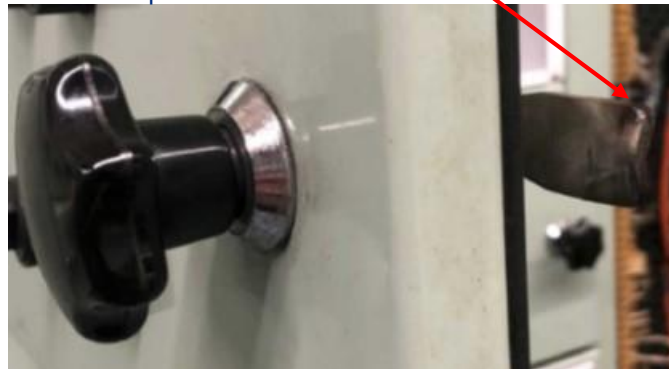
Two views of the door latch tongue.  
- From behind showing the arc burn  
- From the front showing the burn mark on the lip

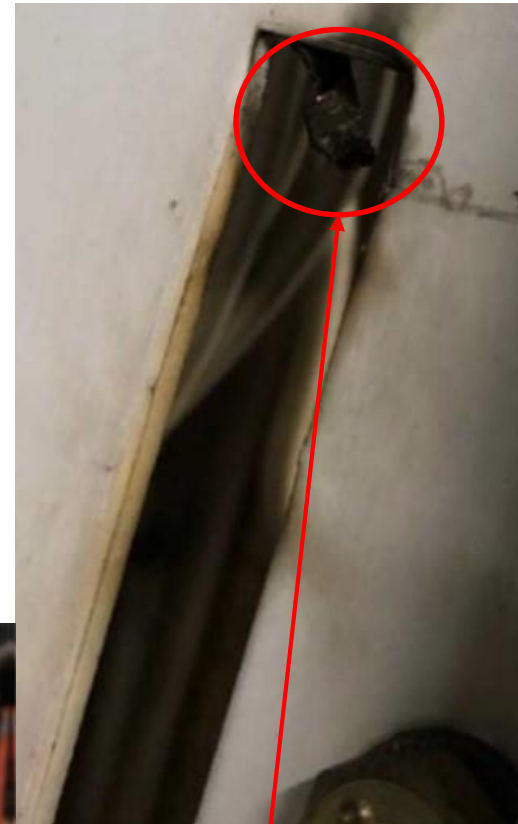
Showing the slot in the metal work between the cell and the cable tier with the door latch tongue in place when door is closed

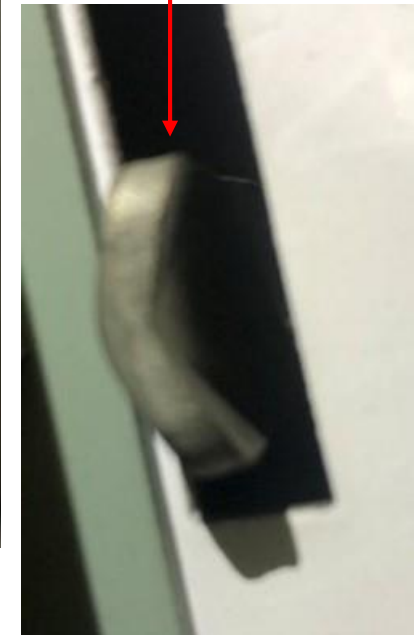
A view from inside the MCC cell with the control wire inside the slot in the metal work where it has made contact with the door latch tongue

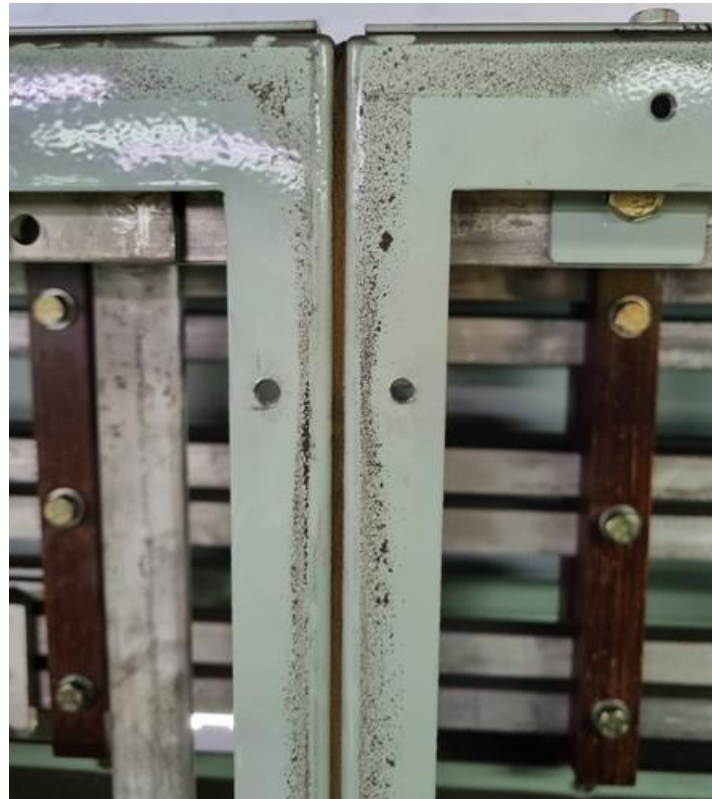
The same gap between the panels as viewed on the side but filled in with appropriate insulation

As per Electrical Safety Manual 1.4.22 all electrical installations are to be regularly inspected and maintained. Electrical owners of the equipment have a duty of care to ensure the installation still complies with the relevant Australian standards and is safe to operate.

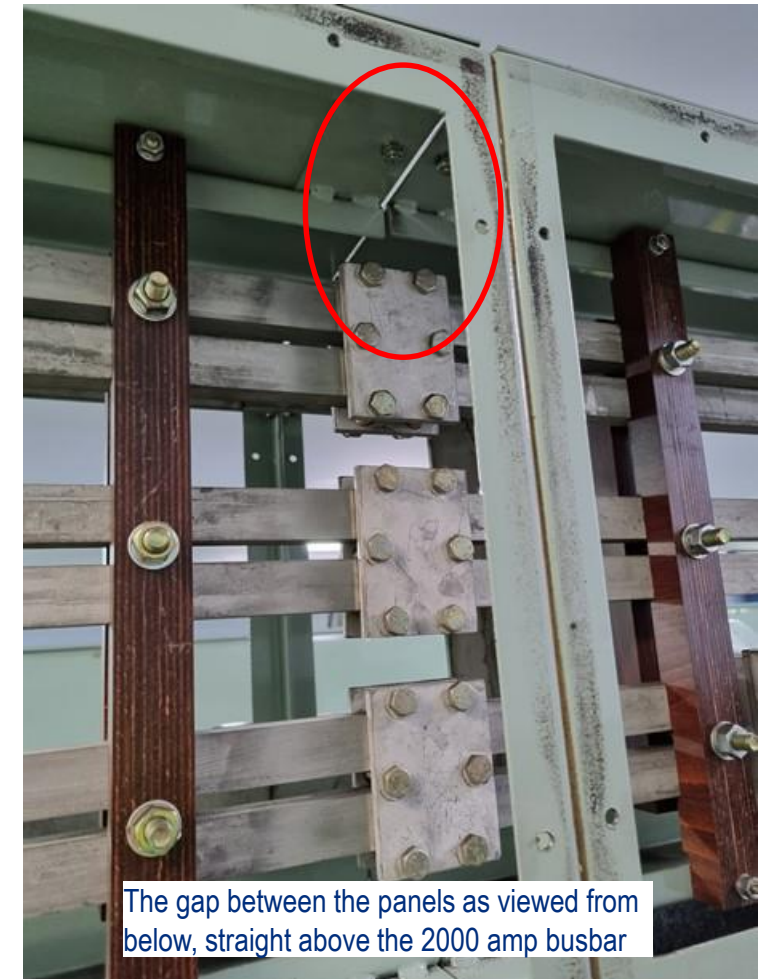
Whilst carry out maintenance and inspections of the 415V main distribution boards a gap has been found between the panel sections and covers on the busway chamber. The high fault level 2000 amp busbar could be accessed through this 3mm gap by dirt, moisture, foreign equipment or venom. This board is 25 years old and has been in this state since initial installation.

The gap between the panels as viewed from below, straight above the 2000 amp busbar

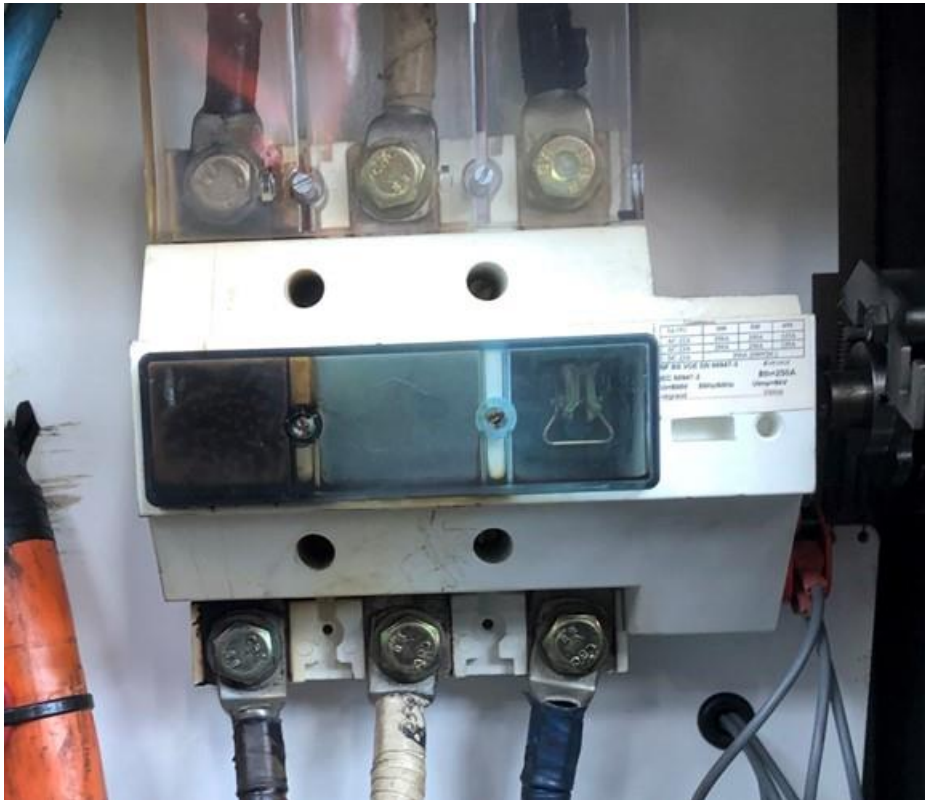
A pump which had been in regular service was fully isolated for periodic maintenance. An electrician doing the maintenance has notice the full load isolator in the field had a blacken window over the contacts. A closer inspection has found the red phase contact inside the isolator to be welded closed and had not opened when the isolator handle was placed in the open position. When measured across the damaged contact less than one ohm was recorded. All connections to the isolated we found to be secured and in a good working state.

The field isolator contact cover as found.

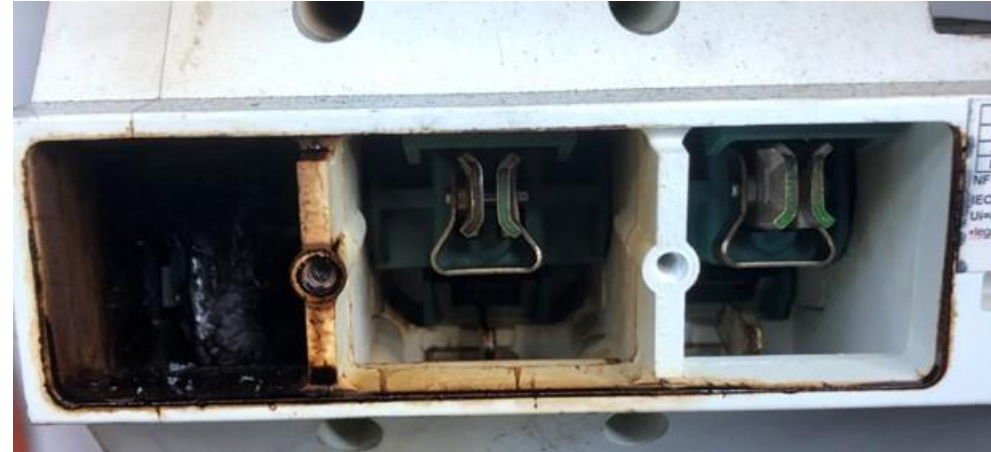
The red phase contact after the plastic cover was removed. The other two phase contacts are still in working order.

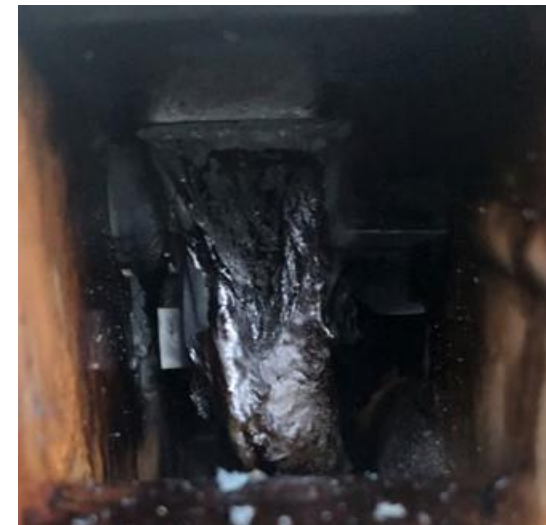
A close up view of the welded red phase contact

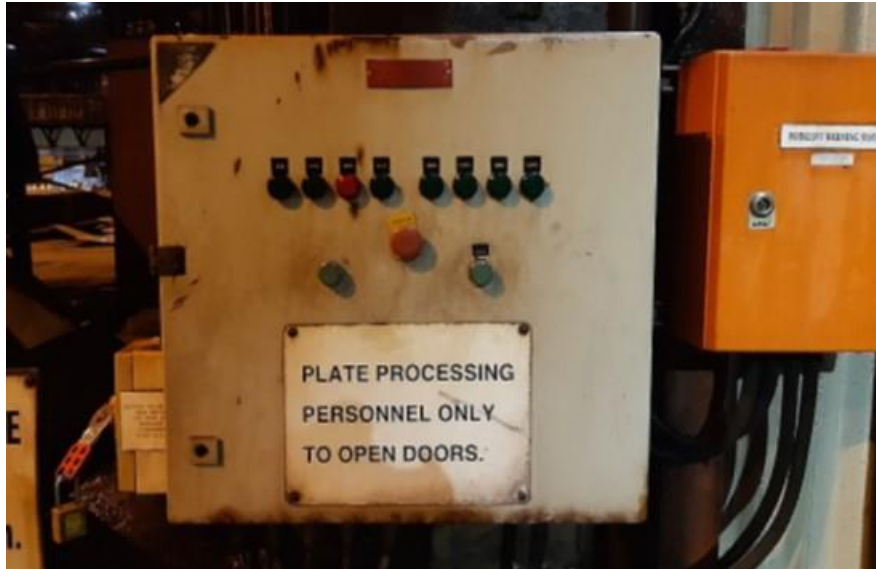
An operator attempting to close a roller door by operating a local isolator has heard a bang inside the enclosure for the isolator. An electrician called to investigate has found the roller door control box and isolator to be covered with water from the recent rain. The isolator mounted on the side of the control box has a top entry cable installation. Water has entered the enclosure through this top entry and run down internally onto the isolator. The action of the isolator being rotated has shorted two phases of the power supply. Two 32amp fuses have been found blown. The fuses were in an old style fuseboard with all the cables top entry and again this board had water ingress from the top entry.

The site of the roller door control box with the isolator on the left hand side. The whole area and all equipment is covered with rain water.

As per Electrical Safety Directive 2017-01 and Electrical Installation Manual section 4.5 all electrical installations should have bottom entry for all cabling as to not compromise the IP rating of the equipment and to suit the environment of the installation.

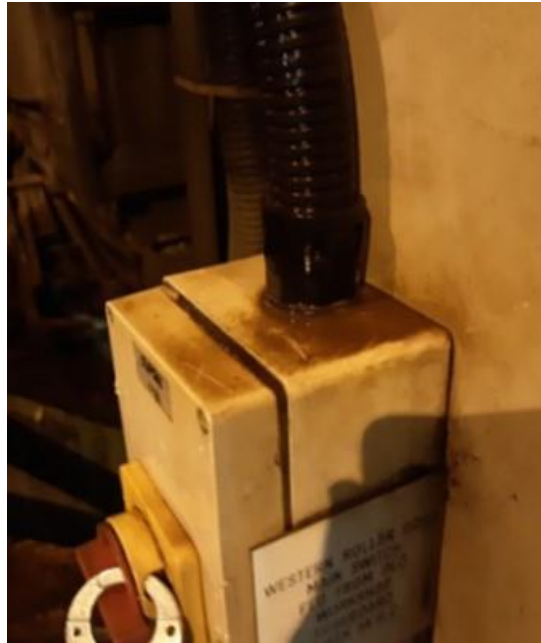
The local isolator with water evident on the top. The top entry cable fitting which has allowed water to ingress onto the isolator contact block.

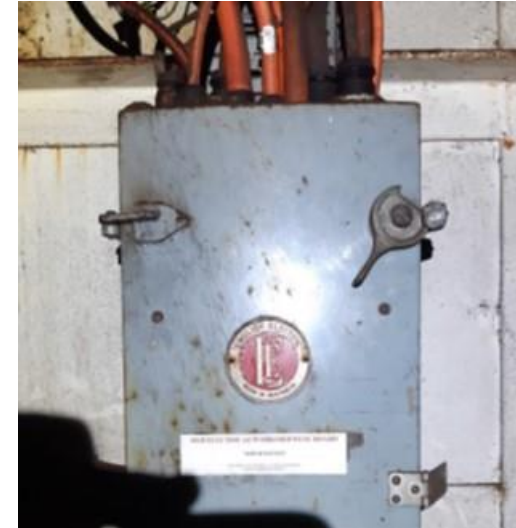
The supply fuseboard with all the cables top entry. Below the internal bottom of the fuseboard with moisture and rust evident.

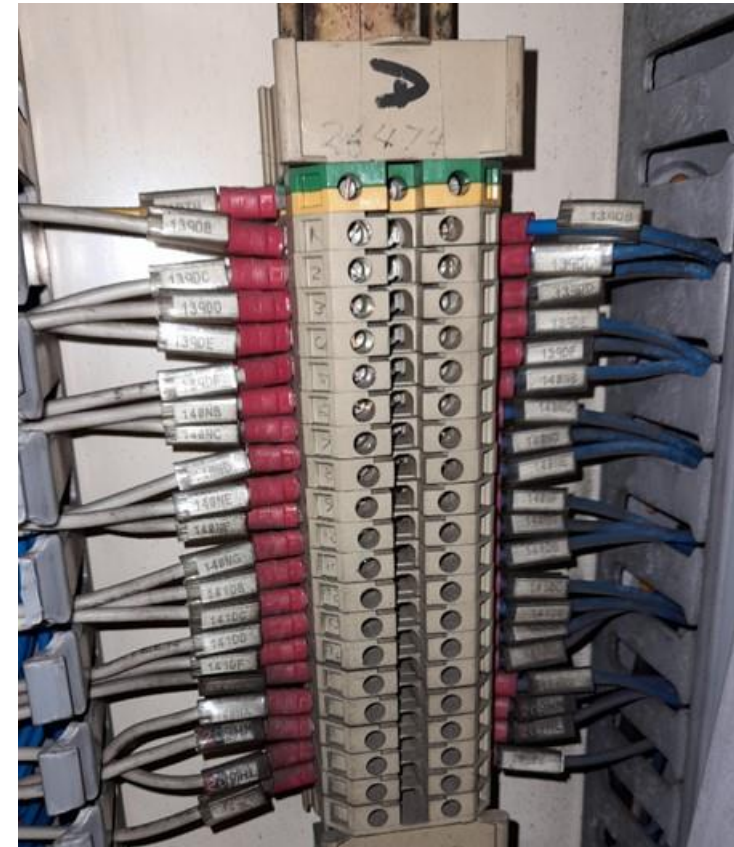
The Regulator panel PLC I/O terminal strip where the redundant cores were terminated.

This is an example of why all redundant electrical equipment should be disconnected and removed at the time of de-commissioning, and finally all the documentation updated to reflect the equipment and cabling being removed.

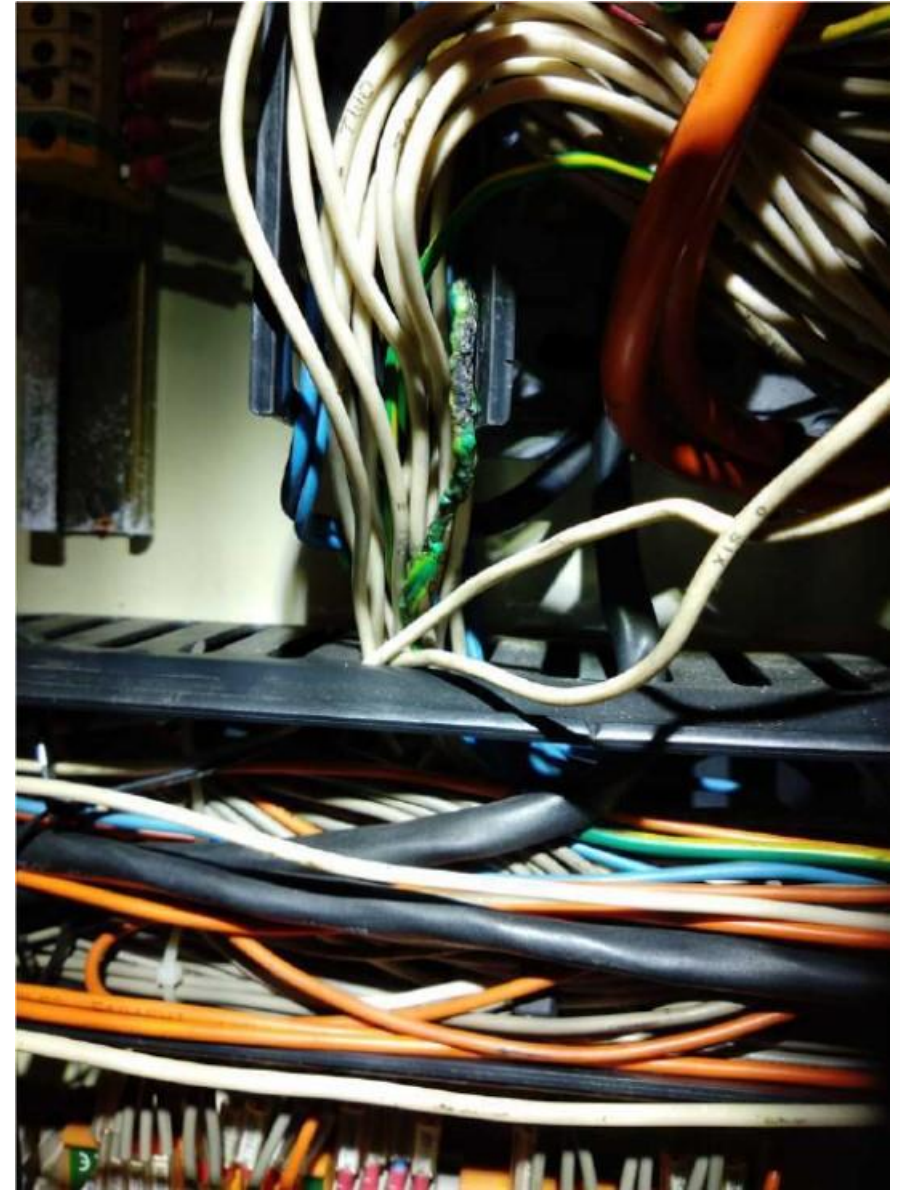
An electrician investigating why the circuit breaker supplying the PLC I/O to a pump motor starter was tripped, has found the circuit shorted to earth. The wiring for the circuit was traced to find a burnt and melted earth wire had melted itself to the I/O supply core. This had created a short circuit to earth. The earth core was found to be part of a cable to a pressure switch in the field for different pump. An inspection of the area near where the pressure switches are mounted has found welding had recently taken place.

The badly melted and burnt earth wire melted to the PLC I/O power supply core.

As per Electrical Safety Manual section 1.4.15.2 the return lead of a welding machine shall be securely connected to the work piece and the connection point shall be located as close as physically possible to the welding work.

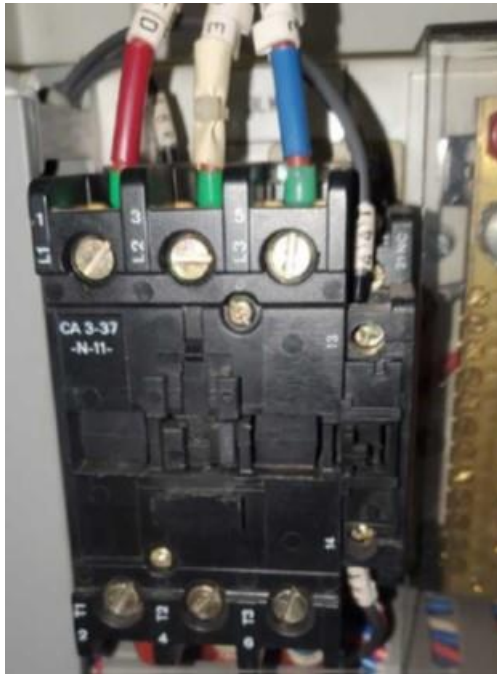
An electrician attempting to verify an isolation inside a blower motor terminal box has caused an arc flash when one of the supply wires has come from its lug and shorted to earth. Previously the electrician had isolated the motor at the motor starter main isolator. Then had conducted Test Before You Touch by verifying the testing meter at a known energised location, followed by testing the load side of the isolator to be de-energised. However, the electrician has failed to recheck the testing meter to be fit for duty. An investigation has found one of the leads of the meter to be open circuit not allowing TBYT to be conducted properly. The investigation also found the white phase of the main contactor of the blower to be welded in, contacts of the main isolator did not open during isolation, there was only the white phase connection at the motor terminal box energised and this wire shorted to earth which tripped the motor protection.

The common main contactor for multiple motor starters which had the white phase contact welded in

Test Before You Touch is an essential procedure used by electrical workers to confirm the electrical installation they are about to touch is de-energised. It is a three step process involving testing the test equipment to be fit for duty, testing the work site with the test equipment to confirm de-energised and finally re-testing the test equipment to confirm it is still fit for duty. If all three steps are not properly followed the TBYT process cannot be stated as conducted correctly or completed.

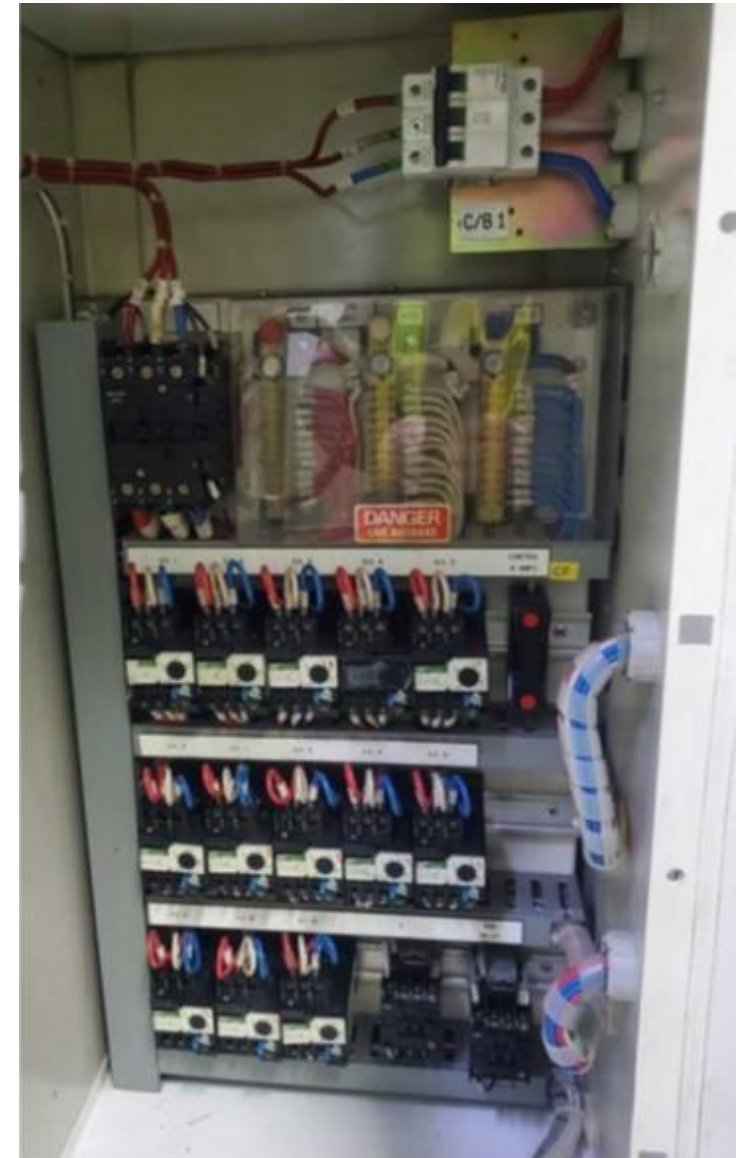
The panel with all the motor starters which has its main isolator on the door

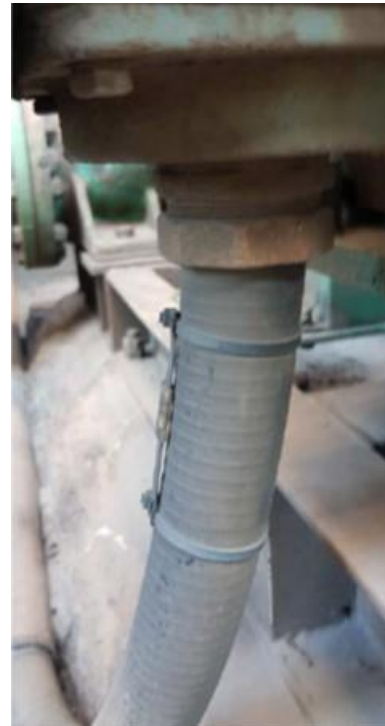
An electrician doing routine maintenance on a motor has opened the terminal box to find water at the bottom of the box. There was approximately 100mm clearance between the pooled water and the motor terminals which had allowed the motor to remain in service. A inspection of the installation has found the bottom cable entry into the terminal box was by a fixed Anaconda fitting which had not allowed the water to escape. The motor cable had come off overhead cable rack into water pipe which is run all the way to the motor. The high end of the water pipe is open to the elements allowing rain water to enter and fill up the pipe. With the water pipe high enough there is sufficient head pressure on the water in the pipe to allow it to run up inside the motor terminal box.

The full view of the motor and cable installation. The water pipe on the wall is open at the end allowing water to enter. With enough pressure water in the pipe can enter the motor terminal box.

As per Electrical Installation Manual section 4.5.1 the integrity of the IP rating all field enclosures shall not be compromised by additional protection, which should be installed to suit the environmental conditions. All cable entries should be from the bottom and all conduits (fixed or flexible) have an allowance to let water exit before it enters the electrical installation.

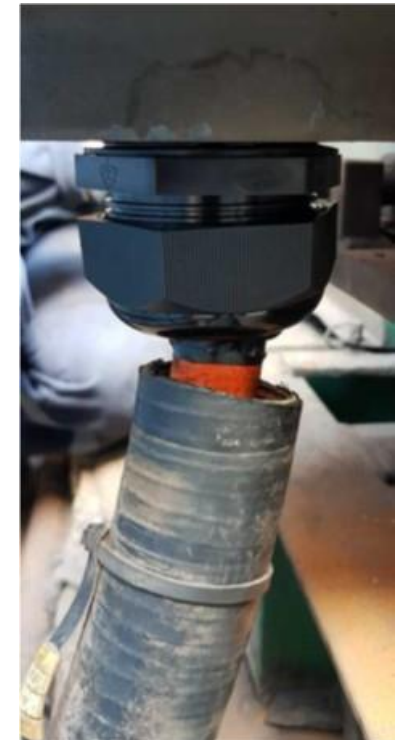
The original installation on the left with no means of water exiting the conduit.

The correct installation on the right with the conduit cut short to allow any water to exit and the bottom cable entry is via a compression gland which does not allow water entry.
