# MONTHLY ELECTRICAL INCIDENTS

**ASP Manufacturing**

**February 2023**

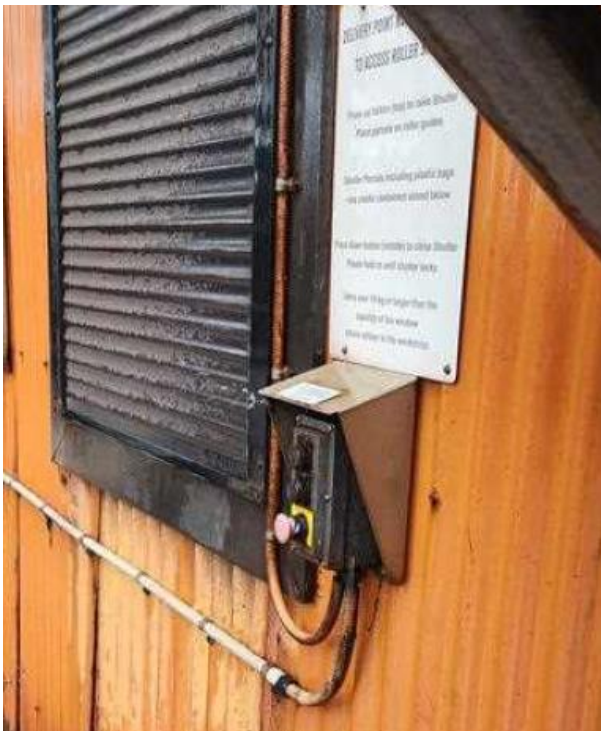
A delivery person received an **Electric shock** to the right hand when pressing pushbuttons on an outdoor IP66 rated pushbutton station, which was wet following a heavy rain storm. An electrician tested the enclosure surface, pushbuttons and the heads of screws which secure the cover for voltage to earth and measured between 90 and 110V ac on the screw heads. This circuit is supplied at 240V and is protected by a 6amp fuse with no earth leakage protection. The pushbutton station was found to be half full of water, with corrosion on the contact blocks and an earth BP connector. Further testing using a hose revealed water was able to enter the enclosure through the seal between pushbutton and enclosure. Water has compromised insulation of active conductors providing a tracking path to the external pushbutton area and screws.

The pushbutton station as found, installed with a weather shroud, IP66 rated enclosure and buttons, bottom entry, compression cable glands and flexible conduit cut off short of the glands.

The push button station needs to remain in this location for functional reasons and has been converted to Extra Low Voltage to reduce the risk of electric shock.

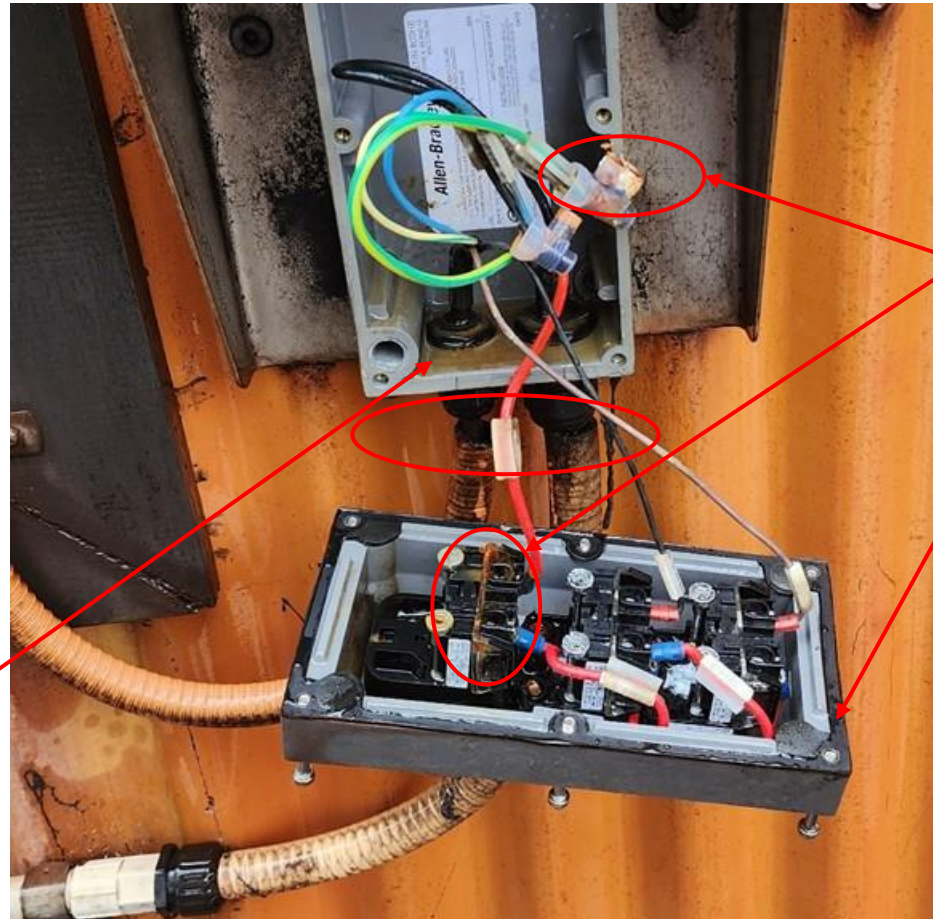
The pushbutton station once opened to find it is half full of water.

The amount of corrosion of the back of the buttons and earth BP connector are evident.

Surrounding rubber gasket was saturated with water on all surfaces.

The front cover securing screws are all connected by the gasket even though they are insulated from each other by the insulative material of the station.

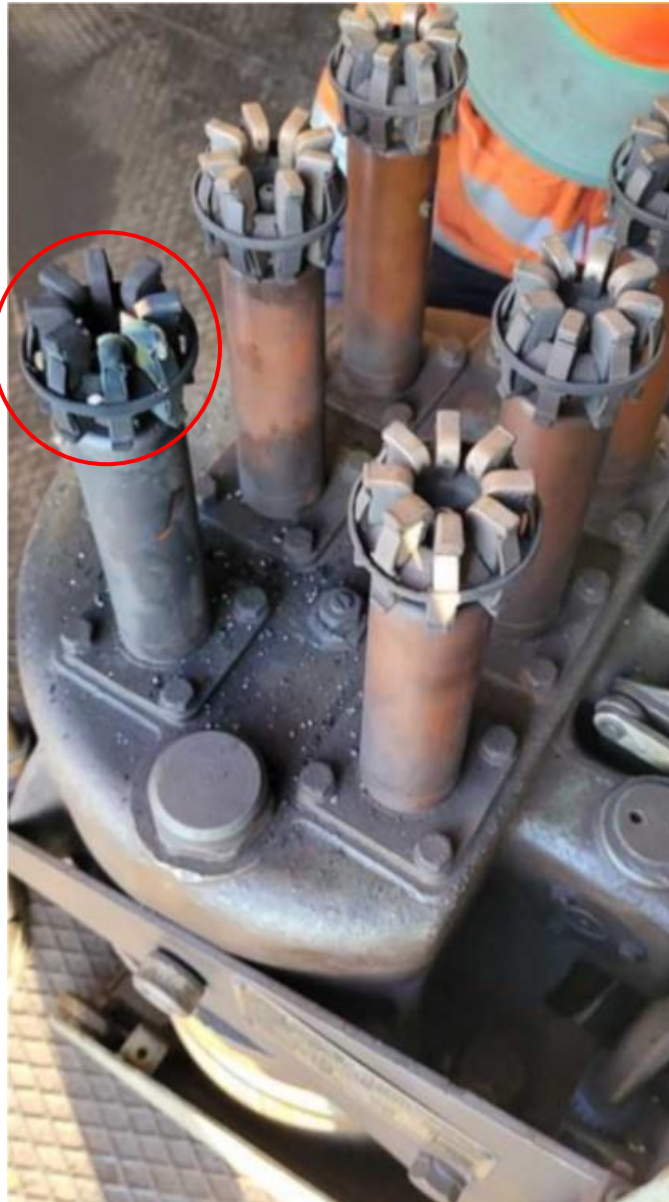
An investigation found the red phase spout contact and bus connector had been pushed up out of position, preventing the breaker from making adequate contact. There was evidence of arcing and deposits of molten copper debris left on the breaker below the spout.

The removable circuit breaker section with the six insulating posts which are inserted inside the fixed section of the HV board.

The red phase post showing signs of an arc flash and burning.

**Key Learning** - Never locally operate a high fault level switch or circuit breaker showing physical signs of damage or failure, use remote controls or alternate switchgear instead. During normal switching operations the correct PPE is to be worn by the operator and anyone in the vicinity should be out of line of fire by being more than 5 metres away.

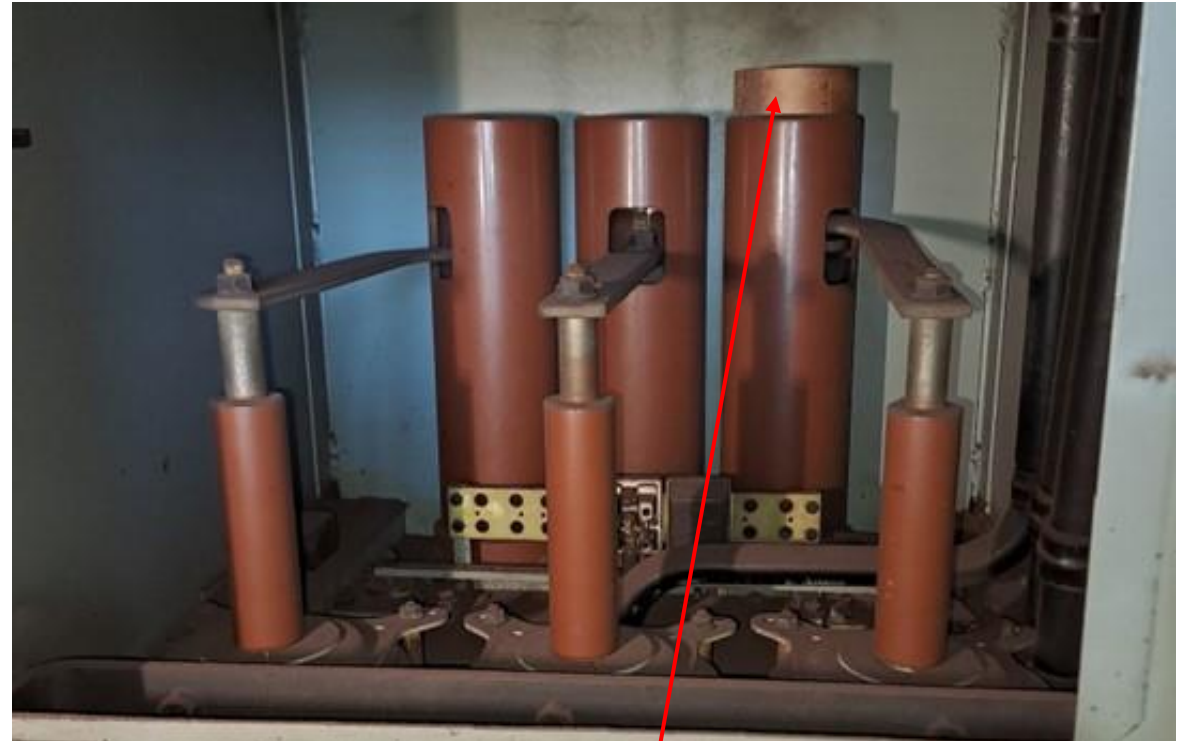
Inside the fixed section of the HV board where the removable circuit breakers posts are inserted when the breaker is racked in. This photo clearly shows the red phase busbar and spout contact have been lifted up, which resulted in circuit breaker post not making sufficient contact inside the switchboard.

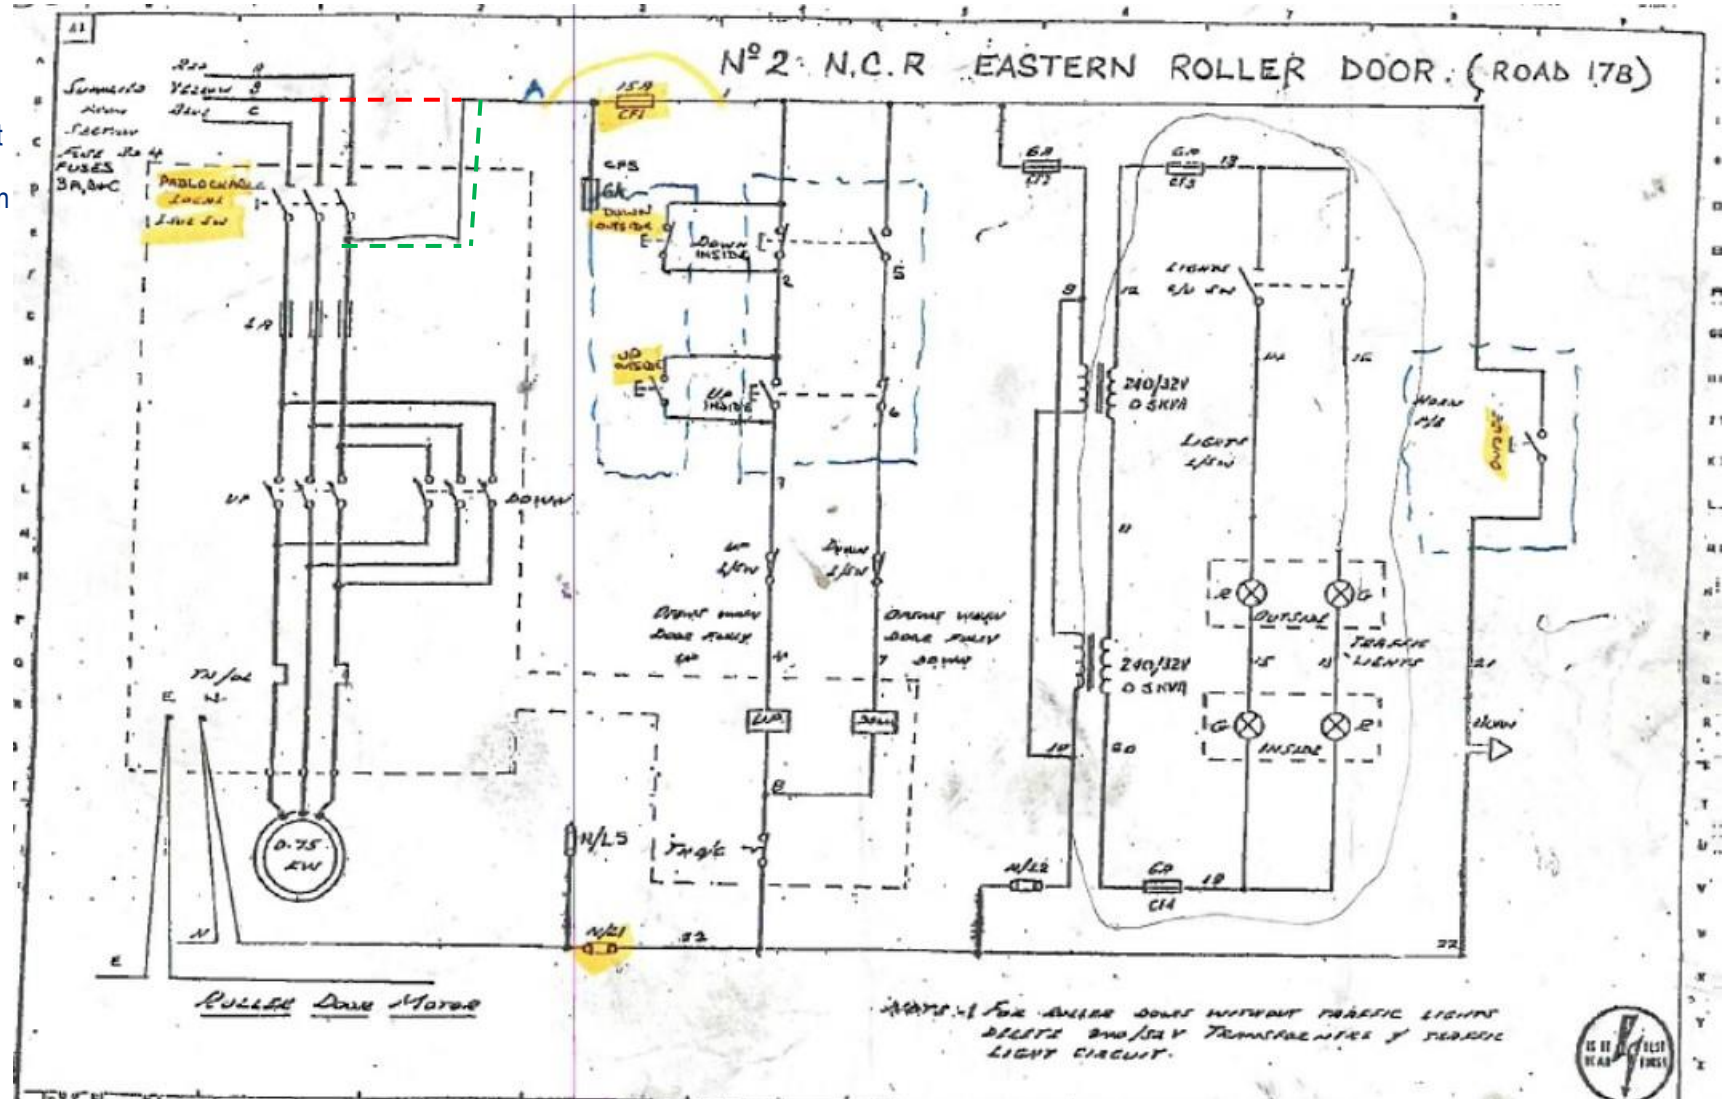
An electrician and an apprentice have found a control circuit to be incorrectly wired as per the circuit diagram by conducting Test Before You Touch correctly. After isolating CF1 and N/L1 as per schematic 240V ac was found on circuit to be worked on. Rev 1 of the schematic circuit used for isolations had been modified with the hand marked up version found in the field j-box. However, even this version was not what was actually wired. CF1 was not actually in the circuit any more with the control circuit fed directly from the "Padlockable Isolator Switch".

The circuit schematic found in the field j-box. The red dotted line is where the control circuit was originally fed from.

The green dotted line is where the control circuit was found to be fed from.

Also the yellow bridge over the top of CF1 was found to remove CF1 from the circuit.

Accurate circuit diagrams are essential to correct operation, maintenance, fault finding and isolation. It's imperative modifications are appropriately reviewed and approved and accurate drawings are maintained.

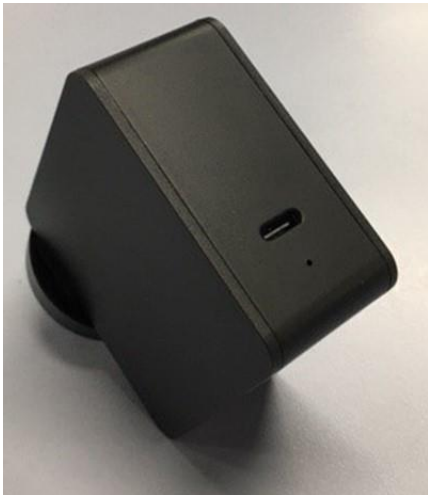
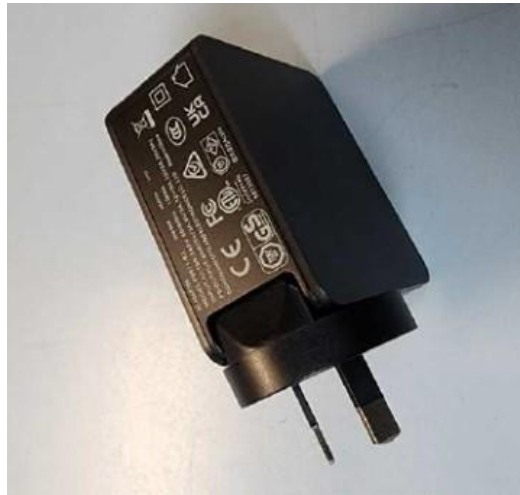
Front and back views of the USB charger with adapter attached.

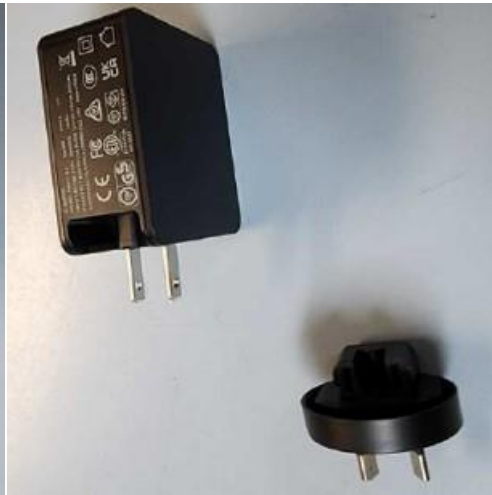
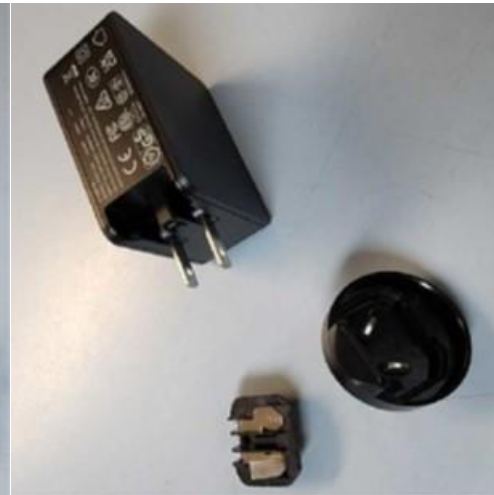
An operations person noticed a USB charger pack in a desk mounted media outlet was sitting at an odd angle. An electrician investigated and found the charger had separated from an adapter used to convert the charger for use on Australian sockets. The adapter cover was damaged effectively leaving the pins inserted into the 240V outlet exposed to any unsuspecting person to touch.

2 views of how the adapter was found with the top cover separated from the base leaving the pins exposed

All USB charging devices used should only be proprietary items supplied by the manufacturer and certified fit for Australian conditions. Alternatively USB charging outlets integrated into 240V outlets should be used to eliminate the need for USB chargers., which comply to IEC 60884-3-1:2021 Plugs and socket-outlets for household and similar purposes - Part 3.1 Particular requirements for socket-outlets incorporating USB power supply.

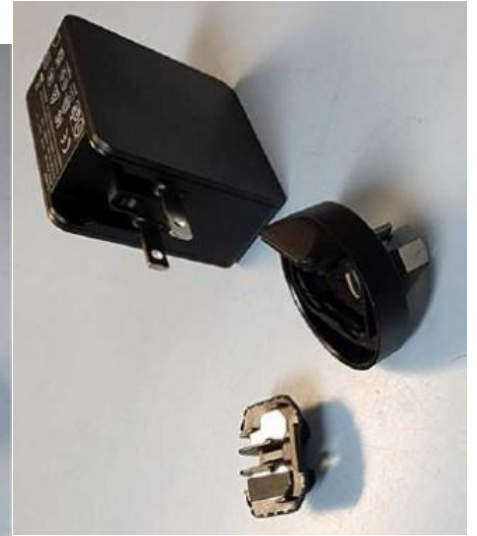
The adapter detached from the charger

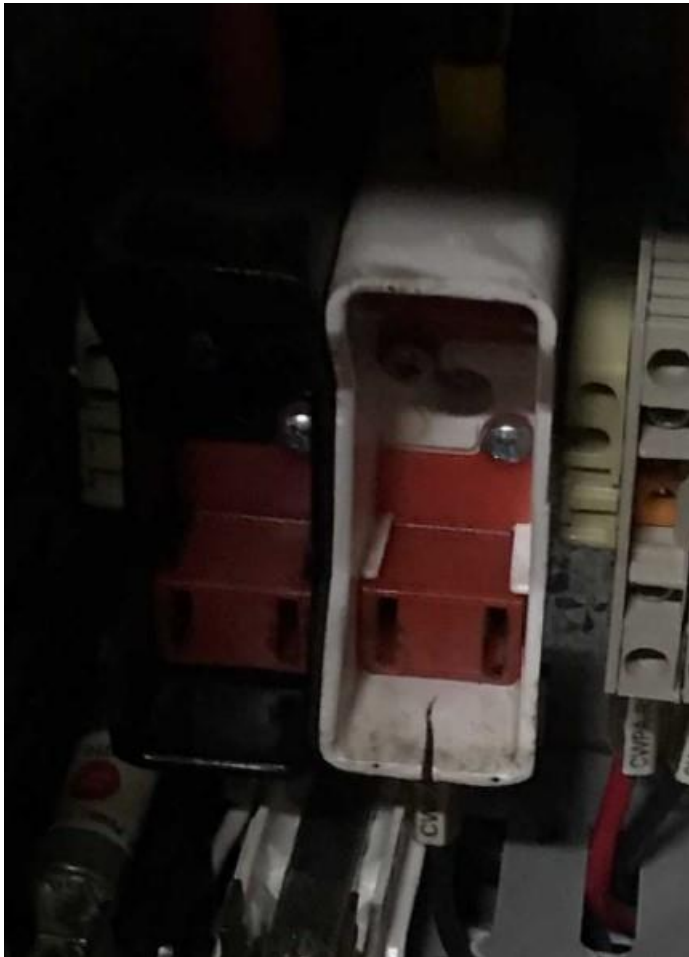
Cracked neutral links were found during a routine maintenance of Motor Control Centres. These MCCs were manufactured in 2011. The boards have been maintained and inspected every two years, with no sign of cracking in 2021. It is believed the cracking is not heat related due to the adjacent Red Spot style fuses showing no signs of cracking.

Other neutral link holders with different signs of cracking. Some parts of the holders have broken away exposing the internal conductors.

As per Electrical Safety Manual section 1.4.22 all electrical panels and installations should be regularly inspected and maintained to ensure the safety and satisfactory operation of electrical installations and articles.

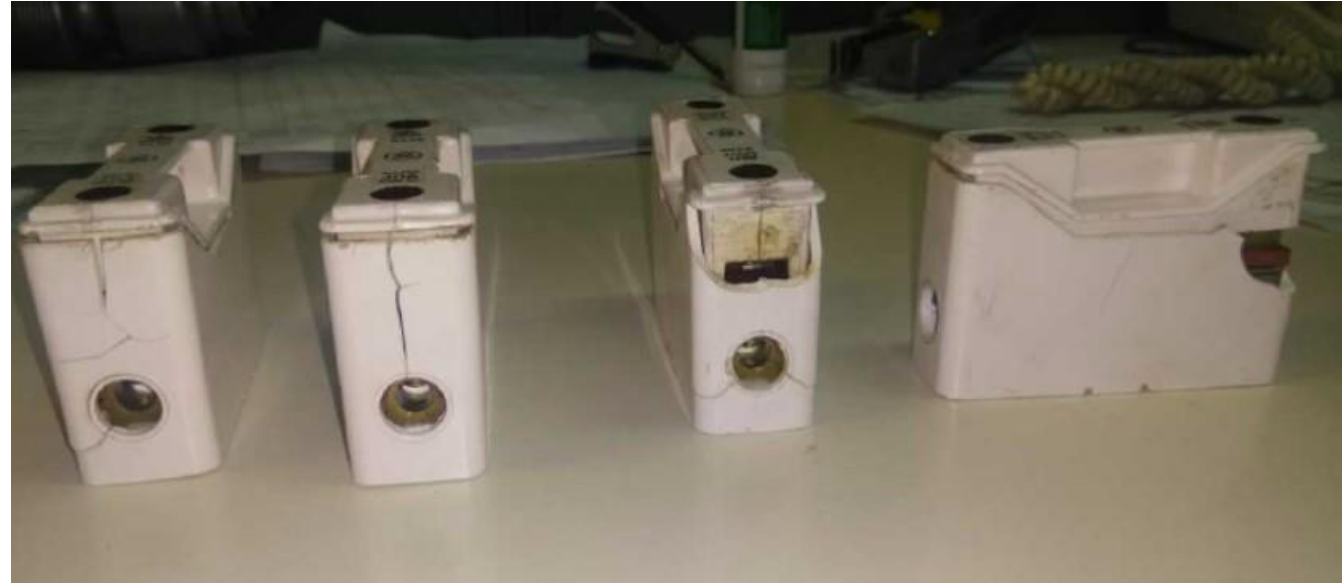
One of the neutral link holders found in the MCC with signs of cracking as opposed to the red spot fuse holder which is in good working order

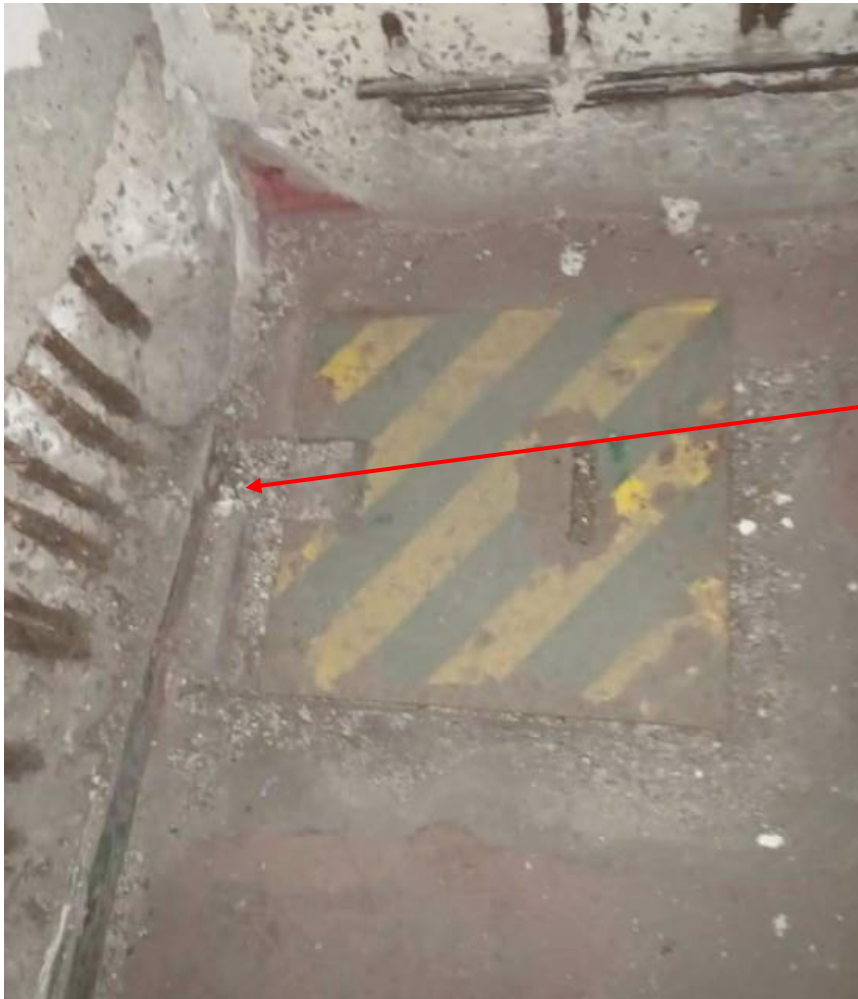
On a routine inspection of switchrooms an engineer has discovered the main earth pile in a poor condition. This earth pile is the main earth for the switchroom and is connected to earthing system of the switchroom 415V distribution. The pile was discovered in an unused section of the switchroom, with the cover plate and the pile heavily corroded and the pit full of debris. The pile did not have a registration number and was not included in a scheduled maintenance plan.

The earth pile cover lifted to show the pit full of debris and no indication of the condition of the earth pile below

Earth piles are an integral part of the earthing system of the BSL distribution network. They must be registered, tested, kept clean and in good condition and regularly inspected by the owners. As per DIV-ENG-ET-008 for Electrical Stations and Field panels.

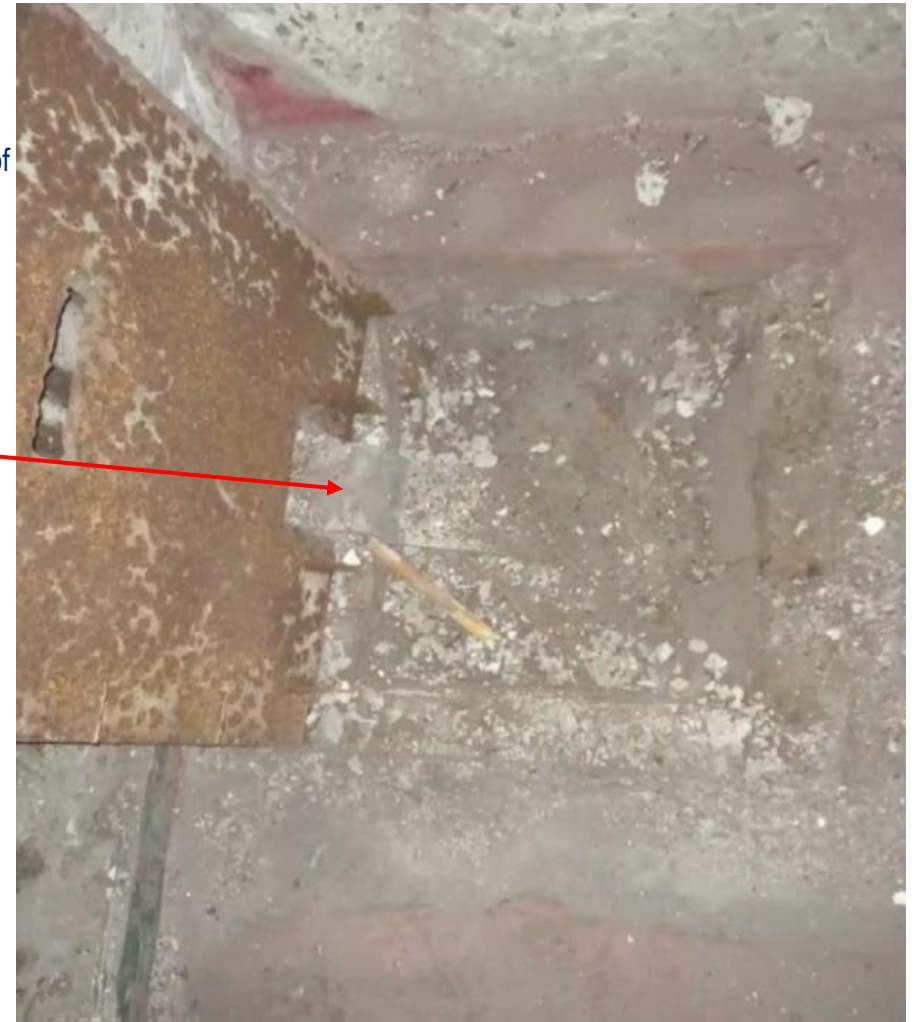
The earth pile busbar which runs along the wall of the switchroom. This should be cleaned and painted green

The earth pile cover in the corner of the switchroom with busbar connected to the wall

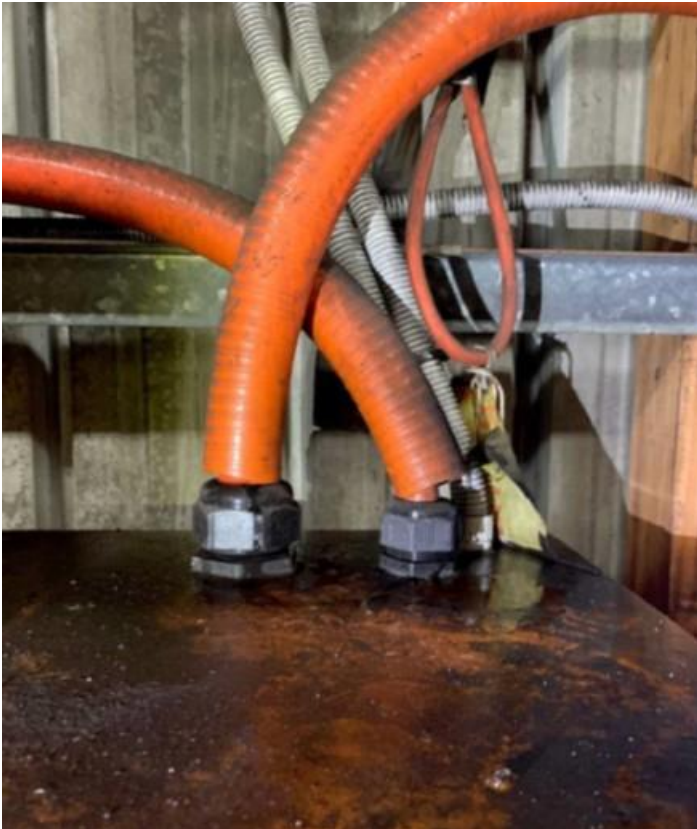
Water has entered a control panel due to poor installation practice. The installation uses top cable entry, glands were not installed correctly and were not tightened. The supply cable has been installed with Rhino style flexible conduit run to the outside of the building from above the panel. The conduit on the outside has been left open allow water to collect in the conduit and run to the top of the panel.

The top of the panel as found covered in water with top entry cables and loosely fitted glands

Field panels should be installed with only top cable entry, refer to Electrical Installation Manual section 4.5.1. Conduits must be arranged to avoid water collection and allow any trapped water to escape before reaching cable glands.

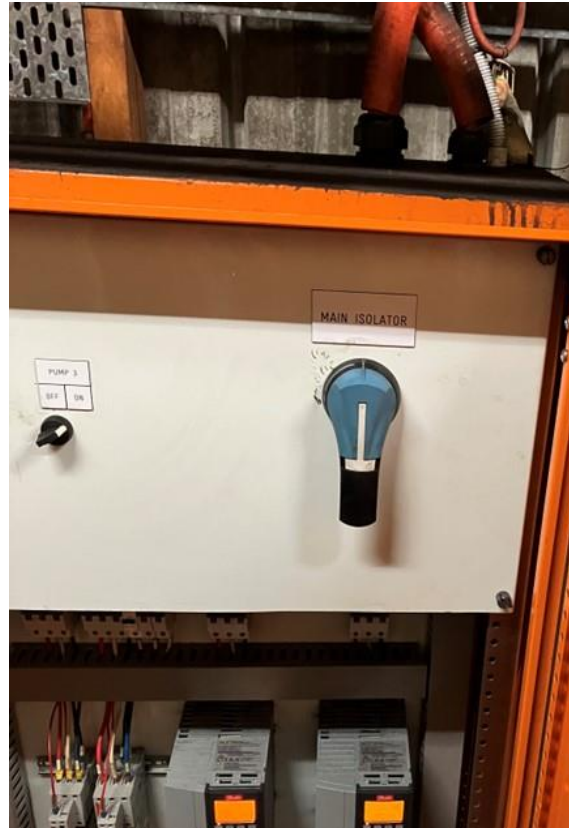
The inside of the panel with the main isolator straight below where the water was entering

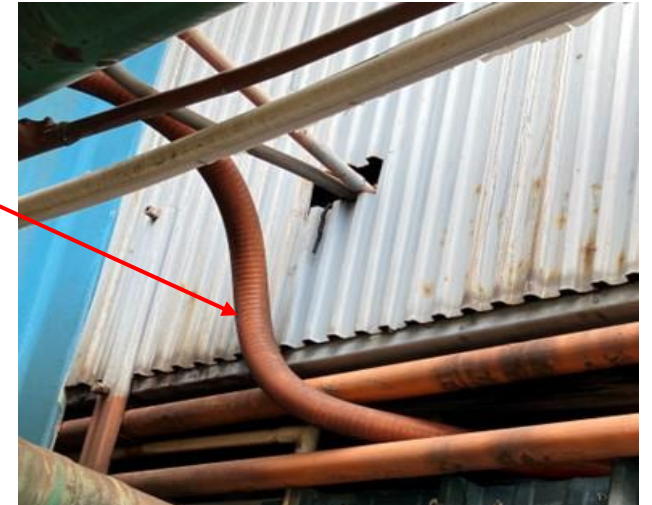
The outside installation of the power supply cable in the flexible conduit with water entering from above

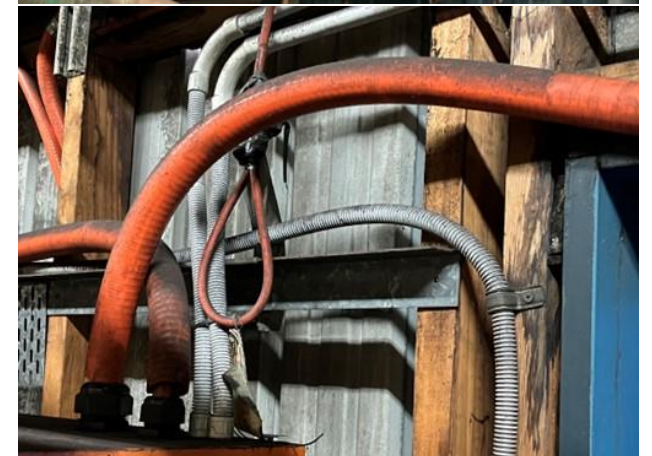
The power supply cable installed to the top of the panel
