# MONTHLY ELECTRICAL INCIDENTS

**ASP Manufacturing**

**March 2023**

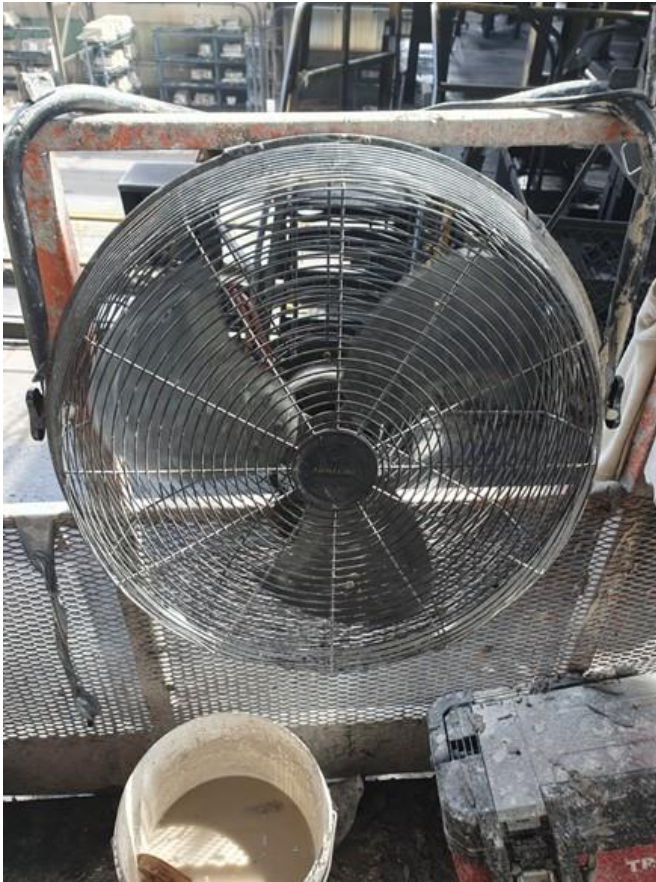
It has been determined that the EWP frame had voltage on it from the outrigger contact with the damaged extension lead. The lead is used to power a fan mounted on the EWP which is used to keep the crew inside the oven cool.

The man cooling fan secured to the hand rail of the EWP bucket fed by 240V extension lead.

As per Electrical Safety Manual 1.4.13 electrical extension leads may be subject to damage if not installed or used correctly. Leads must be protected against crush damage, pinch points and cuts. Extension leads may not be suitable for some environments or tasks. Battery powered tools and equipment or other means of removing LV power will reduce electrical risks.

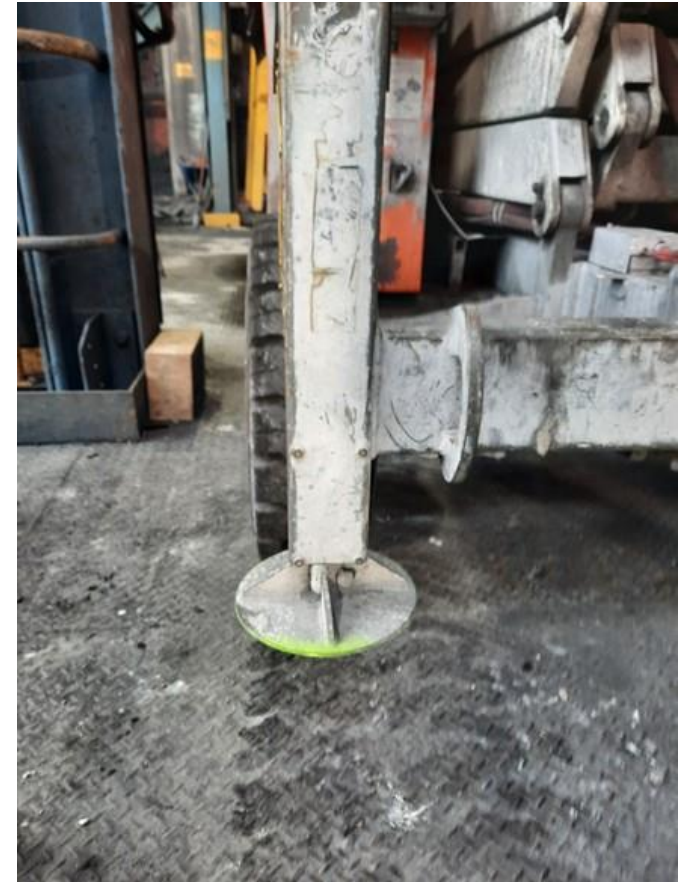
A person received an **electric shock** after repositioning an EWP. The operator was not aware an outrigger had been driven onto a 240V electrical extension lead. Soon after this occurred, the operator received an electric shock to their hand when they picked up an aluminium plank inside the EWP which contacted the battery heat shield. RCD protection then operated.

The outrigger leg of the EWP. When driven down to stabilise the EWP the foot has crushed the extension lead and explosion the conductors.

RCDs quickly disconnect the supply to minimise harm, they do not prevent electric shock. RCDs are essential for work with LV leads and portable appliances and require regular inspection and testing to ensure reliable operation.

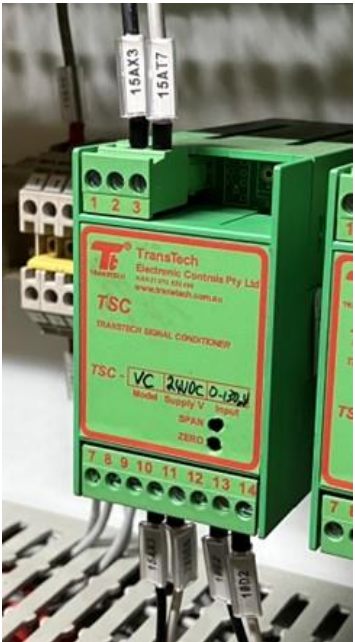
An electrician received an **Electric Shock** while commissioning the Main Hoist current feedback to new PLC I/O. A wiring error was first identified with the control power connections to a signal isolator, the 24 Vdc supply was isolated and the wiring corrected. A decision was then made to calibrate the signal isolator by disconnecting current feedback wiring from the Main Hoist shunt to the signal isolator and connecting a milli volt injection unit. The 230 Vdc Main Hoist circuit was not isolated and the electrician received a shock after touching wiring from the shunt.

The signal isolator. Shunt wiring is on terminals 13 and 14

Testing and fault finding may place individuals in close proximity to hazards, job steps must be carefully planned and reviewed before proceeding. Prepare and follow a JSEA. Before disconnecting any wiring stop and Take Two to understand the task, perform Test Before You Touch and isolate ensure wiring is safe to work on. Refer to Electrical Safety Manual section 1.4.3.9.

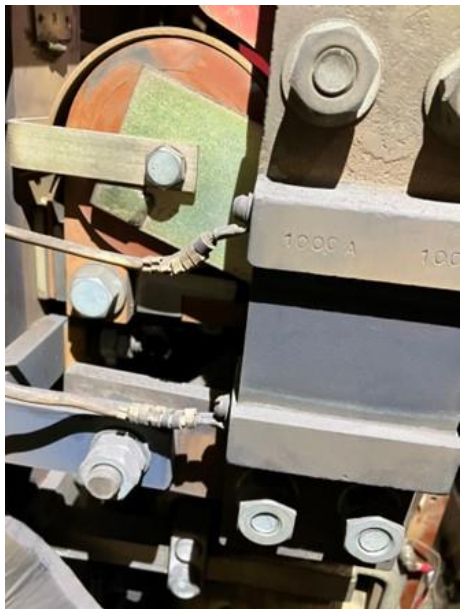
The DC shunt rated at 1000amps

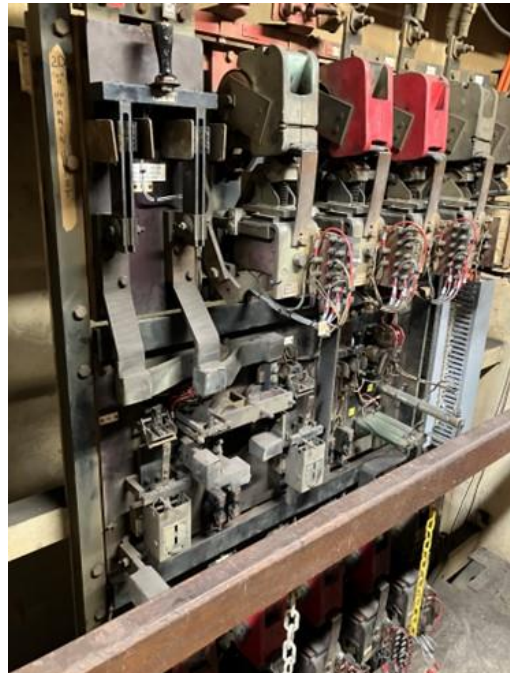
The Main Hoist DC flat back panel

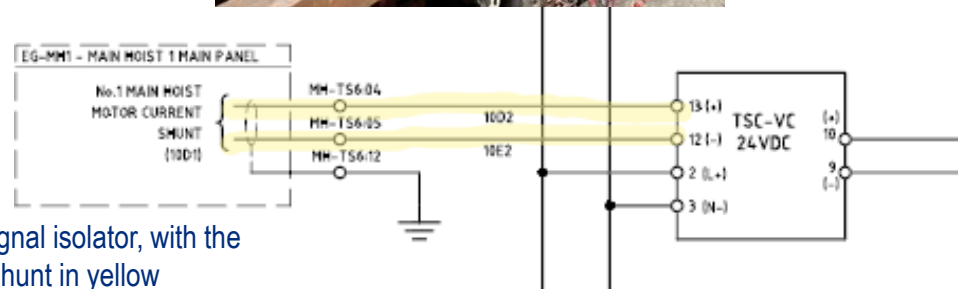
The wiring for the signal isolator, with the wiring going to the shunt in yellow

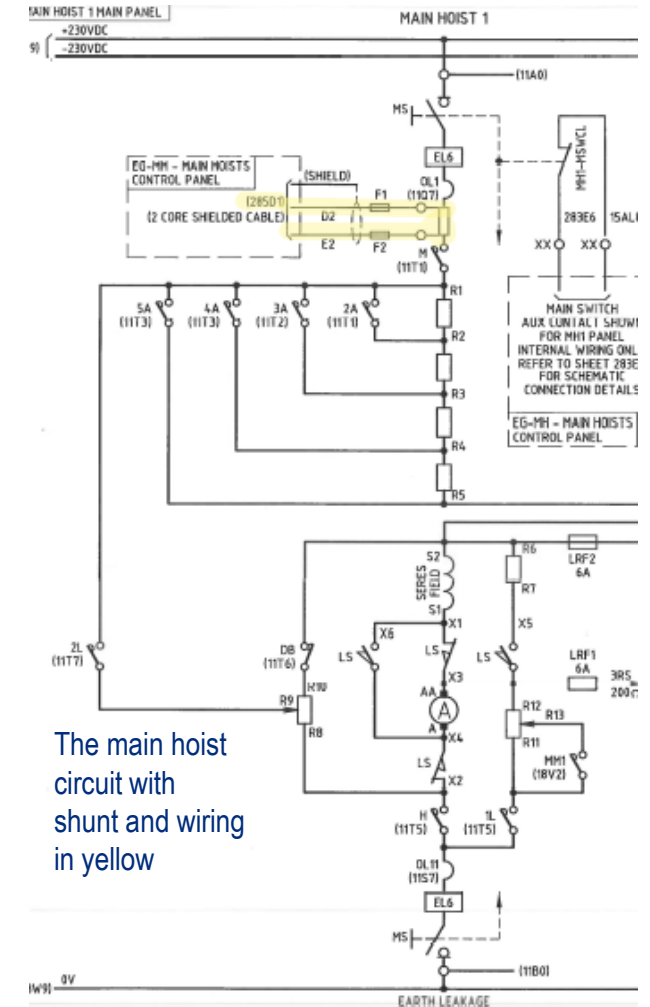
The main hoist circuit with shunt and wiring in yellow

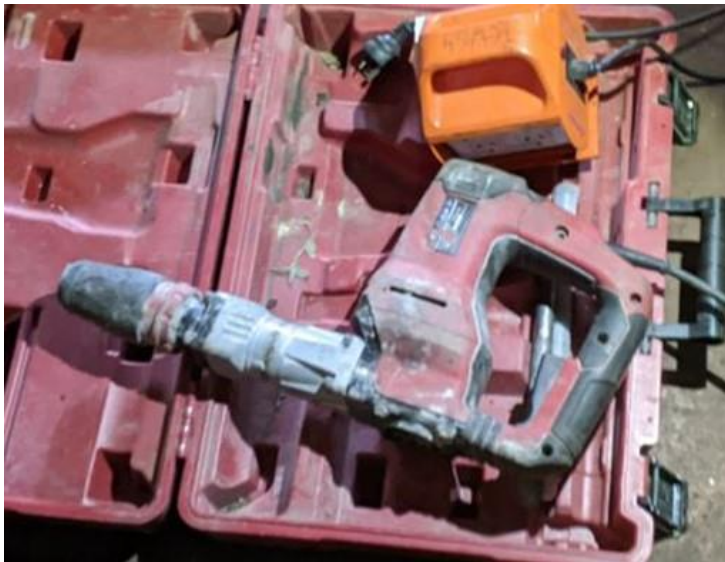
A plumber drilling a hole close to the ground with a double insulated 240V ac rotary hammer drill has received an **Electric shock** to the left hand. When the plumber has commenced the drilling the portable RCD unit tripped as well as the upstream RCD breaker. The plumber has stopped work and checked the drill and lead for any sign of damaged as to the cause of the RCD trip. Finding no cause for the trip the plumber has reset the two RCD breakers and restarted work. This time with one hand on the trigger and the other hand on the base of the drill touching the ground the plumber has received the shock through wet gloves. The RCD breakers did not trip on this occasion. An investigation has found in the drilling process the base of the drill is either touching or sitting in a puddle of water. This has compromised the double insulation integrity of the drill allowing moisture to enter the drill through vents at the base, with the plumber providing an earth path when hand touched this wet area.

The rotary hammer drill

Always ensure portable 240V ac electrical equipment is kept in good working order, is not used in presence or near wet and damp situations, where the IP or insulation integrity is compromised. Reduce or eliminate the risk by using battery powered tools and equipment

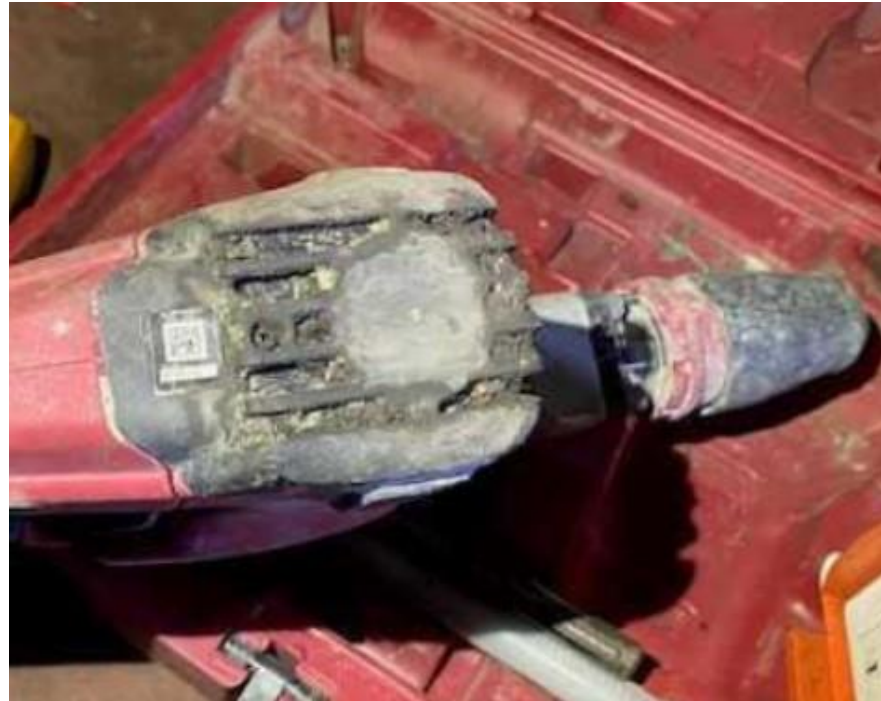
A close up of the base of the drill.  
Note all the moist dirt build up inside the slots.  
Some of the slots are vent hole which have allowed moisture to enter the drill

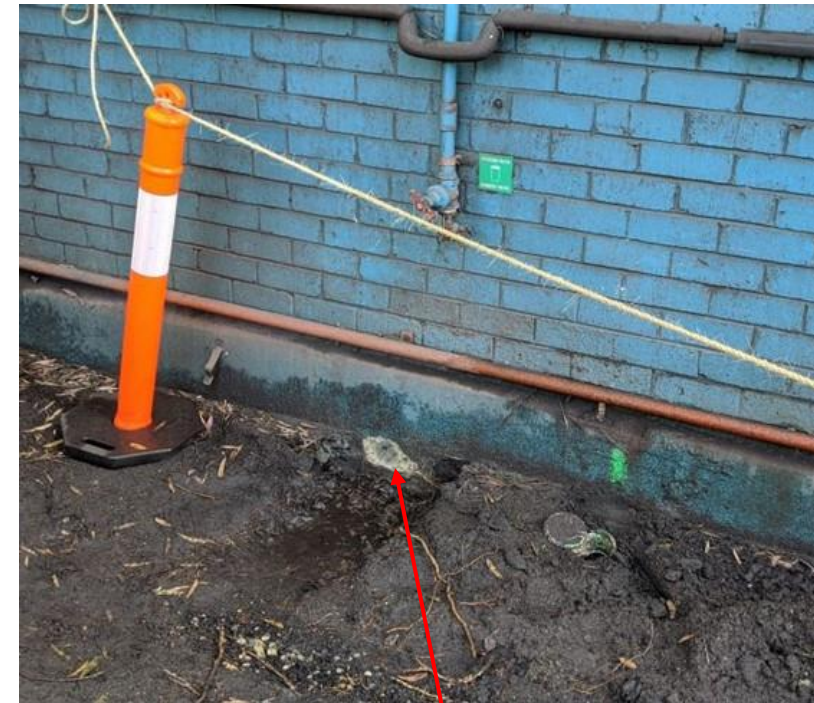
The area being drilled close to the ground.  
The pool of water and wet soil which the base of the drill has touched.

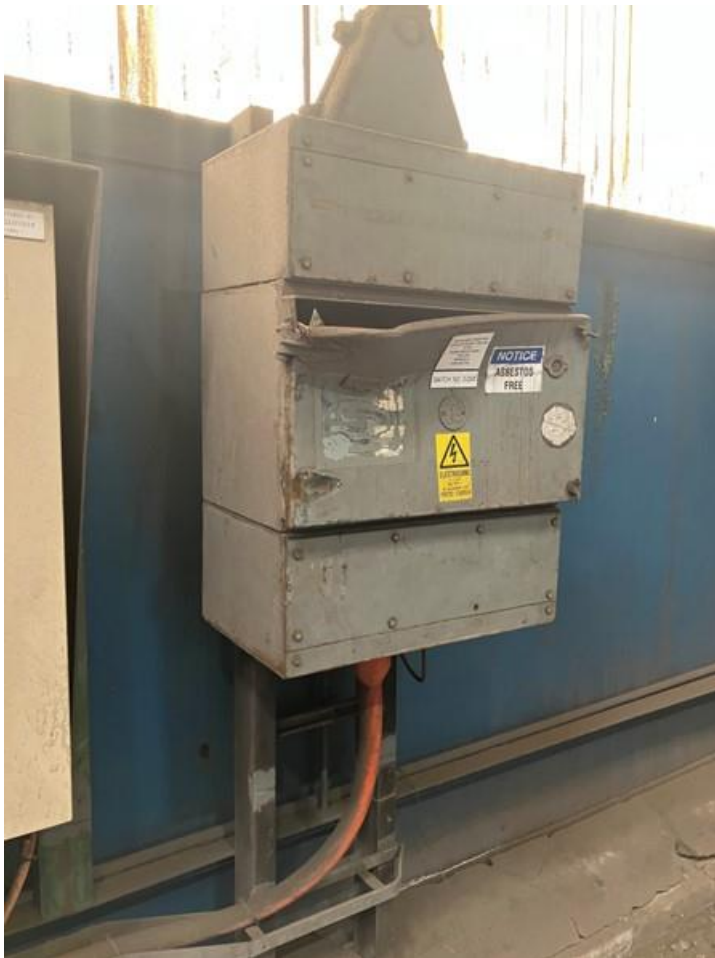
During an audit in a warehouse recently taken over by the HCPD operations a 500amp CFS unit was found damaged with exposed energised conductors. The CFS unit has been hit with some force believed to be the tines of a fork lift as there was product in the vicinity. The top of the door of the CFS has been bent open to expose a 100mm gap. Inside there is copper busbar and fuses which are energised and easily accessible.

The damaged CFS unit ,  
with door bent open and  
hinges sheared off

As per Electrical Safety Manual 1.4.2.3 all removable covers or doors of high fault level low voltage equipment should be suitable secured to prevent accidental or inadvertent access.

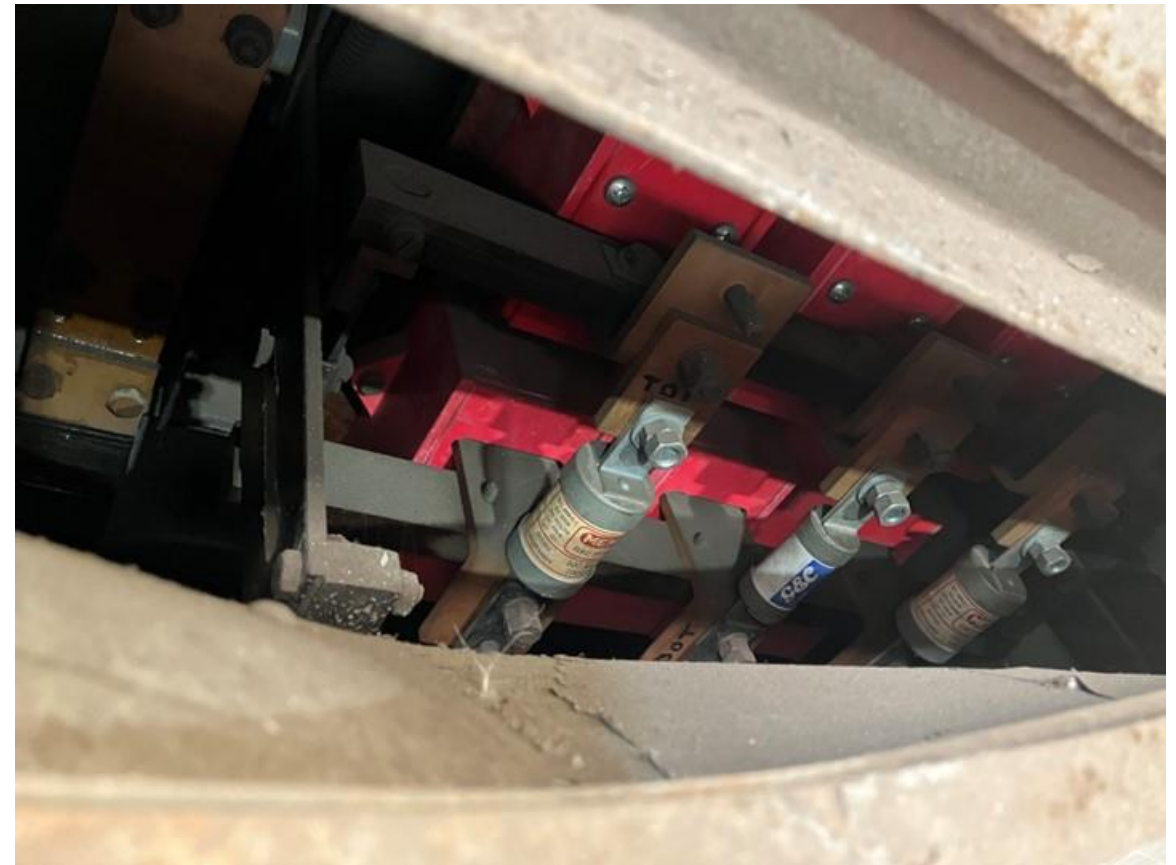
The inside view of the CFS unit  
through the 100mm opening.  
The exposed busbar and fuses  
are energised

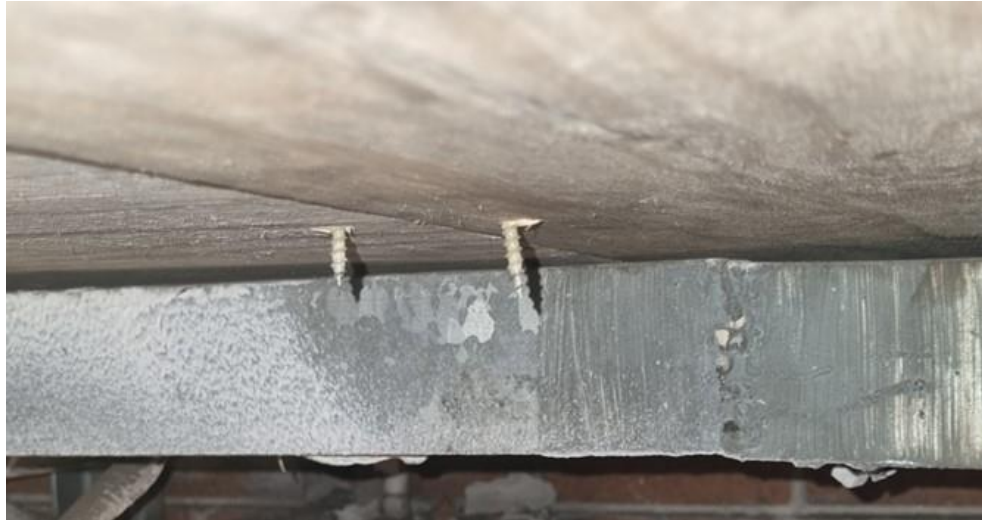
A motor cable was found to have been damaged by wood screws after removing boards installed for protection as part of work to install a new air conditioning system. The work required making penetrations in brickwork above a cable rack, temporary barriers were installed for protection before penetration work commenced. The screws used to construct the barrier were longer than the board depth, resulting in damage to the sheath of an out of service 415V cable.

Two screws on the outside of the cable rack show the extent of penetration beyond the plyboard surface.

Work in close proximity to energised electrical equipment introduces the risk of electric shock or arc blast. Precautions must be taken to address the hazards and protect the safety and integrity of the electrical installation. Always check the position of cables before drilling or penetrating into a hard surface or structure and use the appropriate fastening equipment for the task.

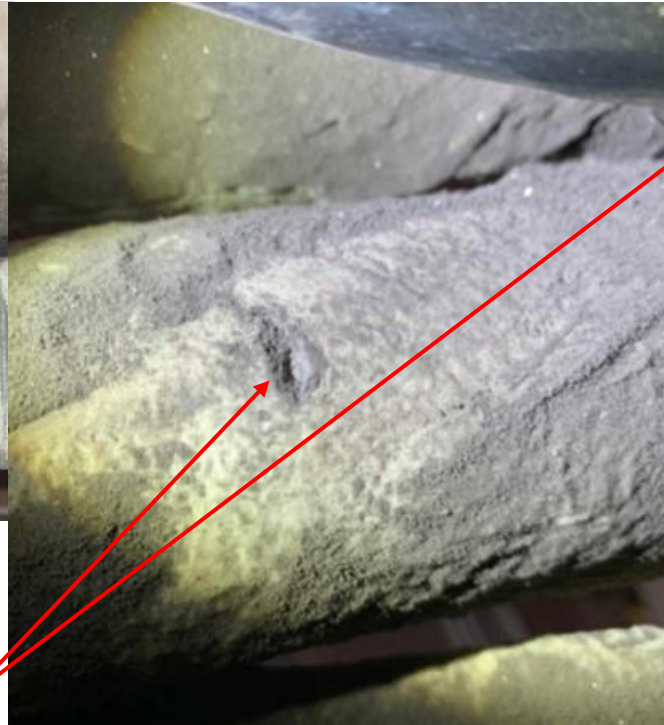
A section of ablative coating penetrated and damaged by the wood screw.

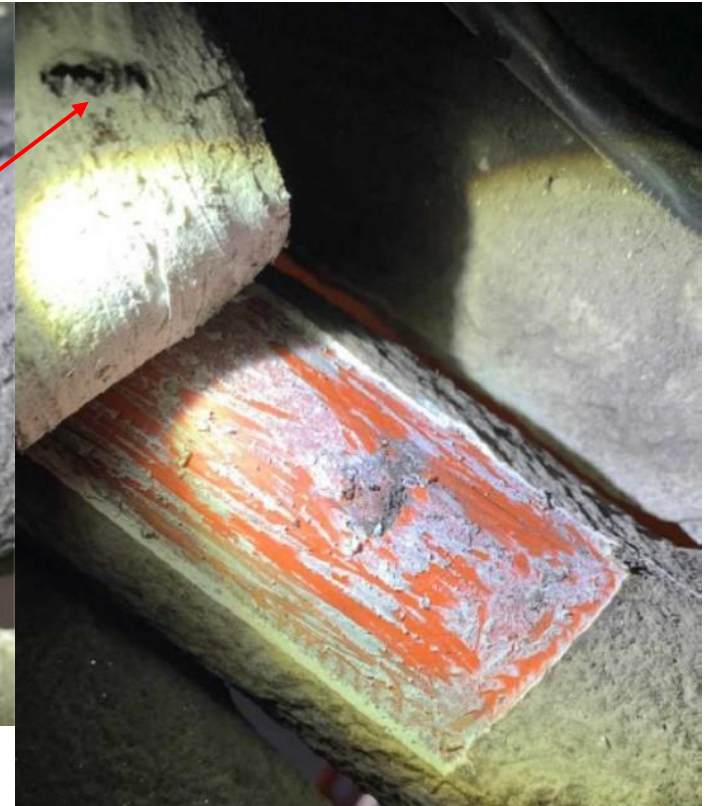
Minor damage to the cable sheath evident after removal of the ablative coating.
