# MONTHLY ELECTRICAL INCIDENTS

**ASP Manufacturing**

**June 2023**

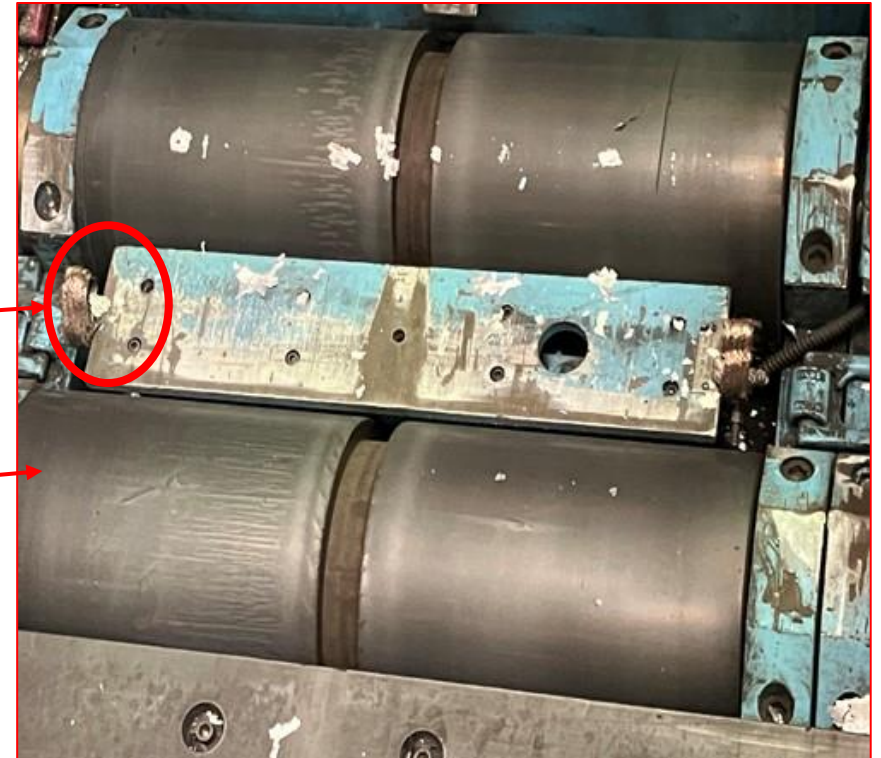
At Springhill – ZAL1 Exit Coil Car has an anti-static magnet as well as earthing tails on the coil car to eliminate the hazard. For both incidents, the coil car tails were found to be squashed down and not touching the metal coil. Tails were lifted to rectify the issue & new operators trained in the use of these and the anti-static magnet.

ZAL1 Exit Coil Car – Earthing Tails, that were found to be bent over and not contacting the coil.

Coil sits here on insulated blocker rolls

- Anti-Static Safety Devices require maintaining and regular instruction on their use.
- All Static Shocks should be reported, and those affected assessed by our Medical Professionals at the time of the event.

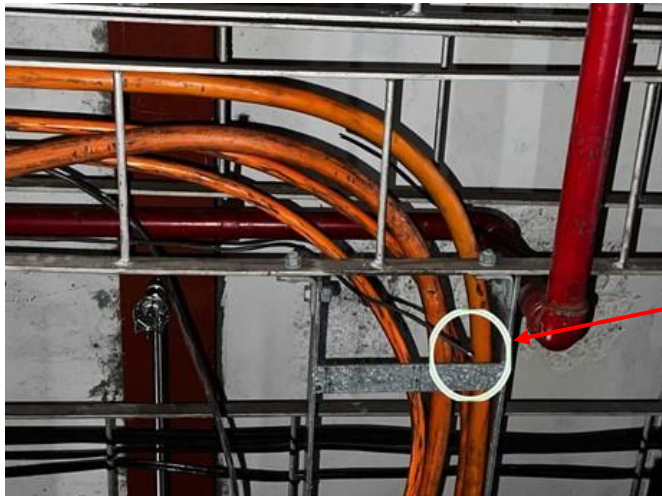
The cables in the basement were checked and it was found that the cable with the Zero Volt core had been cut. This cable was part of the group board isolation, so it was not energised when it was cut, nor was it identified during subsequent point-to-point tests as it was not part of the scope of testing for these works.

The only cutting activities that may have been undertaken in and around the area where the cut cable was found are believed to have been to remove cable ties. It is assumed that the cable may have been inadvertently cut during the process of removing one of these cable ties.

Cut cable

Multiple cables on rack, after several were removed

- Care must be taken when cutting cable ties, especially around other cables. In this instance, all surrounding cables were isolated at the time.

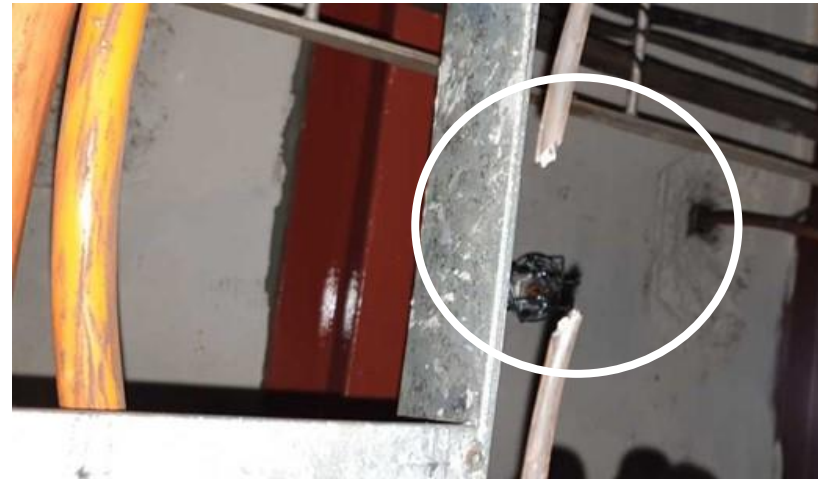
Close up of cut cable

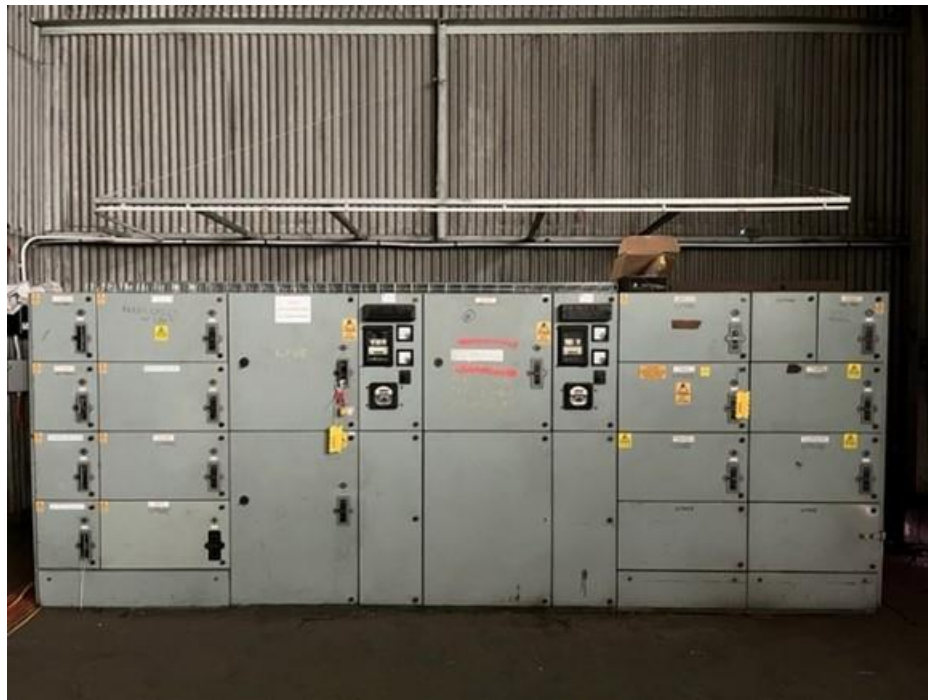
Whilst connecting a temporary generator for a site wide power outage bars of the Main Earth Bar inside the Main Super Form Board were found overlapping but not bolted to the transformer earth pile side busbar. This could have possibly resulted in CFS3 in warehouse 1 not being correctly earthed.

Work stopped, and the connection was correctly bolted before re-establishing power. This issue had likely been present for many years and was missed during previous board overhauls.

- During commissioning, verification of the earthing system is required (AS/NZS 3000, refer to Section 8.3.5)
- It is important to do regular maintenance on all Distribution Boards (Electrical Safety Manual, 1.4.22.1)

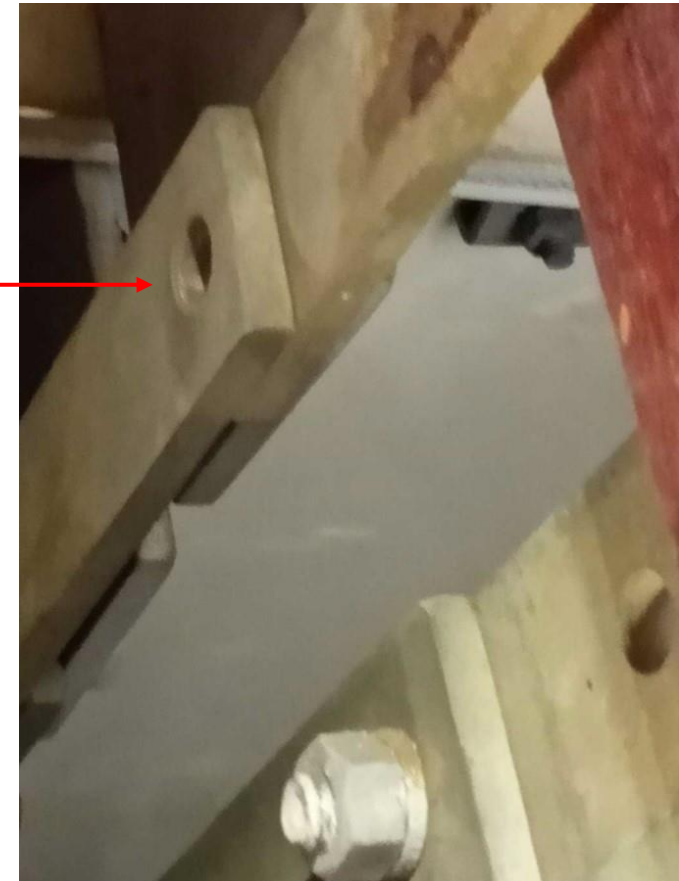
The unbolted section of Earth Bar

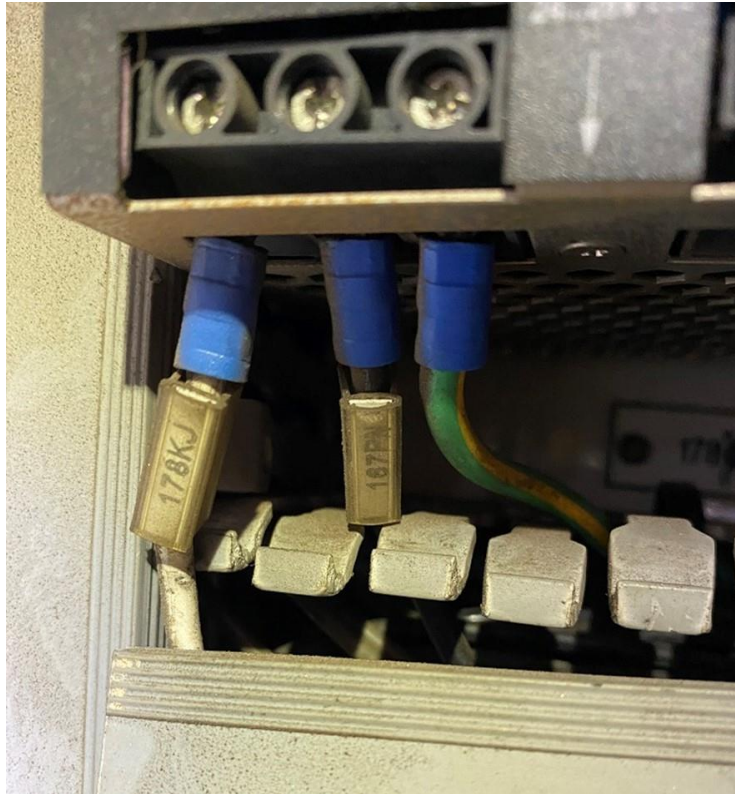
The supply terminations

Crane 4 at Western Sydney Service Centre lost power during normal operations. An electrician isolated the supply circuit breaker and checked the wiring, they found a crimp lug at the power supply end was broken off, possibly due to fatigue. They removed the broken lug and re-terminated with a new one. Crane restarted without further issue.

- Some faults are not always visually obvious. Regular maintenance where the integrity of each connection is checked is key.

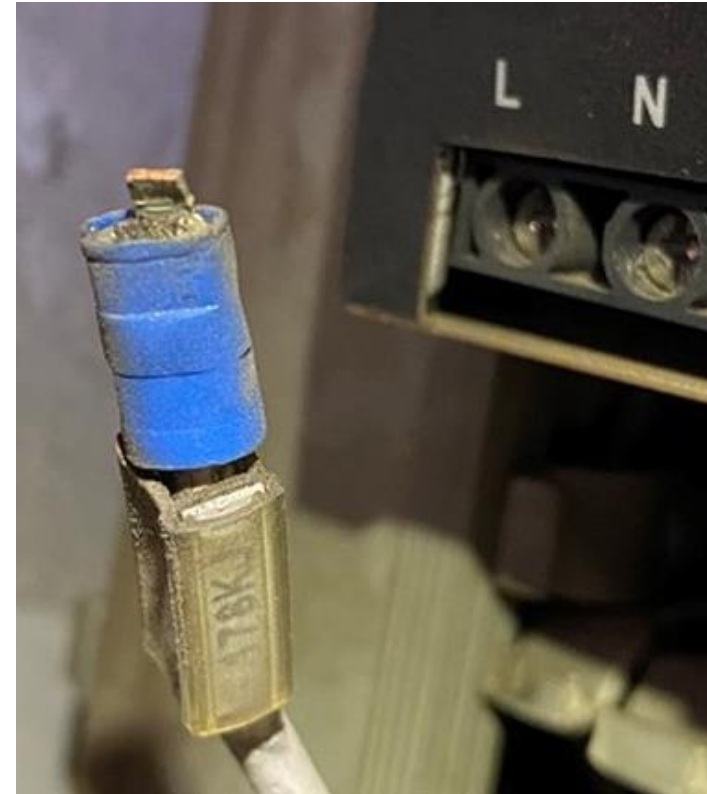
Close up of broken lug

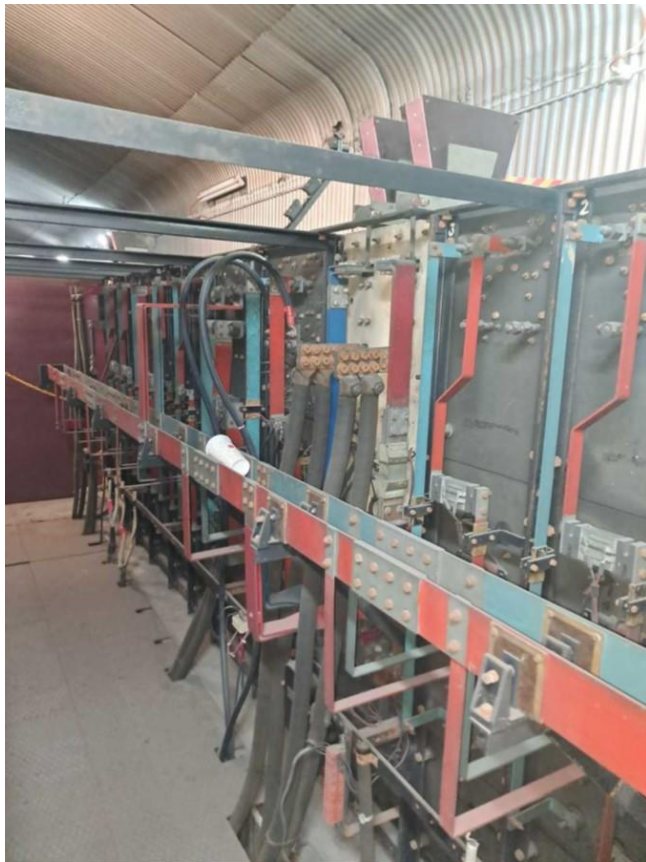
Back of DC Panels

Whilst inspecting the Gallery switchroom 230 Volt DC flat back switchboard, a "paper" cup could be seen laying between the main positive and negative busbars on the rear of the board. There appeared to be no evidence of liquid in the cup and no evidence of shorting between the conductors. The board was isolated, verified and locked out, and then the cup was removed safely.

- People entering or working in a switchroom, must be aware of all electrical hazards and the housekeeping practices required in those areas.

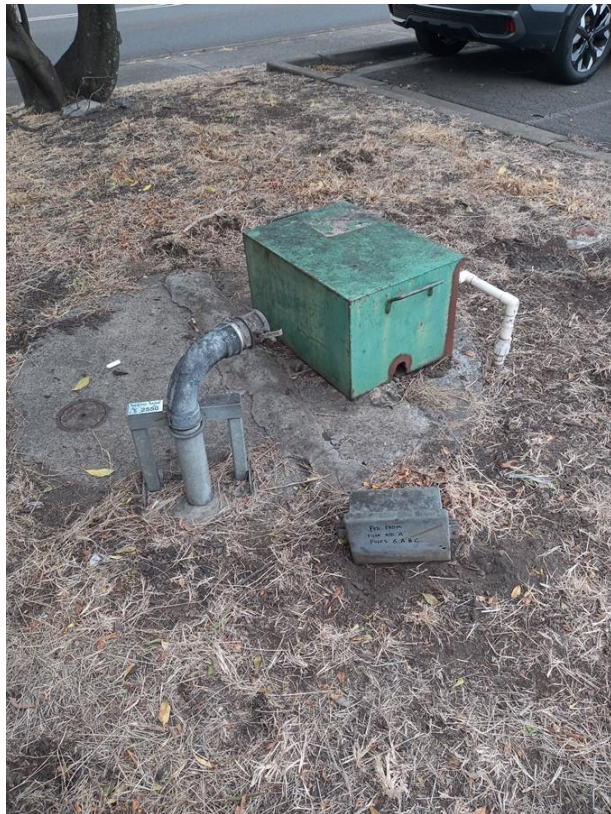
The septic tank area

Electricians were asked to disconnect and make safe a septic tank pump and float switch. After removing the float switch lid, they observed it had a Mercury filled glass bulb. They safely disconnected the switch and returned it to Electrical Services for it to be disposed of properly.

- A reminder that we still have old electrical equipment on site that contain hazardous materials (E.g. Mercury, Asbestos, PCB's), and proper handling and disposal needs to be considered.
- Reference : Management of waste material DIV-AR-RS-01.

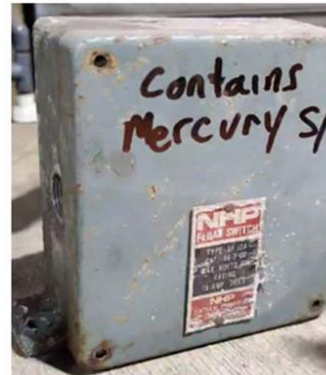
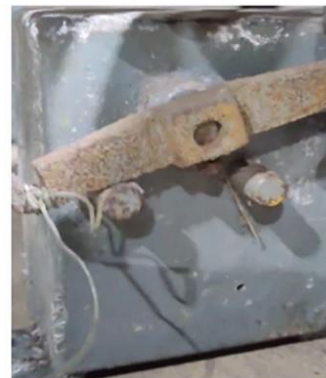
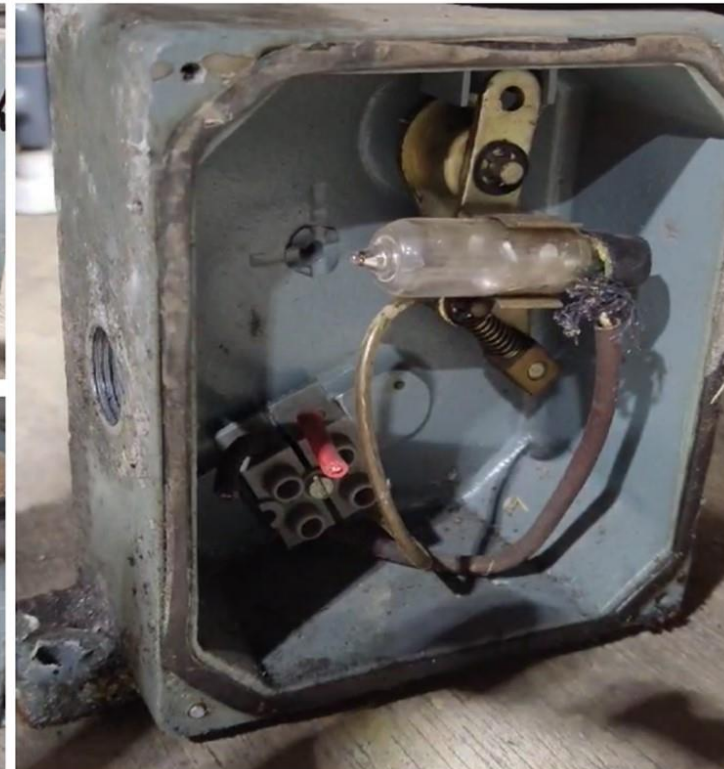
The Mercury Switch
