Electrical Incidents

Key Learnings

ASP Manufacturing

November 2023

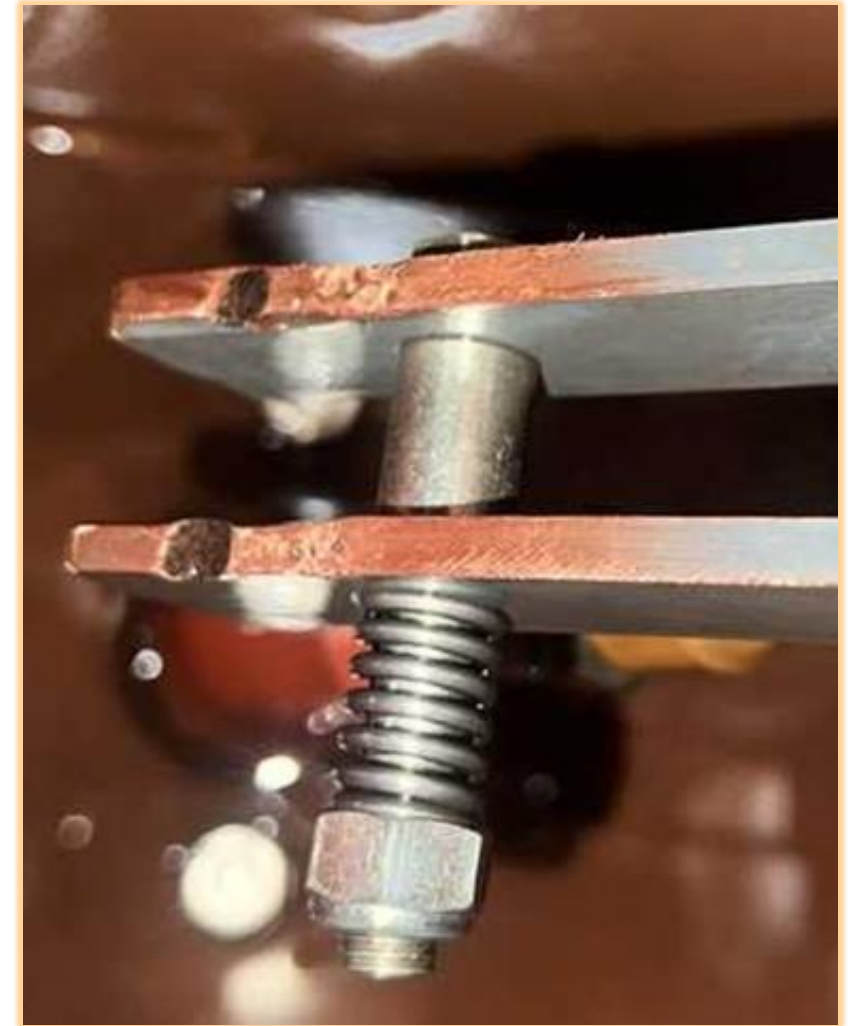
An engineer noticed an unusual noise coming from a 6.6kV switchboard and contacted Power Control to investigate. The noise, which stopped after a short time, was coming from an oil filled switch that was on load.

The switchboard was offloaded, and the switch isolated for inspection. Investigations revealed contacts of the switch were worn and the noise was due to arcing activity in oil.

6.6kV contacts showing signs of arcing

It is important to remain aware of your surroundings and to identify unusual noises or conditions as a potential hazard. Respond with care, keep the area clear and report the fault for urgent investigation. Reporting the incident immediately may prevent faults escalating to equipment damage or a serious hazard.

Reviewing maintenance records of equipment found like this will help determine whether procedures are effective or need to be adjusted.

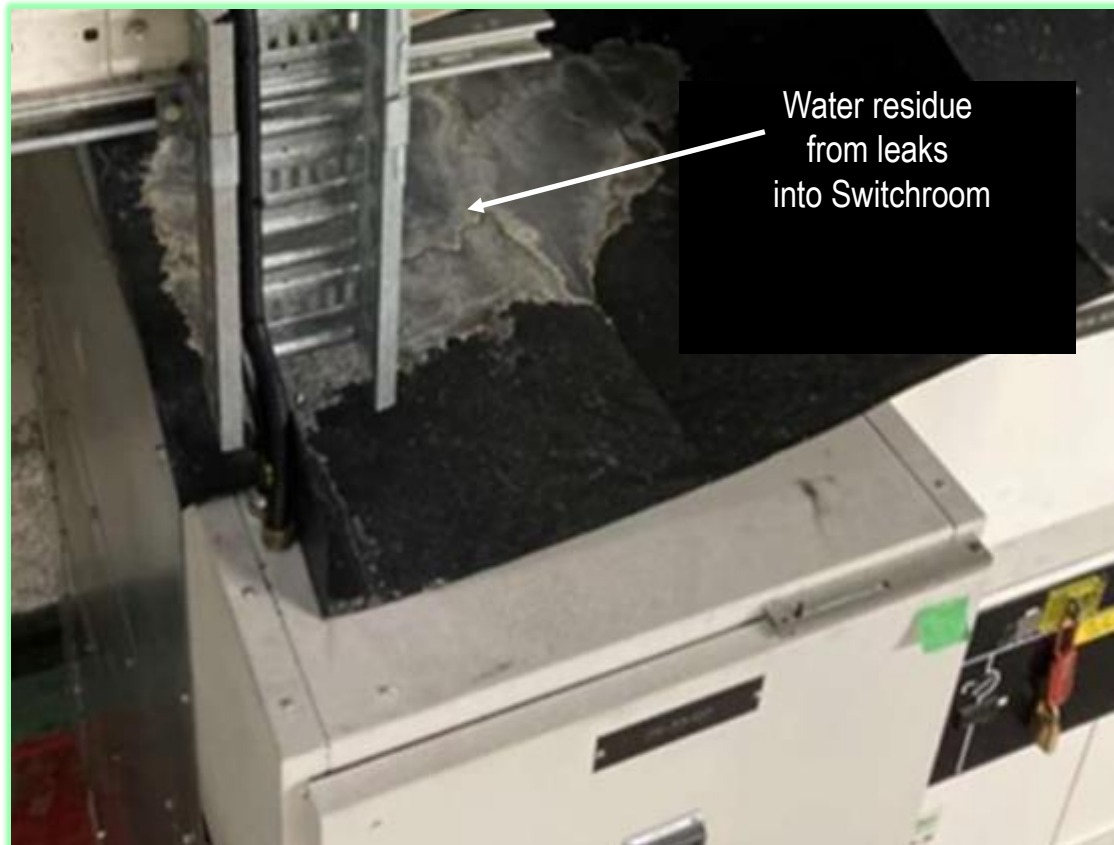
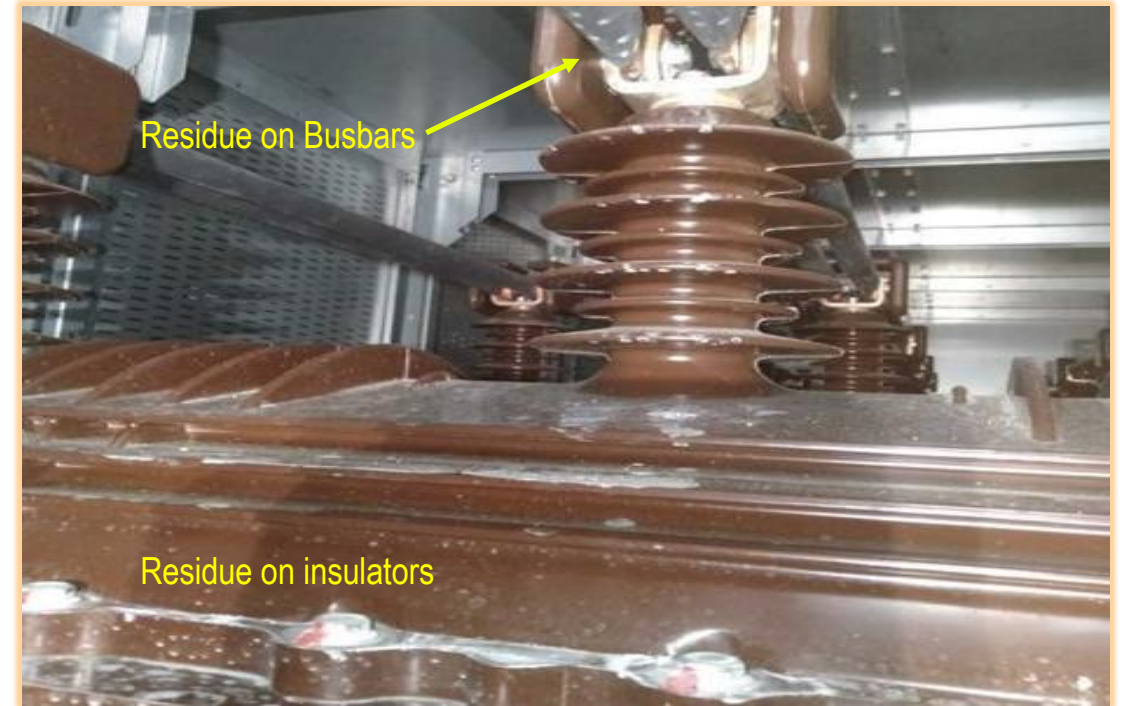
Reference: i2398484 – Partial Discharge testing reveals ingress into High Voltage equipment

- During routine maintenance, a partial discharge test picked up noise in a 33kV switchboard.
- Signs of moisture and concrete dust were found inside.
- Deterioration of the surrounding building had resulted in water and residue entering the switchgear.

- Indoor electrical equipment is selected and installed on the basis that buildings provide a level of protection from water, dust, corrosive fumes and extreme temperature. It is essential buildings are maintained to provide the required level of protection.
- Building damage, water leaks, or ventilation faults must be reported and addressed before the integrity of equipment is compromised or the installation no longer safe.
- Temporary shielding may be required to divert contamination until the building is fixed. Equipment must be isolated if conditions are no longer safe.

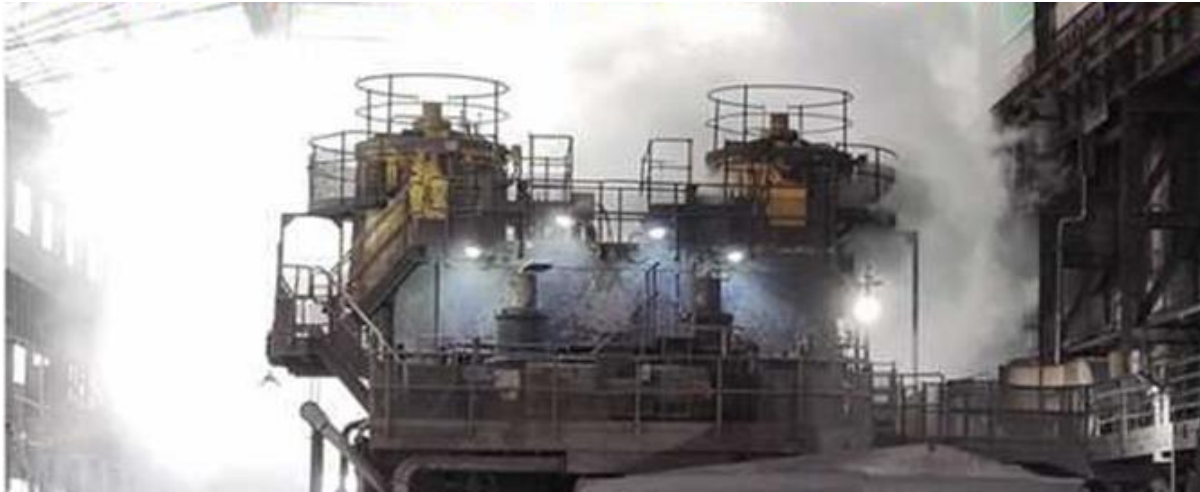
Smoke around Roughing Mill

- A large 1500 kW DC motor overheated & caught fire after the main control board was replaced. The motor had not been run yet, only the fields were energised. An investigation found a redundant control cable was inadvertently connected to the main control board instead of the field current feedback cable. Loss of field current feedback resulted in undetected overcurrent and damage to the shunt field coils.

- The drive had two independent field converters added in 2016 to allow operation using motors with different field characteristics. The original common field converter was decommissioned but the feedback cable was not removed. The original field converter also featured separate overcurrent protection which would have protected against overcurrent in the event of feedback failure, this wasn't part of the new design. The two defects resulted in significant motor damage and a 48 hour production delay.

- De-commissioned equipment should be either fully removed or clearly identified and made safe.
- Thorough design review is required to identify failure modes, effects and controls required.

- Procedures, checks and tests are required when replacing equipment to ensure equipment and protection is functioning correctly.

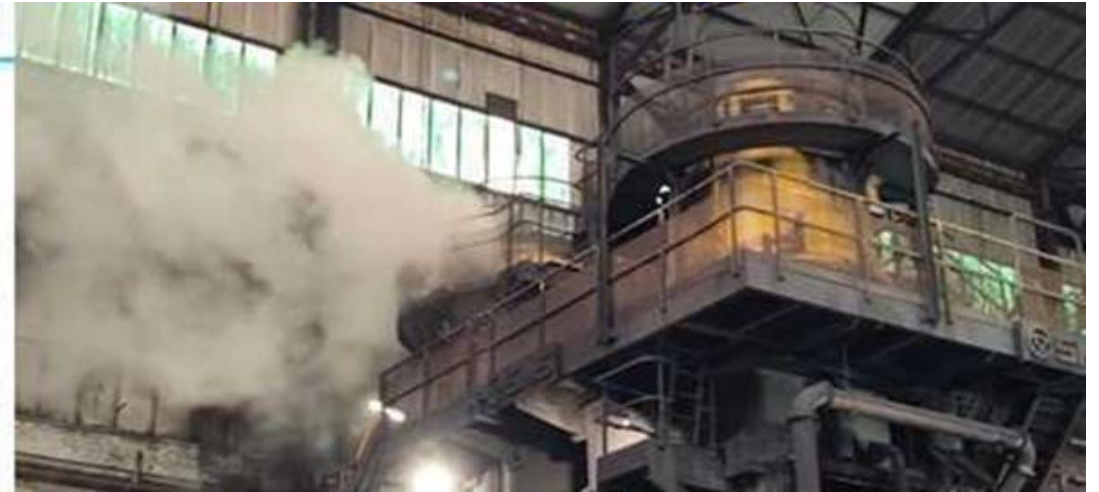
Motor area (photo of motor on front cover of this report)

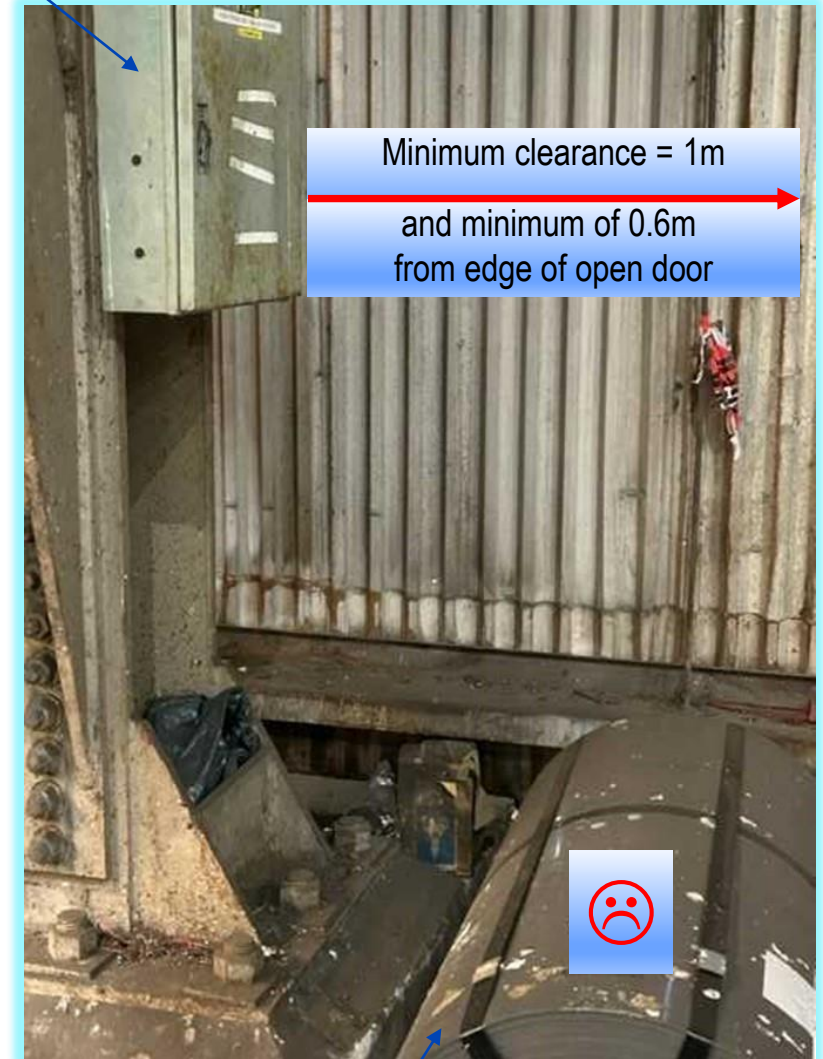
- Whilst performing the steps of an isolation procedure, an electrician's access to a distribution board was impeded by the storage of steel coils in front of and leading to the board. The coils were incorrectly stored in this location.
- Switchboard Accessibility & Emergency Exit Provisions are covered in the wiring rules:
Refer to AS/NZS 3000:2018, Section 2.10.2.2, (p.136-140) - 1m minimum clearance is required from all faces that need to be accessed & a minimum of 0.6m unimpeded space is required with the door in any position and switchgear racked out.
- Signage and floor markings should be prominent to remind people to keep clear of electrical equipment.
- The installation of appropriately placed bollards (or other mechanical barriers) that still allow access and emergency exit, will also assist in maintaining a clear space.

— Steel Coil Blocking Access

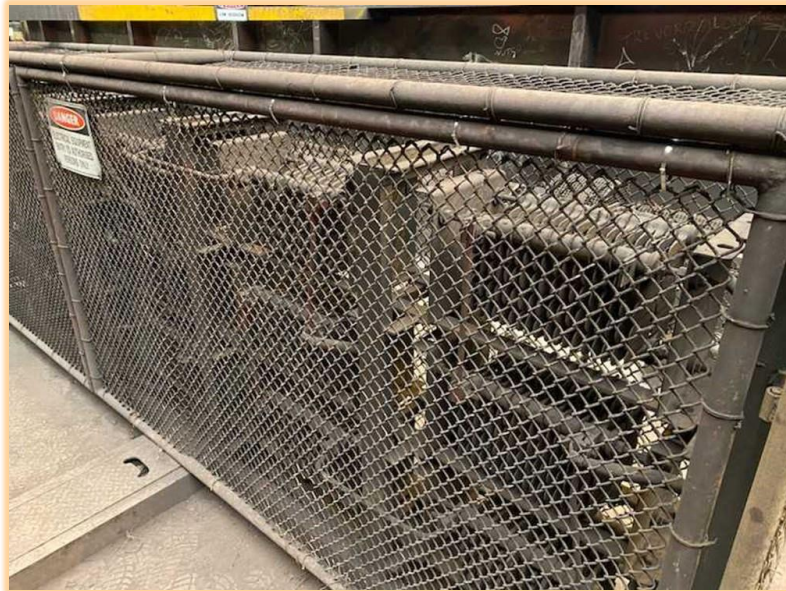
DC Crane Resistor Bank Enclosure

- During inspections of a DC Crane, it was noted that the wire mesh guarding of some resistor banks had shorted with one of the resistor power connections and melted a hole in the mesh. Wire mesh was used as guarding to provide a physical barrier whilst allowing heat dissipation via the open weave design.

- Inspection of protective covers and their securing points must be included in maintenance checks, especially on equipment subject to movement & vibration. An audit of cranes with similar enclosures will assist in identifying this potential hazard.

- Rigid covers that have minimal flex (welded mesh, welded to a frame and braced) can be installed with appropriate clearance to prevent contact and still allow adequate heat dissipation. Covers and frames must be equipotential bonded to earth.

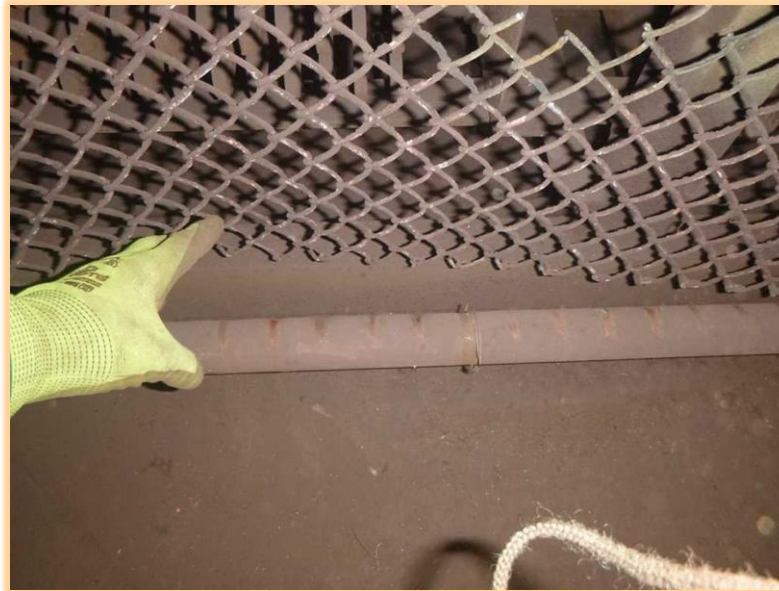
- The wire ties that held the mesh guarding in place had rusted and broken away, allowing the mesh to flex excessively with crane motion and vibration and then touch live parts.

Loose Protective Mesh – wire ties broken off

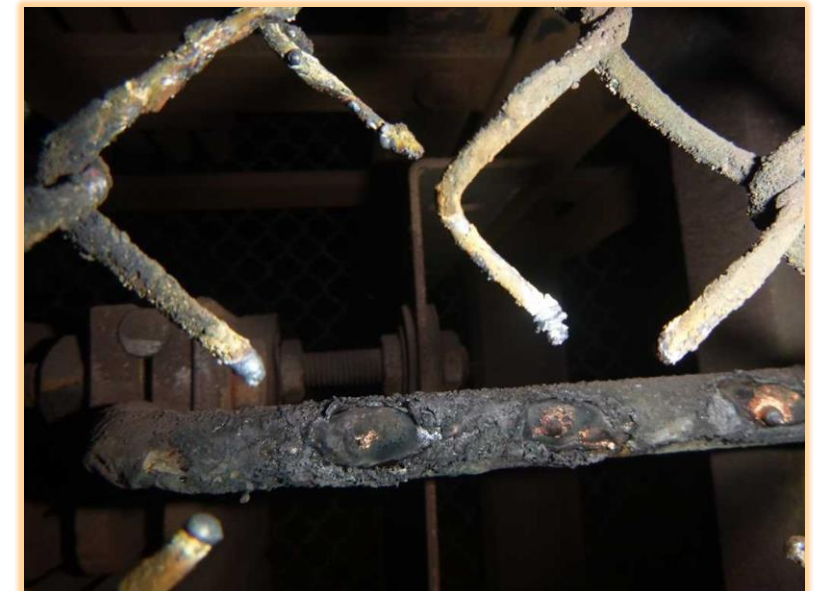
Arc marks where resistors were shorting to loose mesh
