BlueScope

# Electrical Incidents

# Key Learnings

2024 / #5

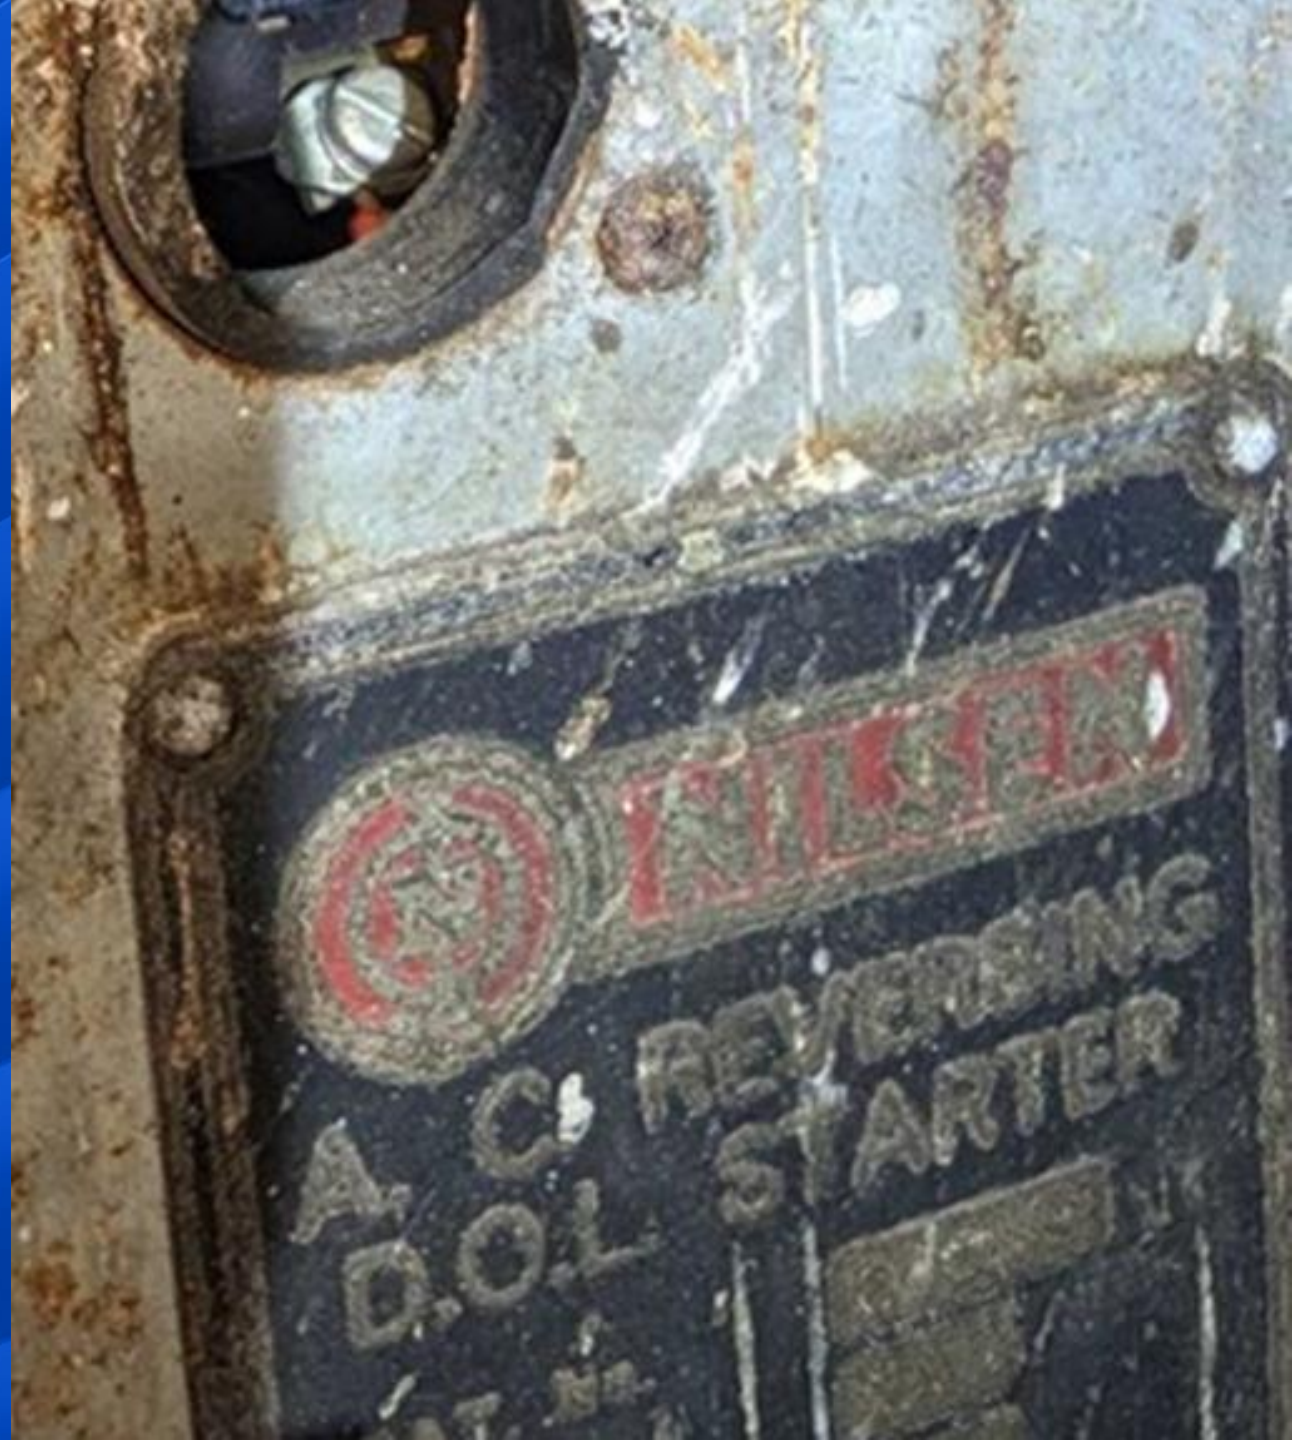
Crane Cabin Heaters

An electrician was called to a crane cabin to investigate water leaking near a light fitting. When they went to isolate the light at an electrical panel, they pushed a floor heater out of the way for access. As they did this, they felt a “tingle” (electric shock) between their hands touching the panel and the heater. The RCD circuit protection did not trip. After medical treatment and assessment, they were able to return to work.

The RCD breaker was later tested and confirmed as functioning correctly. The heater was constructed of a plastic external casing with a metal grille not attached to any internal components or earth. It was partially full of water which had most likely caused tracking of electricity to the grille.

Faults in the crane cabin’s roof had allowed water ingress into an area with several electrical panels and appliances designed only for indoor use.

- Crane and building maintenance must be prioritized to prevent water ingress into electrical equipment.
- When investigating water issues around electrical equipment, take care to broaden your focus from what you were originally looking at to also include any other possible water ingress hazards in the area.

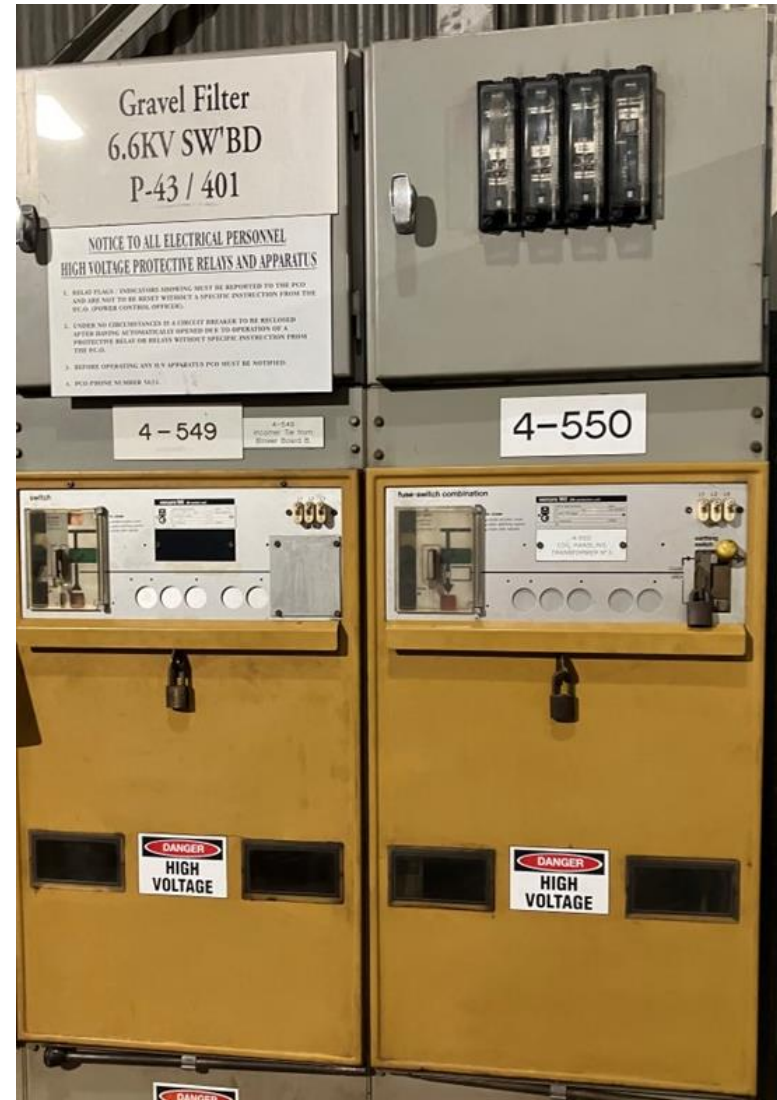
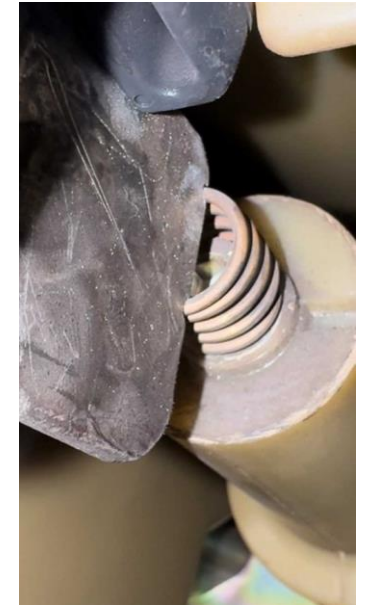
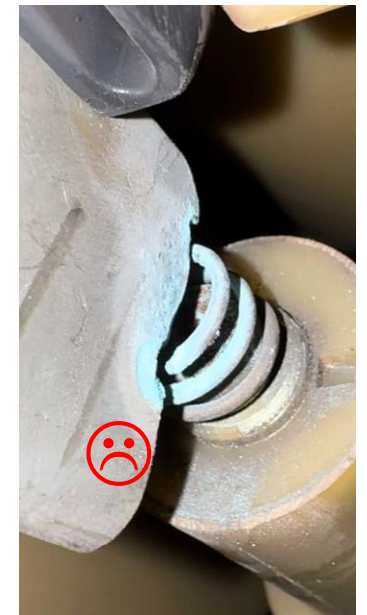
6.6kV Circuit Breakers and contacts inside

Whilst performing isolations, an electrician noticed abnormal noise coming from a 6.6 kV board. High Voltage were notified, and a Power Control Officer sent to assess. The noise was deemed worthy of investigation, so circuits were off-loaded, the area barricaded and access to the switch room restricted.

Investigations revealed contacts of the switch were worn and the noise was due to arcing activity.

It is important that we are aware of our surroundings and identify unusual noises as a potential hazard.

Acting on our findings by responding immediately can prevent an escalation of faults (keep the area clear and report the fault for urgent investigation).

Reviewing maintenance and failure records of equipment found like this will help determine if frequency and types of inspections need to be adjusted.

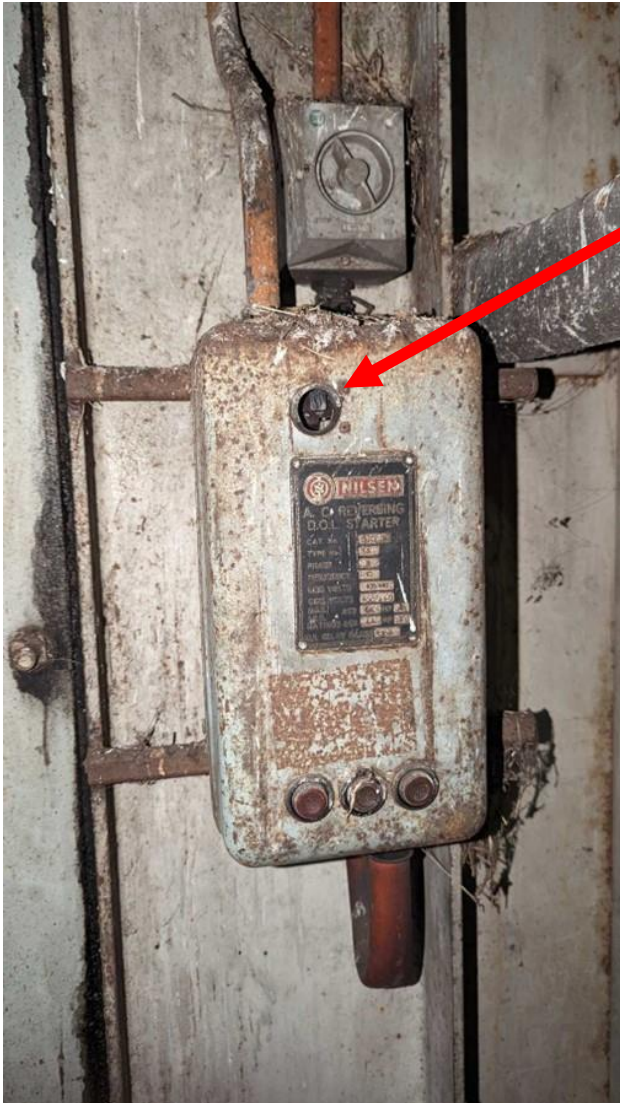
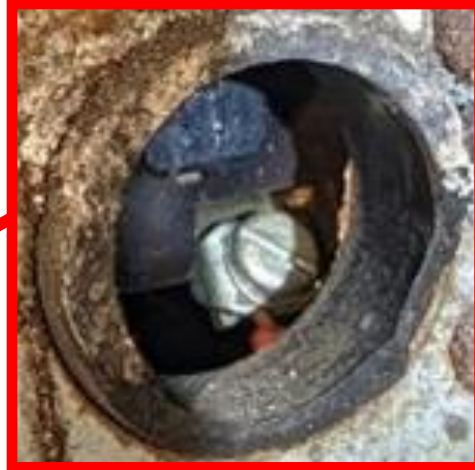
Roller Door Controller

During fault finding, an electric roller door controller was found to have its overload reset button removed and exposed terminals from the control circuit inside were energised. These could be touched if someone put their finger in the pushbutton hole.

In the past, the overload inside the enclosure had been altered and was not in its original location.

Also, the isolation switch above isolated all power, but to enable a lock to be applied, someone had drilled a hole through it. There was no labelling indicating its function or point of supply.

This looks to have been in this condition for a long time.

Failings of the original installation, from incorrect repairs and missed maintenance all led to this potential hazard.

We must ensure equipment is installed, commissioned & labelled correctly.

Repairs and modifications must retain the original functionality and safety of equipment.

All electrical equipment shall have a maintenance and testing plan.

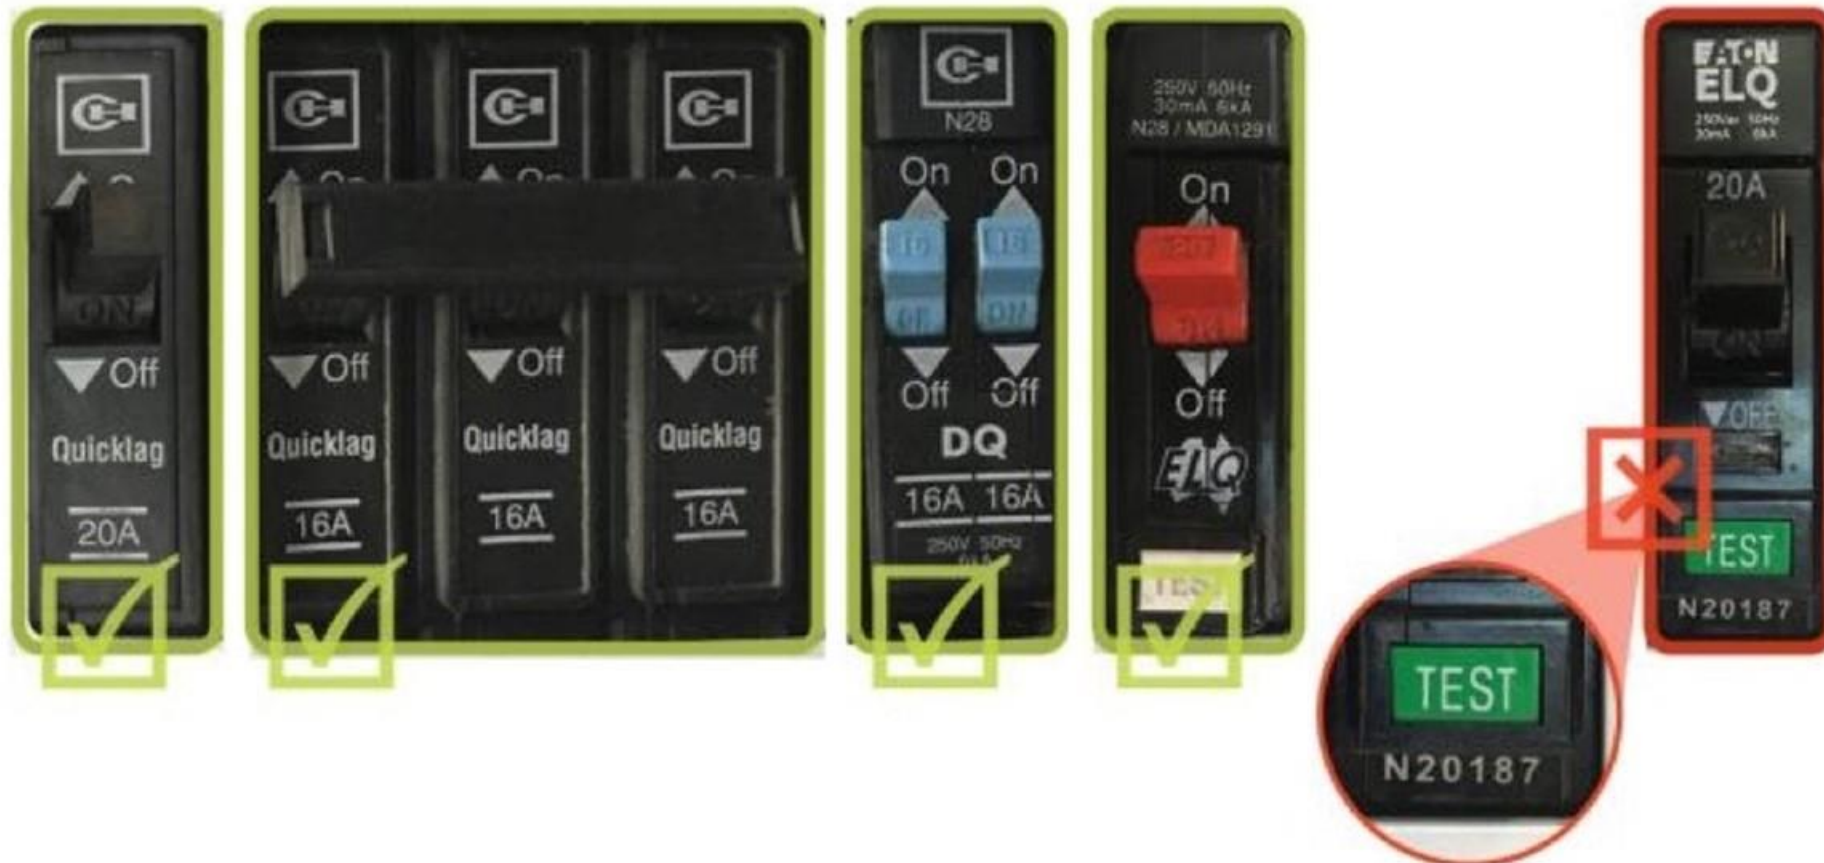
## ELQ-TW recall

During an audit of an electrical distribution board, a circuit breaker was identified as being of a type that was recalled several years ago. The Eaton Quicklag ELQ-TW earth leakage circuit breakers (RCBO's) had been recalled by suppliers due to the risk of electrical fire. This one was not identified at the time and remained in service.

**HAZARD:** A non-compliant material has been used in the manufacture of a component, and when operating under short circuit conditions the product may express ionised gases through the exhaust port which may result in conditions creating a fire risk.

**WHAT TO DO:** Building owners, managers and electrical contractors should check switchboards or loadcentres for potentially affected RCBOs. The affected models can be identified by the presence of a green test button, as shown in the above image. Products without a test button or with a white or an orange test button are not impacted by this recall. Further guidance on how to identify an affected model are available at [www.eatoncorp.com.au/elqtw-r](http://www.eatoncorp.com.au/elqtw-r)

Key Learning – it is important we act on product recalls by auditing our areas as soon as we are made aware of them and sharing notifications with others that may be affected. To audit your area - the effected models can be identified by a green test button as shown and were supplied nationally from 1<sup>st</sup> April 2004 to 15<sup>th</sup> December 2016.

If your RCBO is an affected model, contact Eaton at the contact details below to arrange for a replacement RCBO to be installed onsite at no charge.
