MONTHLY ELECTRICAL INCIDENTS

ASP Manufacturing

July 2021

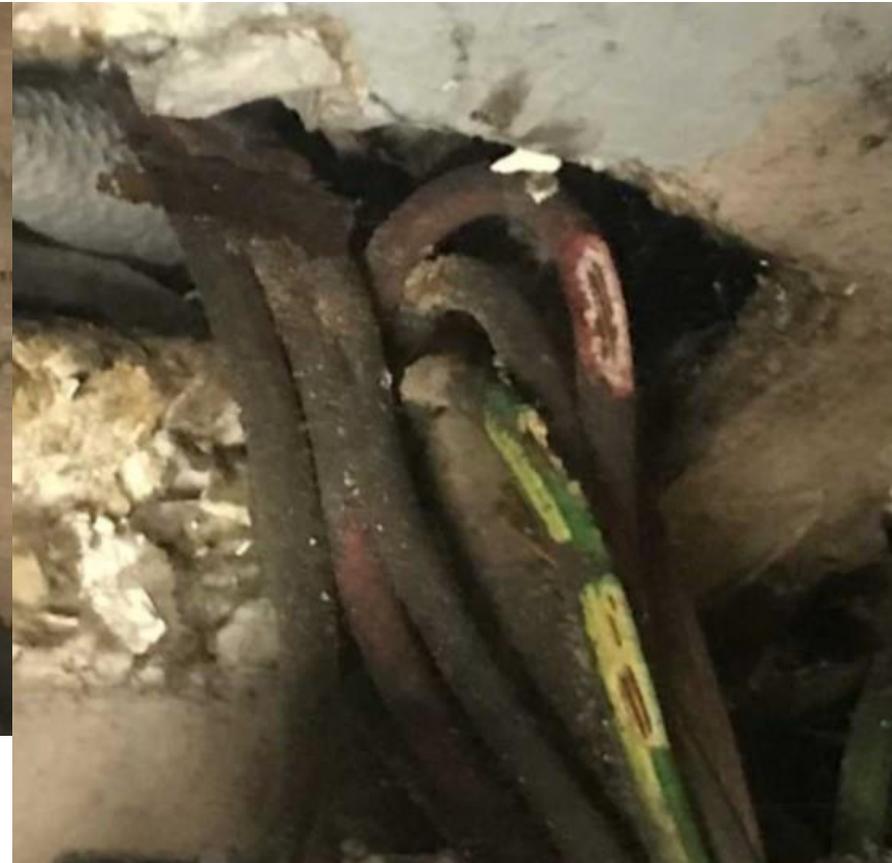
Electricians investigating an issue in a mechanical crib room found two hardwired wall plates with the appliance cables cut off at the wall plate leaving exposed conductors. The outlets remained energised at 240V ac and were fed from non-RCD protected circuit breakers. There was no record of what the outlets supplied.
