MONTHLY ELECTRICAL INCIDENTS

ASP Manufacturing

August 2021

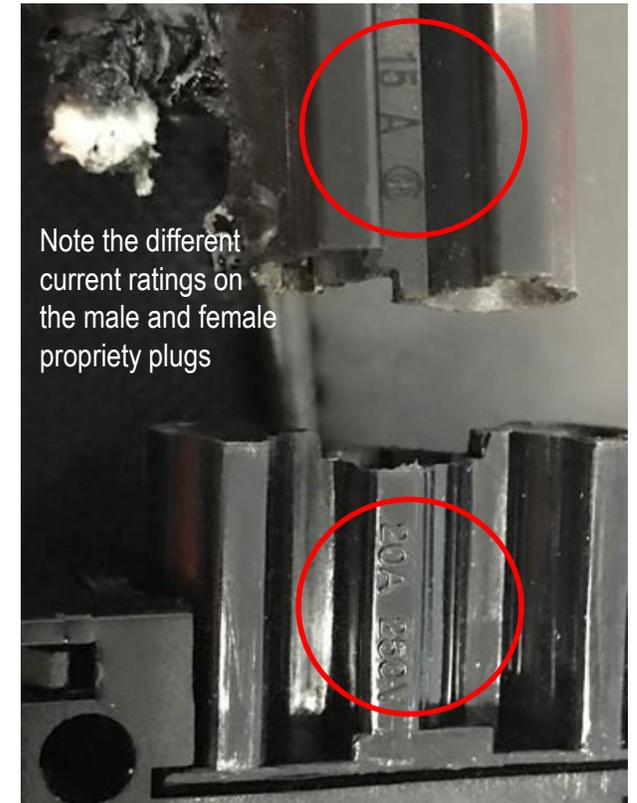
The outlets in two modular office cubicles had no voltage despite the 20 A supply being energised. The outlets are supplied from a TPS cable and plug, and then looped within ducting of the wall units through connectors at each outlet group. An electrician found the plug at the first outlet had come away from the socket resulting in a hot joint, melting the pin on the plug and creating an open circuit in the active conductor. Fortunately the fault did not lead to a fire.

The design of these modular units is four 10amp outlets per desk with two desks connected together all protected by a 20amp RCD breaker. Three large computer servers which pull over 5amps each, plus monitors and personal items were connected to the outlets, the total load was close to or exceeded the 20amp circuit protection.

Note the different current ratings on the male and female proprietary plugs

Supply capacity should be checked before installation of heavy loads. Office furniture, with in built power circuits are designed for standard loads and diversity, outlets may need to be audited to confirm circuits are not excessively loaded.

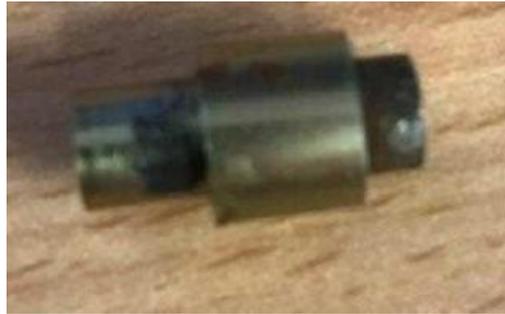
During de-isolation of a 100amp CFS unit an electrician has noticed the switch has failed to close. The switch has failed internally and the fuse cartridge became jammed and could not be removed. When the board was isolated the switch was removed to reveal the drive pin for the switch handle had broken away from drive plate rendering the switch inoperable. This is a similar failure of this style CFS unit from previous incidents which are being investigated.

The style of CFS board

This is a reminder for all BSL owners of this style of 100Amp or 200Amp CFS unit manufactured after 2005 to investigate if their switches potentially have this failure point.

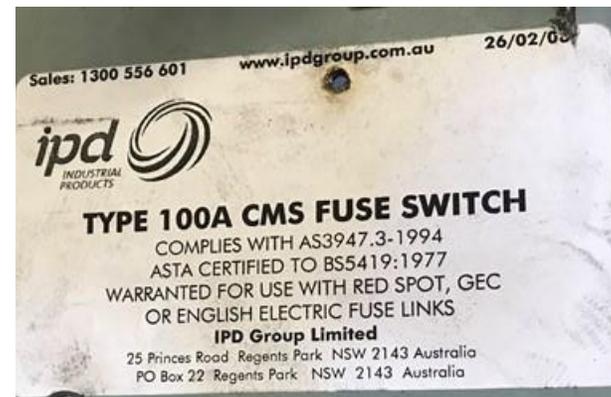
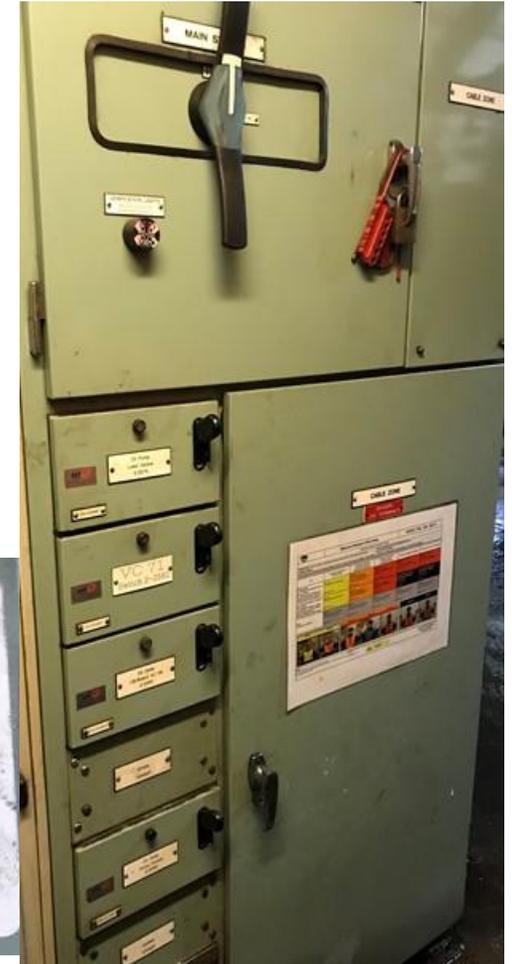
The name plate of the CFS switch

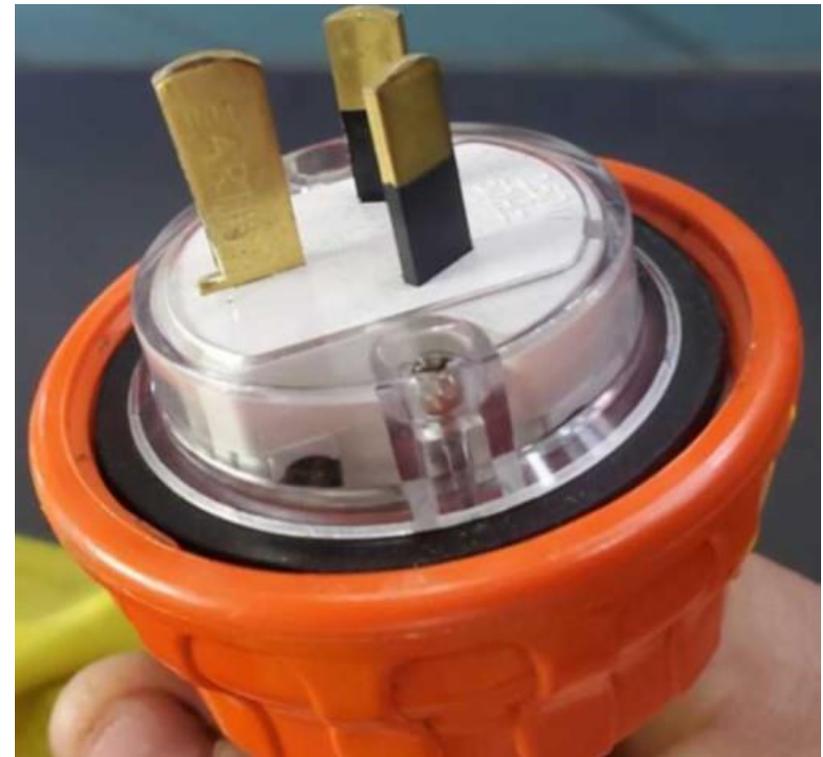
A roofing contractor supervisor returned a 15amp lifeguard power board because his firm could not use it due to the plug being 15amp and there only being 10amp outlets on site. The electrical supervisor with whom the board was returned noticed the 15amp earth pin of the plug had been modified. It seems an attempt had been made to reduce the size of the earth pin to fit into a 10amp outlet. The attempt failed when the cut in the pin was only on the shaft of the pin not the top part of pin, still not allowing the pin to be inserted in the 10amp socket. No one has admitted to modifying the pin.

Two views of the earth pin of the 15amp plug. Clearly the pin has been modified and reduced in size at the base of the pin, however, the top of the pin has not be reduced

Incorrect modifications to or repair of an electrical appliance may result in an electric shock or arc blast and flash injury. All appliances should be visually inspected by a competent person every time they are used and tested as fit for duty on a regular basis.
