MONTHLY ELECTRICAL INCIDENTS

ASP Manufacturing

January 2022

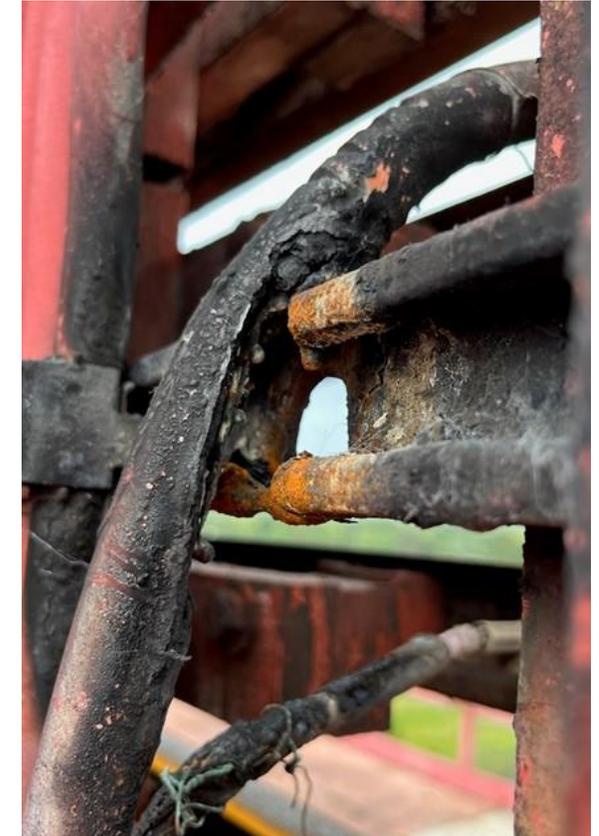
An audit of the earthing system of switchrooms A-21 and A-22 has found the earth piles to be in a bad state. One earth pile is in a pit filled with rust scale and has a busbar which runs into the switchroom connected to the pile with very poor connections. The other earth pile seems to be two driven rods in a pit, with one rod completely disconnected and the other rod only partially connected to the busbar which runs into the switchroom.

As per AS3000 section 5.1.2 an earthing arrangement shall be installed to enable the automatic disconnection of the supply in the event of a short circuit to earth. To ensure the integrity of our earthing systems there must be regular inspections of the earthing system parts from earth piles right through the protective earth connection on an electrical device.
