# MONTHLY ELECTRICAL INCIDENTS

**ASP Manufacturing**

**May 2022**

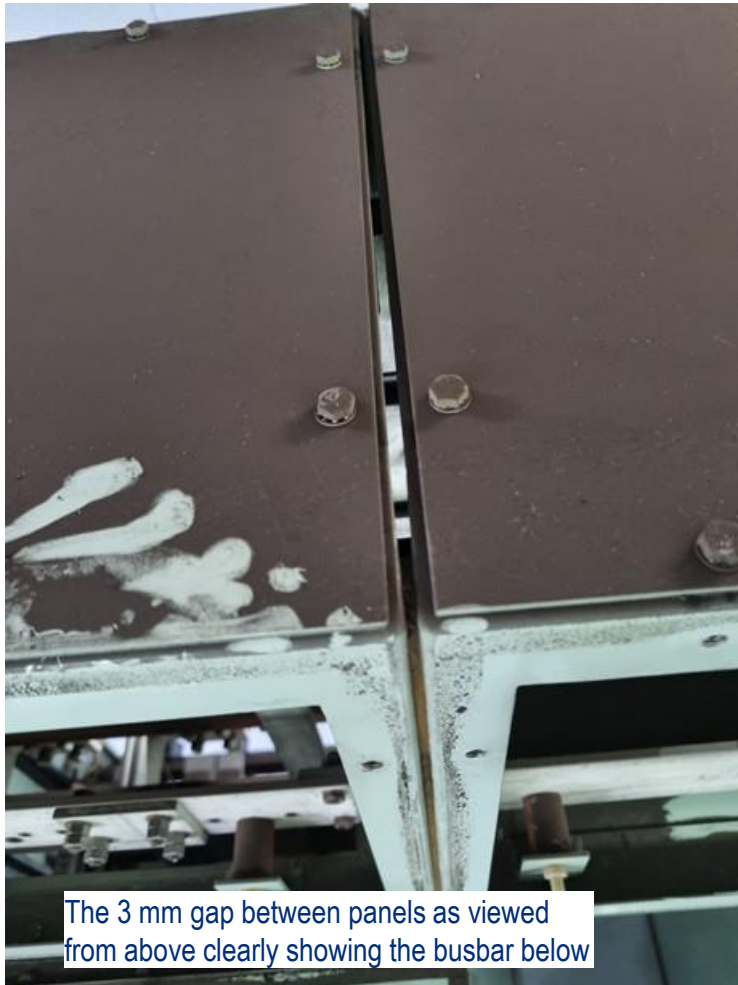
Whilst carry out maintenance and inspections of the 415V main distribution boards a gap has been found between the panel sections and covers on the busway chamber. The high fault level 2000 amp busbar could be accessed through this 3mm gap by dirt, moisture, foreign equipment or venom. This board is 25 years old and has been in this state since initial installation.

As per Electrical Safety Manual 1.4.22 all electrical installations are to be regularly inspected and maintained. Electrical owners of the equipment have a duty of care to ensure the installation still complies with the relevant Australian standards and is safe to operate.

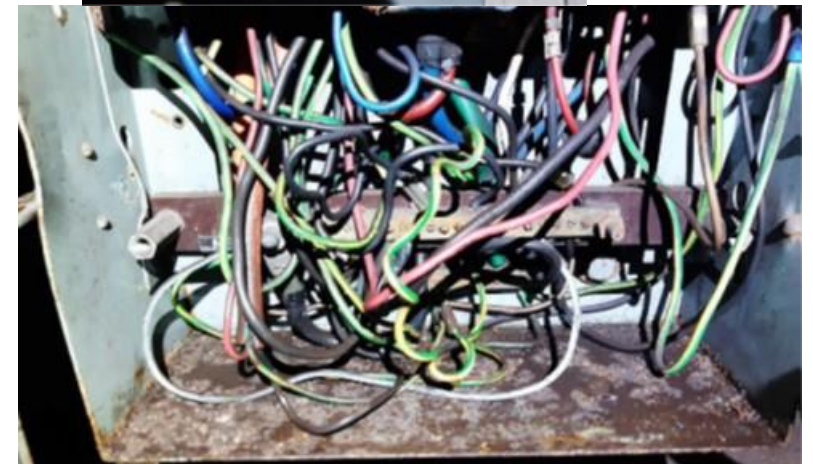
An operator attempting to close a roller door by operating a local isolator has heard a bang inside the enclosure for the isolator. An electrician called to investigate has found the roller door control box and isolator to be covered with water from the recent rain. The isolator mounted on the side of the control box has a top entry cable installation. Water has entered the enclosure through this top entry and run down internally onto the isolator. The action of the isolator being rotated has shorted two phases of the power supply. Two 32amp fuses have been found blown. The fuses were in an old style fuseboard with all the cables top entry and again this board had water ingress from the top entry.

The supply fuseboard with all the cables top entry. Below the internal bottom of the fuseboard with moisture and rust evident.

As per Electrical Safety Directive 2017-01 and Electrical Installation Manual section 4.5 all electrical installations should have bottom entry for all cabling as to not compromise the IP rating of the equipment and to suit the environment of the installation.

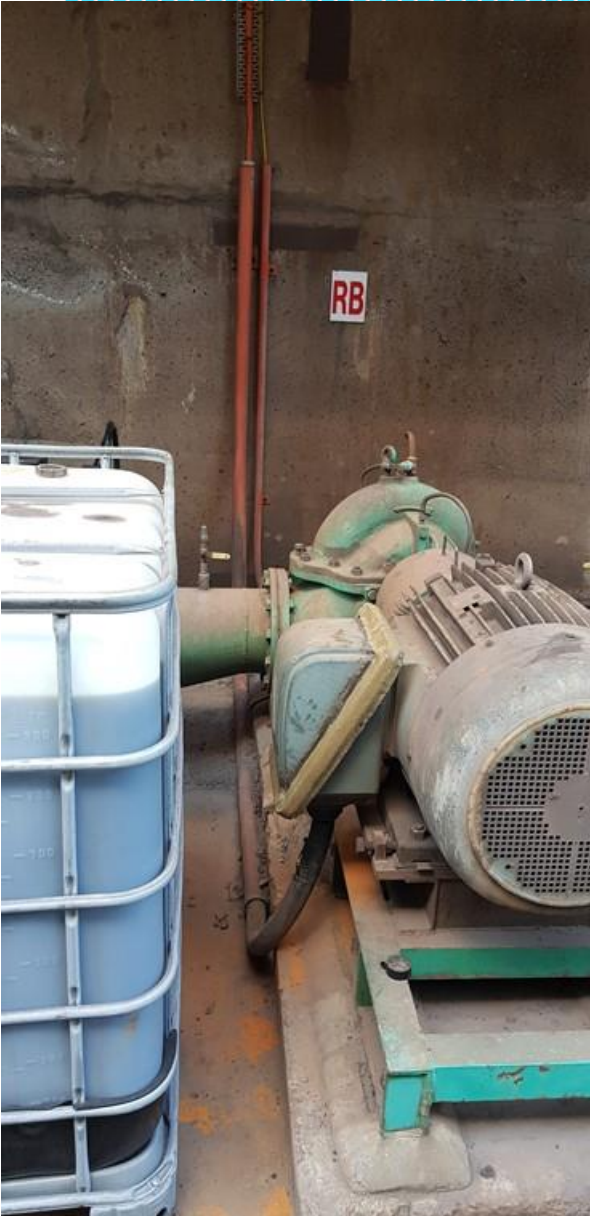
An electrician doing routine maintenance on a motor has opened the terminal box to find water at the bottom of the box. There was approximately 100mm clearance between the pooled water and the motor terminals which had allowed the motor to remain in service. A inspection of the installation has found the bottom cable entry into the terminal box was by a fixed Anaconda fitting which had not allowed the water to escape. The motor cable had come off overhead cable rack into water pipe which is run all the way to the motor. The high end of the water pipe is open to the elements allowing rain water to enter and fill up the pipe. With the water pipe high enough there is sufficient head pressure on the water in the pipe to allow it to run up inside the motor terminal box.

As per Electrical Installation Manual section 4.5.1 the integrity of the IP rating all field enclosures shall not be compromised by additional protection, which should be installed to suit the environmental conditions. All cable entries should be from the bottom and all conduits (fixed or flexible) have an allowance to let water exit before it enters the electrical installation.
