# MONTHLY ELECTRICAL INCIDENTS

**ASP Manufacturing**

**February 2023**

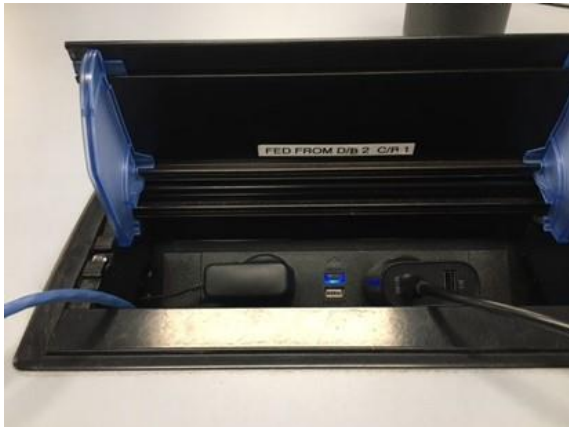
An operations person noticed a USB charger pack in a desk mounted media outlet was sitting at an odd angle. An electrician investigated and found the charger had separated from an adapter used to convert the charger for use on Australian sockets. The adapter cover was damaged effectively leaving the pins inserted into the 240V outlet exposed to any unsuspecting person to touch.

The desk mounted multi media outlet

All USB charging devices used should only be proprietary items supplied by the manufacturer and certified fit for Australian conditions. Alternatively USB charging outlets integrated into 240V outlets should be used to eliminate the need for USB chargers., which comply to IEC 60884-3-1:2021 Plugs and socket-outlets for household and similar purposes - Part 3.1 Particular requirements for socket-outlets incorporating USB power supply.

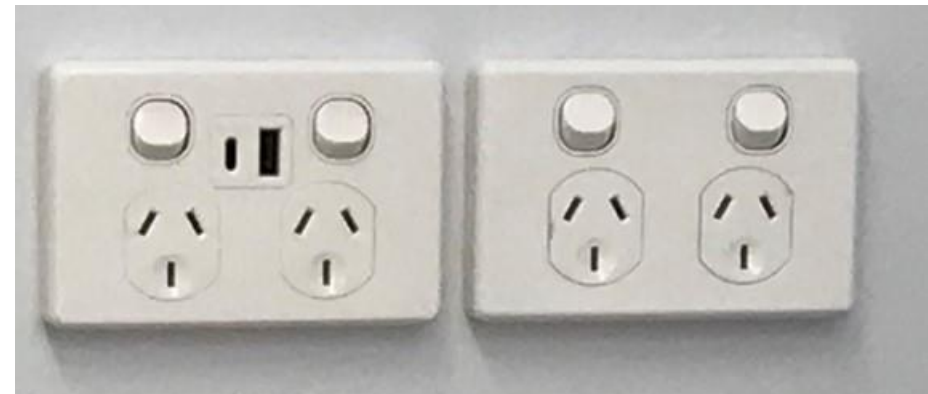
An example of USB charging outlets integrated into a standard 240V outlet.
