Electrical Incidents

Key Learnings

ASP Manufacturing

November 2023

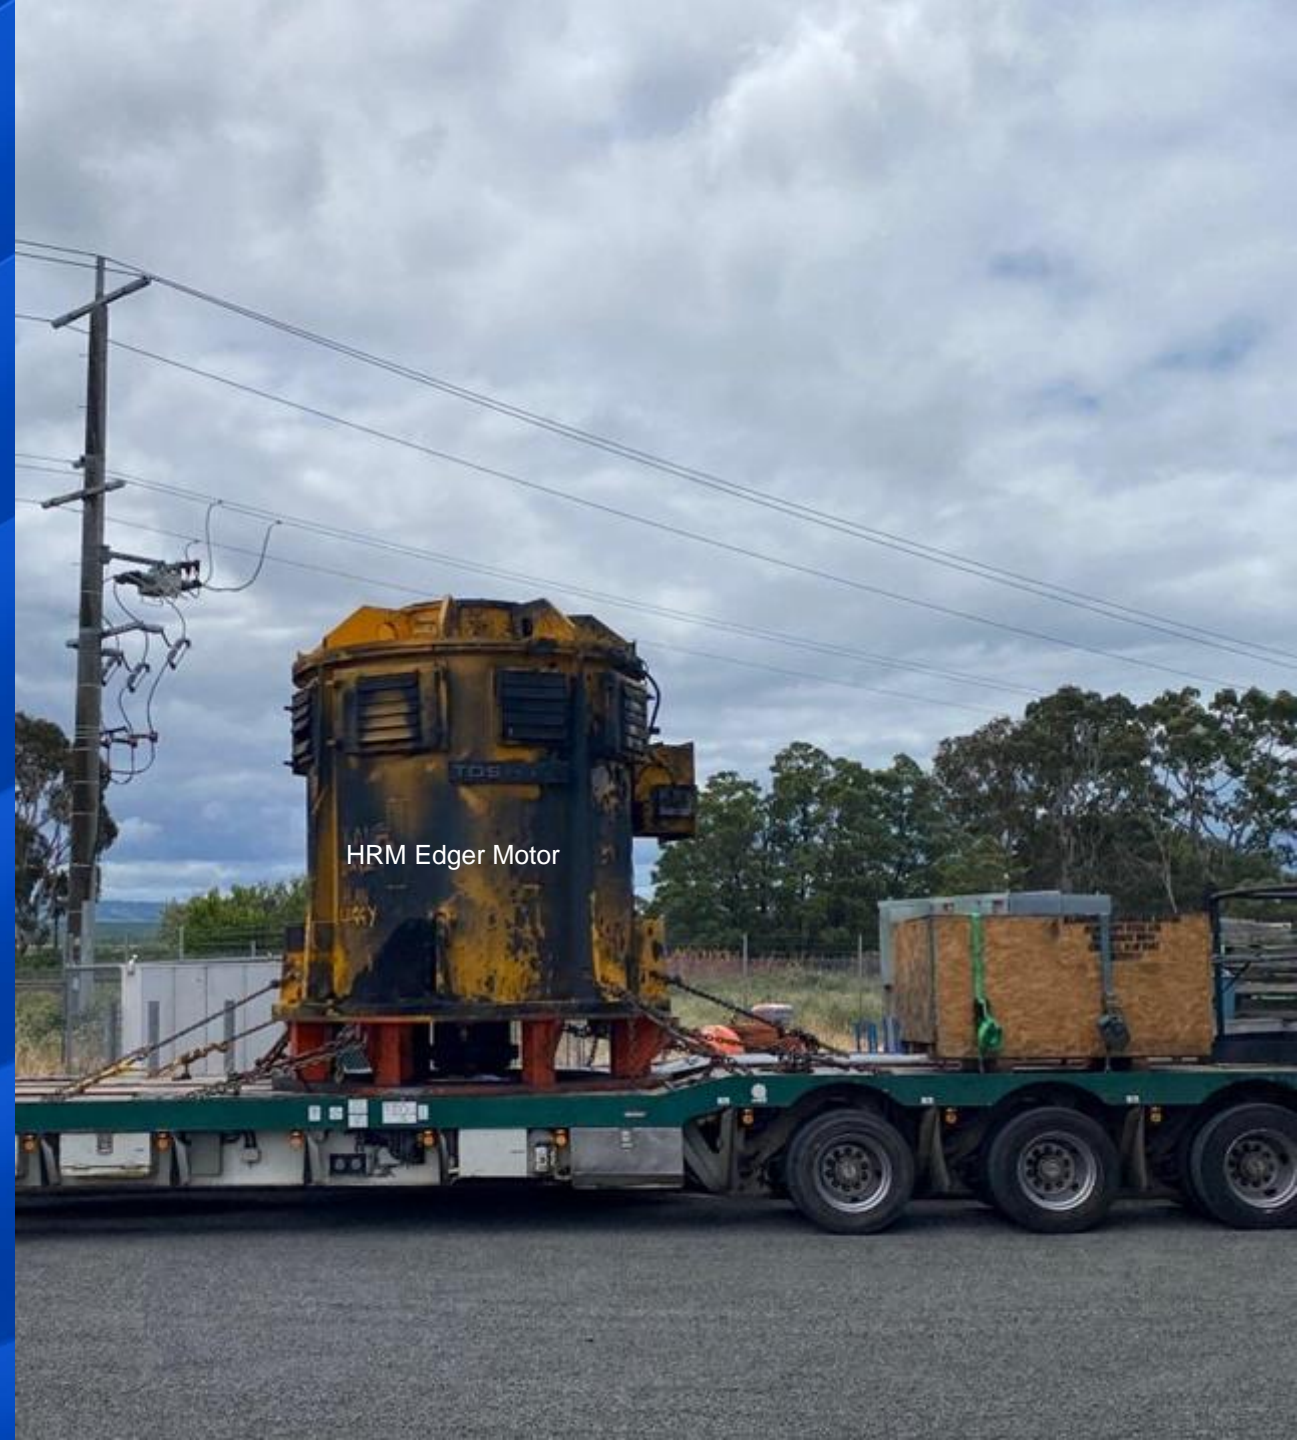
HRM Edger Motor

Motor area (photo of motor on front cover of this report)

- A large 1500 kW DC motor overheated & caught fire after the main control board was replaced. The motor had not been run yet, only the fields were energised. An investigation found a redundant control cable was inadvertently connected to the main control board instead of the field current feedback cable. Loss of field current feedback resulted in undetected overcurrent and damage to the shunt field coils.

- The drive had two independent field converters added in 2016 to allow operation using motors with different field characteristics. The original common field converter was decommissioned but the feedback cable was not removed. The original field converter also featured separate overcurrent protection which would have protected against overcurrent in the event of feedback failure, this wasn't part of the new design. The two defects resulted in significant motor damage and a 48 hour production delay.

- De-commissioned equipment should be either fully removed or clearly identified and made safe.
- Thorough design review is required to identify failure modes, effects and controls required.

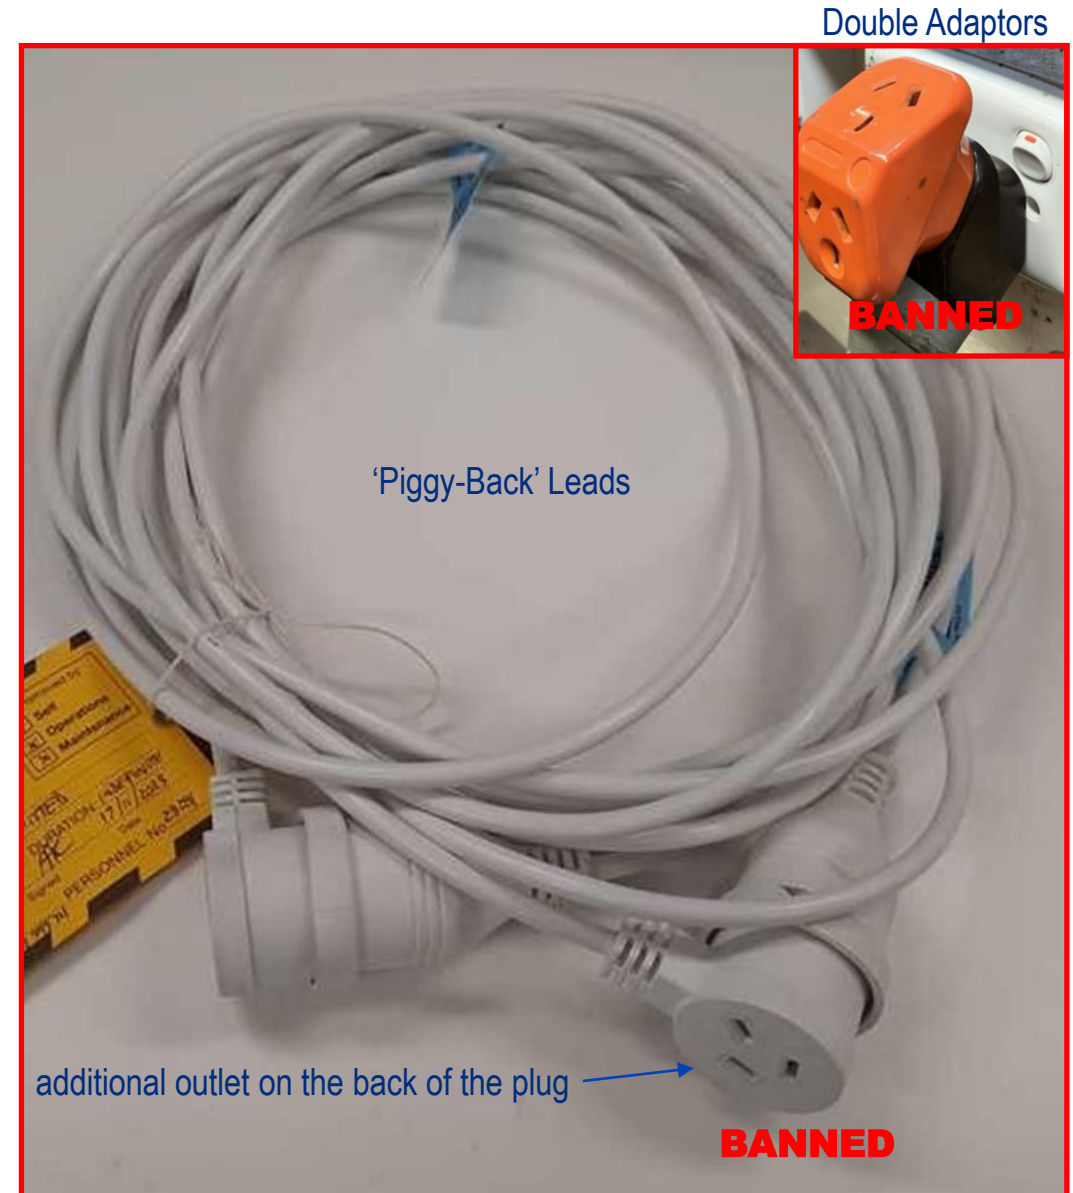
- Whilst setting up a meeting room, two electrical extension leads were discovered that are banned items on the BlueScope Restricted Equipment List. Known as ‘Piggy-Back’ leads, they consist of a 240 Volt extension lead with an additional outlet on the back of the plug. They had not been tagged and tested or connected to any devices.

- These electrical leads had been brought on site without being checked by an electrician.
- ‘Piggy-Back’ leads and double adaptors are banned from BlueScope sites because they may cause an overload condition introducing the risk of fire, equipment damage and electric shock.
Refer to BlueScope Restricted Equipment List – Document [DS.BZ-SEQ-S-10-241.01](#)

- Power boards of the appropriate construction, IP rating and overload protection for the environment may be used as per
BSL Electrical Safety Manual Part 1 – [MA.DIV-ENG-ET-004-01](#), Rev3, sect 1.4.14 (p.28).

Note: Power boards shall not be connected into another power board.
