4/08/2020

## More workers falling through roofs in NSW

## Incident Information Release

SAFEWORK NSW

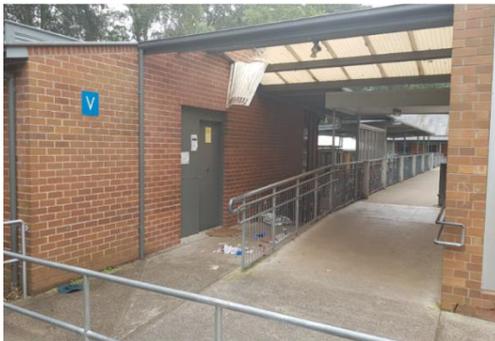
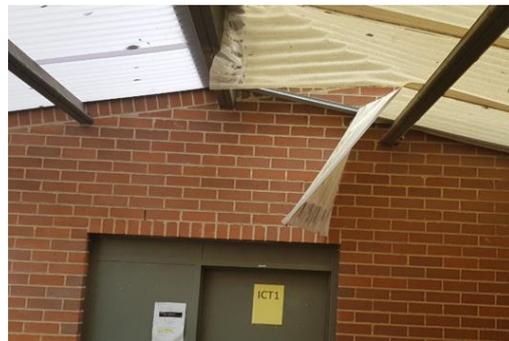
A 52-year-old subcontractor has fallen 3.5 metres onto concrete pavement at a school in Wahroonga. The subcontractor was cleaning the roof gutters when he stepped onto polycarbonate roof sheeting which gave way causing him to fall through. He sustained severe head injuries in the fall and passed away in hospital.

*The site where the incident occurred at Wahroonga*

Not all areas on a roof are safe to walk on. Even roof sheeting that claims to be okay to walk on is reliant on correct installation and can become brittle over time. Don't walk on skylights, or plastic and asbestos roof sheeting, unless assessed as structurally sound by a competent person.

Consider what tasks can be done without accessing the roof. For example, work from underneath using a scaffold or elevated work platform.

If you must access the roof, check its condition, the roofing materials, fixings and safety mesh to determine the safest path.

If sheeting appears brittle, you must manage the risks of falling through the roof.

You must:

- install guardrails around non-trafficable areas, or use a work positioning system
- cover non-trafficable sheeting securely and place warning signs nearby
- work from temporary work platforms (crawling boards) or roof ladders, where appropriate
- install safety mesh
- use an adjustable fall-arrest system, such as a harness, with proper anchor points, and train workers in how to use them
- prepare a site specific safe work method statement (SWMS) for all high risk construction work

- have plans in place in case of emergency, particularly with respect to the use of fall arrest systems

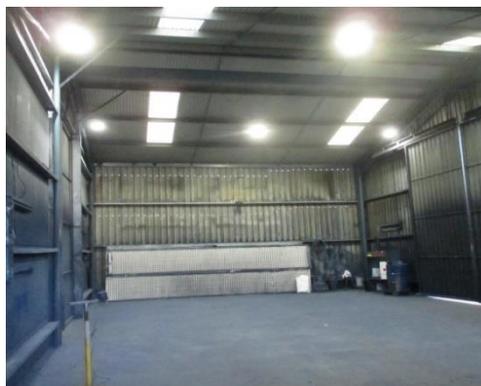
Last month a 21-year-old apprentice carpenter fell through perspex roof sheeting at a manufacturing plant in central western NSW. He landed on the concrete floor 7 metres below, fracturing his wrist, ribs and pelvis.

*The shed where the carpenter fell, noting the perspex roof sheeting*

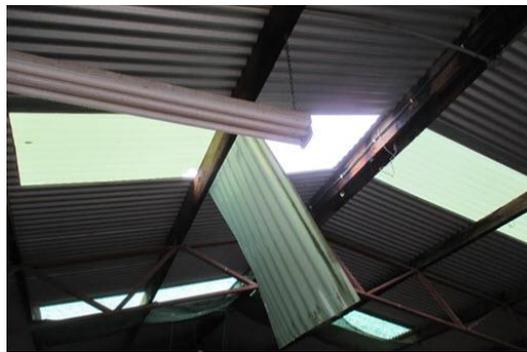
In May, a 27-year-old roofing contractor fell 3.6 metres through a roof of a sheering shed on a rural property near Parkes. The worker was installing solar panels when the alsynite roof sheeting he was on gave way, the fall resulting in a fracture in his back.

*Roof sheet the worker fell through*
